# **Infrared Thermography Goes Underground:**

## **How a Major Metropolitan Subway is Using Thermal Imaging to Help Improve Reliability**

Mary F. Molle, Vice President  
Jersey Infrared Consultants

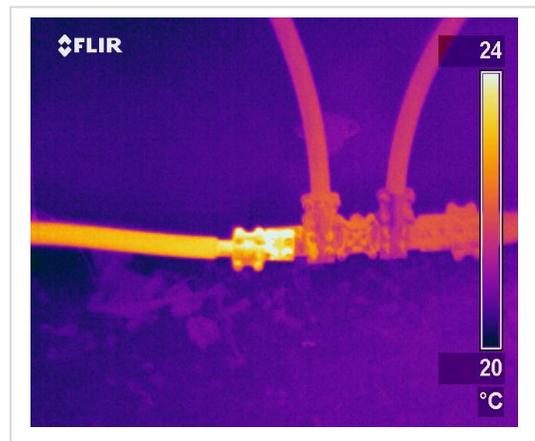
**Thermogram shows an increased temperature (white) at a cable termination.**

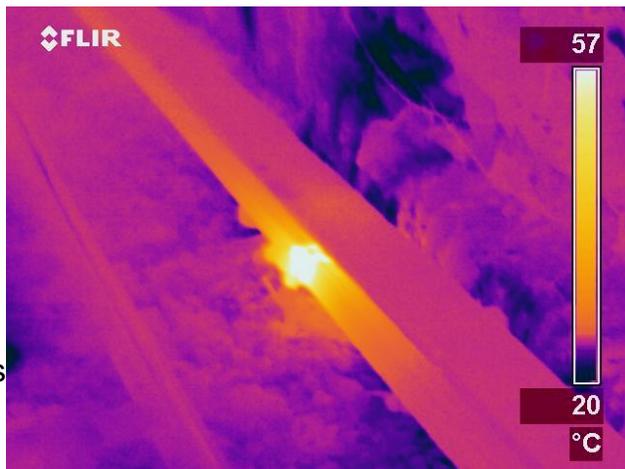
**This thermogram shows a typical third rail problem. At the time this image was taken, there was a 41°C temperature differential between rail sections.**

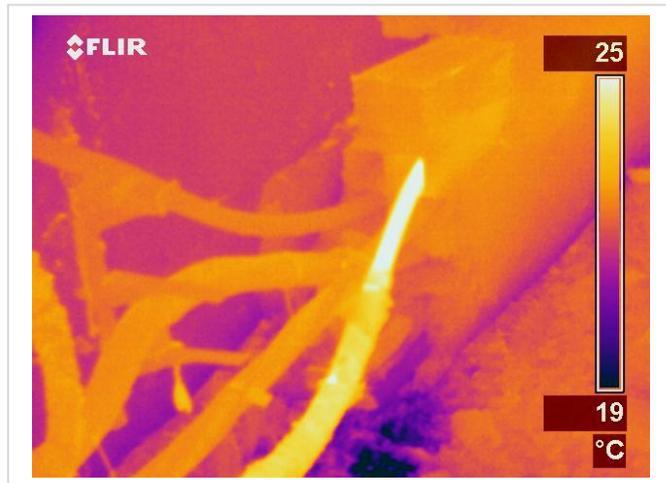
**This thermogram shows a cable entering a junction box. Since it was not possible to do further investigation at the time of the survey, it is possible that temperatures within the box are higher than shown on the cable.**
