# **Power Quality Case Studies**

Frank Sinicola

GFI  
1414 Outlook Avenue  
Bronx, NY 10465  
Ph: 888-511-8721  
Email: Frank@gfipq.com

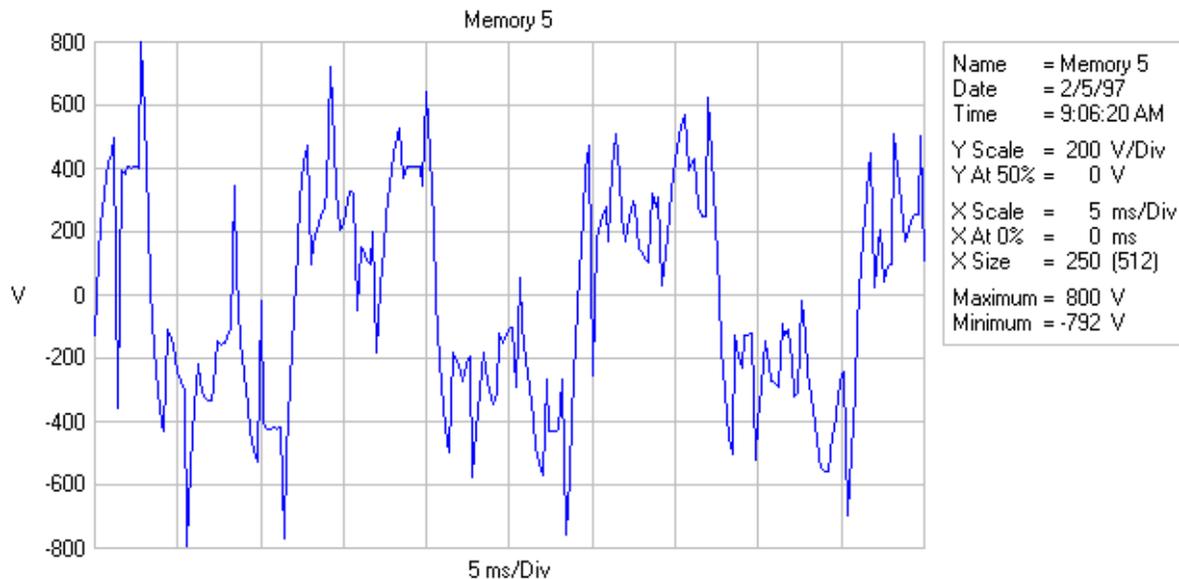
The facility is served by a network, with grounded-wye transformers. Measurements at the motor terminal show that the line-to-ground rms voltages are approximately 340 volts with a peak voltage of approximately 800 volts (Fig.1). This clearly demonstrates a higher line-to-ground insulation stress on the motor side of approximately 2 pu of nominal voltage. This high voltage on the motor side is a result of 'neutral shift' phenomenon that is associated with current source drives connected to a grounded neutral system. Measurements of line-to-ground and line-to-line voltages at the drive input (supply side) were within the expected range (277V, L-N & 480V, L-L).

**Figure 1: Voltage Waveform: Motor Line-to-Ground (Peak 800 Volts, RMS 334 Volts)**

Based on the investigation and the information given to us by OFCO personnel it is our opinion that the premature failure of motors at OFCO is related to a 'Neutral Shift' Problem. This conclusion is based on several observations that are outlined below:

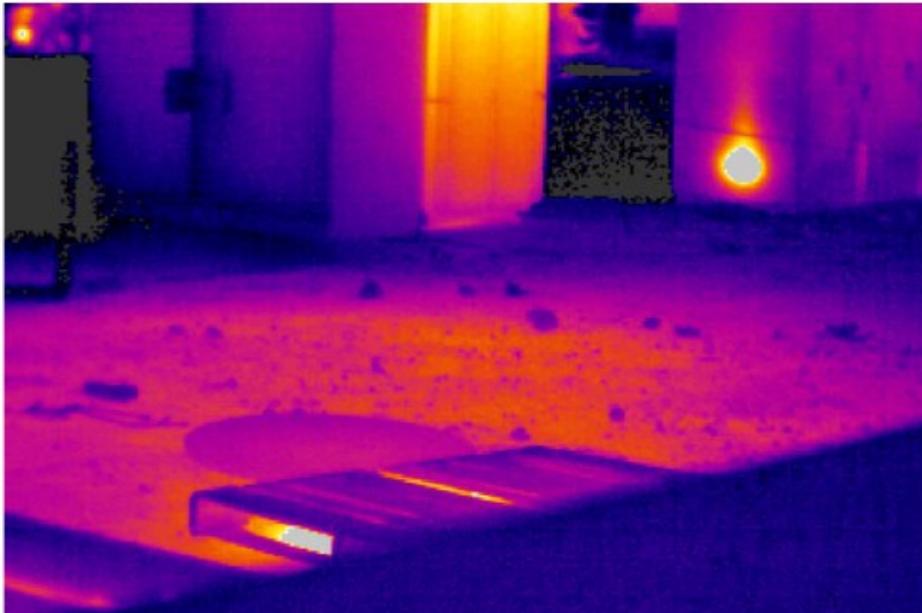
With the need to see what was happening thermally, I was brought in to infrared and possibly pinpoint the anomaly. The first thermal pattern I noticed was the ground between the transformer and the customer's service entrance. Specifically, the area where the customer's transition manhole was located was hotter than the surrounding area. (Figures. 1 and 2)

**Figure 1- Thermal pattern of area over manhole.**

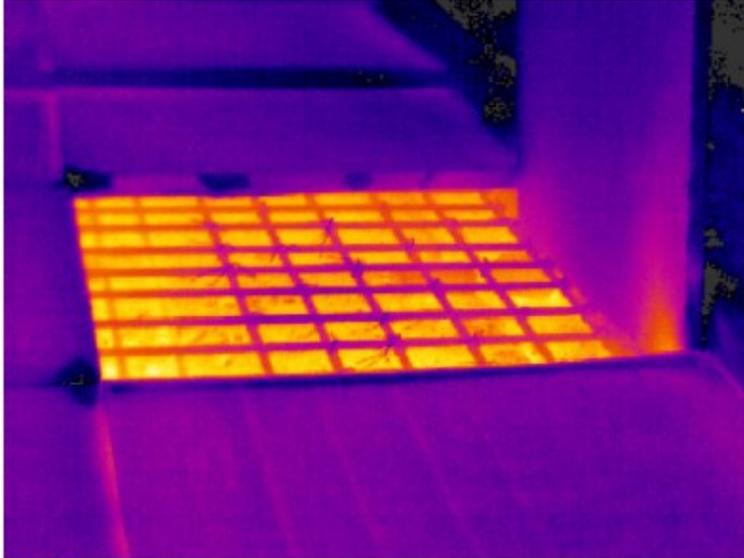
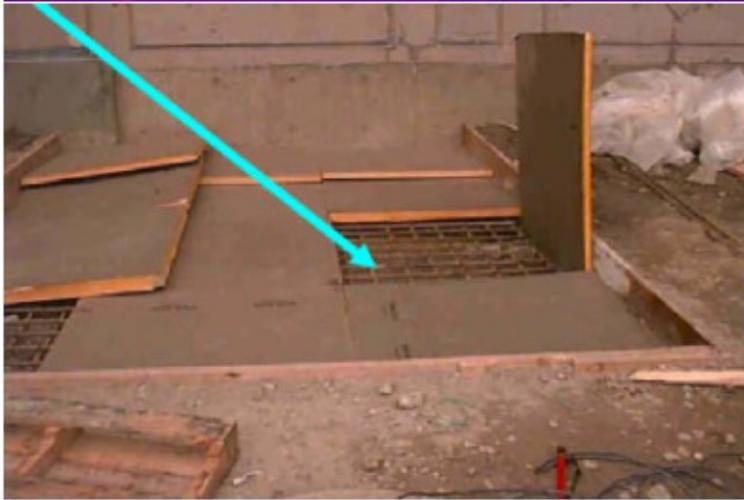
**Figure 2 – Area that was being prepared for a new structure. The pictures show the rebar and insulation.**

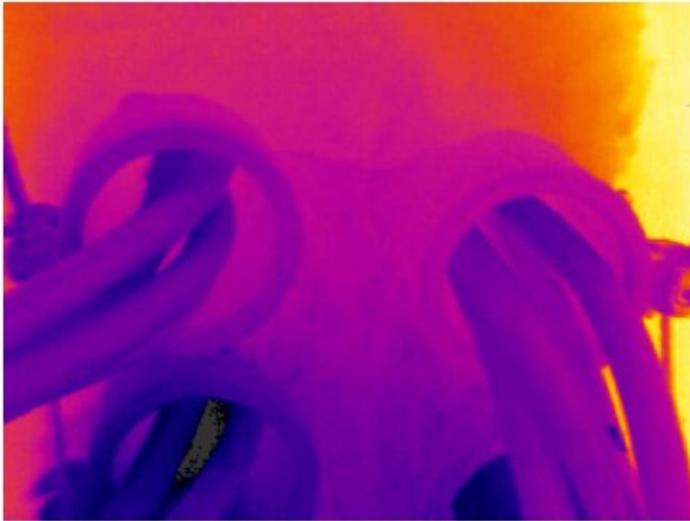
Upon further investigation of the manhole, I noticed that the cable and ducts coming from the transformer were running 15C – 20C degrees cooler than those cables and ducts going to the customer's service entrance. (Fig. 5&6) The cable joints in the manhole all looked normal thermally.

**Figure 5 – Cable and ducts coming from utilities transformer. Temperature = 80C.**

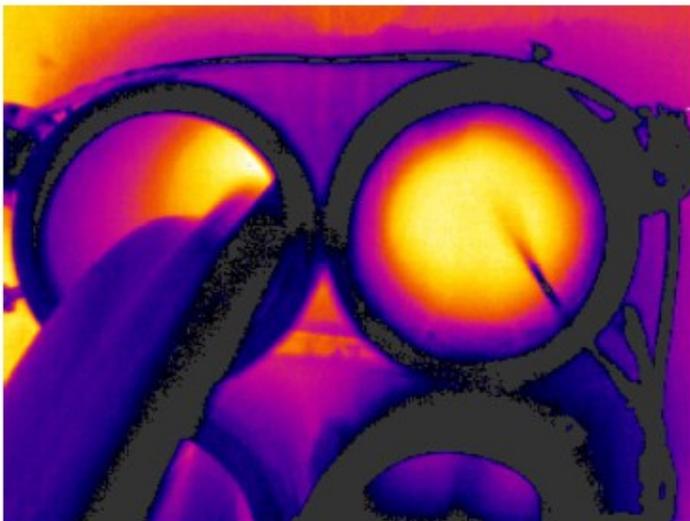
**Figure 6 – Cable and ducts going to customer's switchgear. Temperature = 98C.**

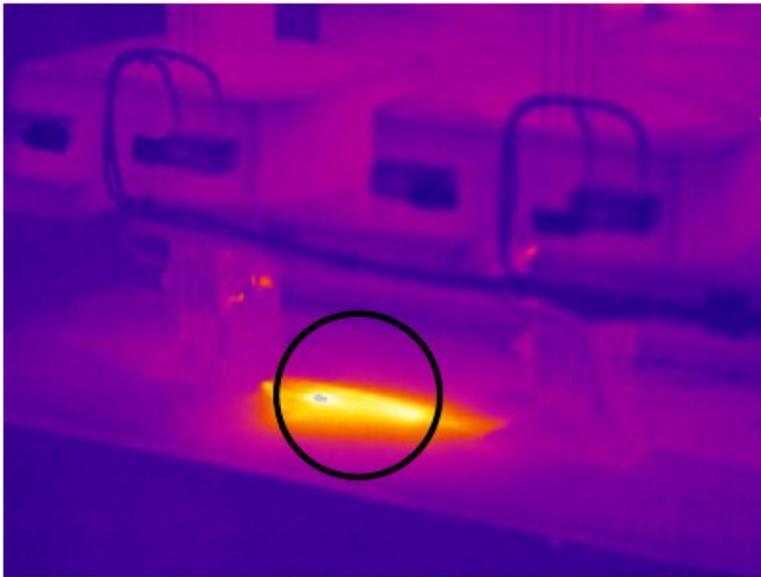
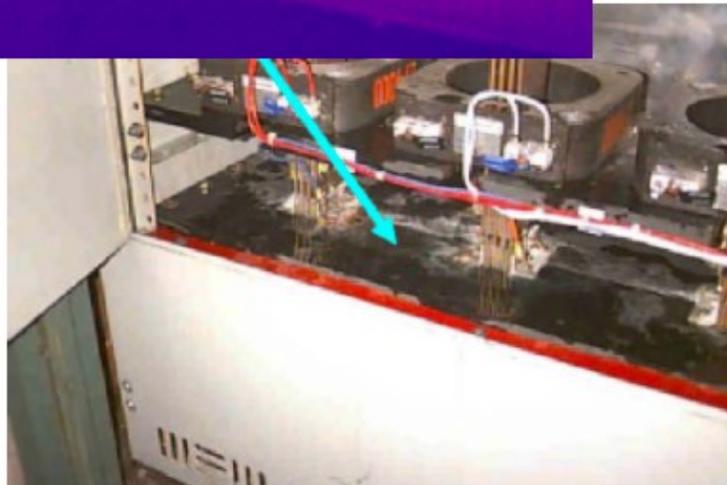
Our next area to investigate brought us to the customer's switchgear, specifically the C.T. cabinet. The cabinet was located at the entrance to the indoor parking garage, about 50 feet from the customer's manhole. It was at this point we realized the customer had a dangerous water and electrical problem. It looked like it was raining in the cabinet. Condensation was forming all over the cabinet and on the electrical equipment. I took some digital pictures for the report and decided to take an infrared picture to see if anything else showed up. Much to the astonishment of all the engineers and electrical experts, we saw that the water was heating up between A and B phases and also between C phase and the neutral bus. Danger signals went up. We took voltage readings of the water. The readings showed that there was 60 to 70 volts, line (water) to neutral. It was determined that there was enough sediment in the water to cause 'TRACKING'. (Figures 8,9&10)

**Figure 8 – Area between A & B Phases. Max Water temperature = 33.1C**

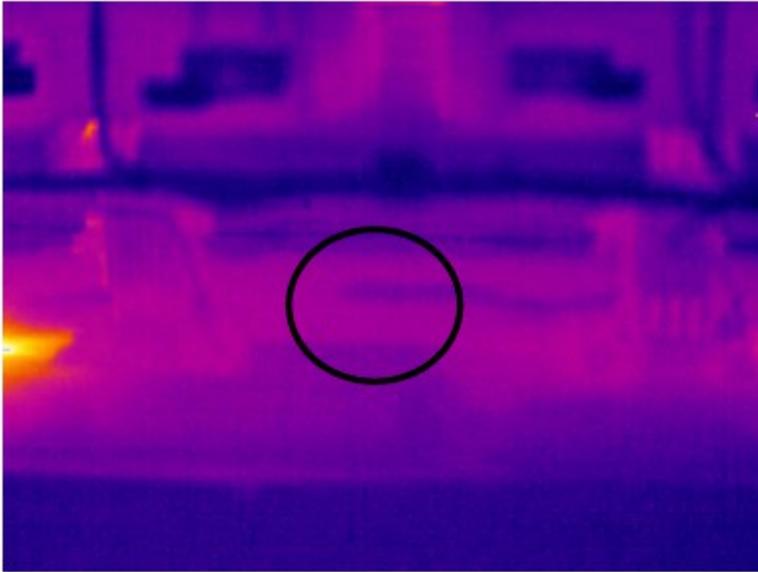
**Figure 9 – Area between B & C phases. Max Water temperature = 7.0C**

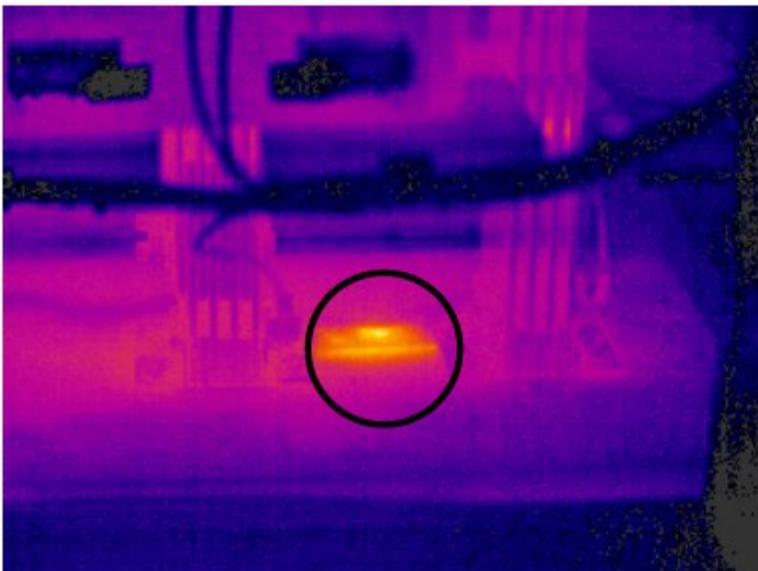
**Figure 10 – Area between C Phase and the Neutral Bus. Max Water temperature = 16.0C**

Over the weekend, with the help of the Utility, the customer's electricians investigated the cables and duct from the customer's manhole to the service entrance and the problem was found. A high impedance fault was found on the customer's side ducts. This caused the area where the ducts were laid to heat up, which in turn caused a condensate problem (steam). The occupied ducts now became load-carrying conductors that heated the adjacent soil causing steam and condensate. The unoccupied ducts going to the switchgear now carried steam to the cabinet that was exposed to the cold weather. The mixture of steam and the cold cabinet now formed the condensate problem that manifested itself in the form of puddles of water between the live bus detail. The potential for a disaster was averted.

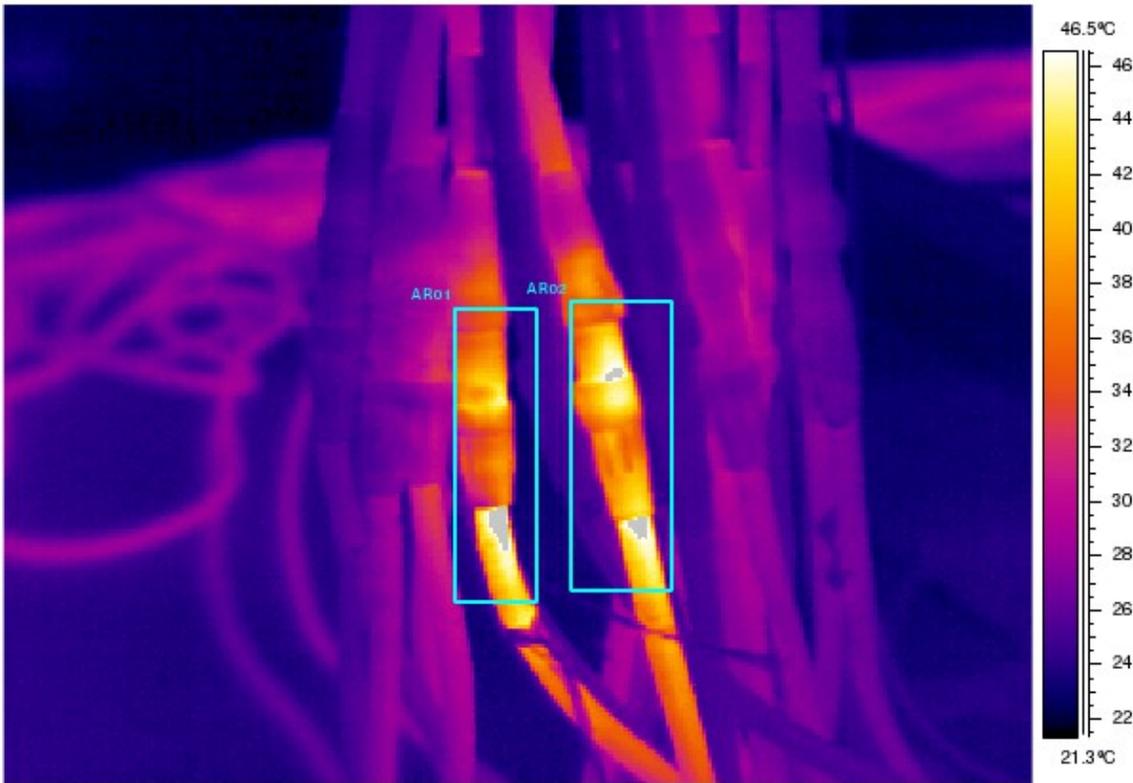
**MERCANTILE  
NORTH END & VESEY  
GENERATOR 009**

IR information	Value	
Date of creation	9/21/01	-
Time of creation	9:53:36 AM	-
File name	B0921-01 .img	-
IR Text Comment	Value	
CUSTOMER	MERCANTILE/NORTH END & VESEY/GEN.009	-
EQUIPMENT	CAM CONNECTORS	-
Object parameter	Value	
Reference temperature	27.0°C	-
Label	Value	Diff temperature
AR01 : max	51.5°C	24.5°C
AR02 : max	49.8°C	22.8°C

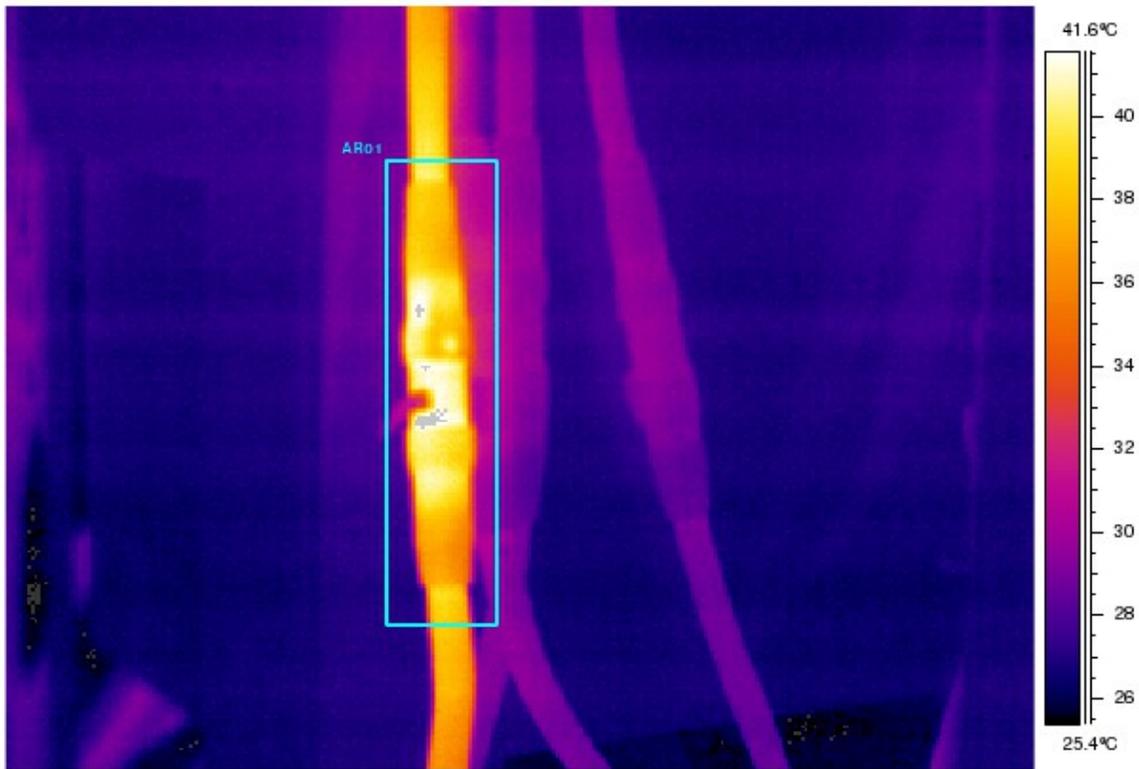
**55 BROADWAY**

<b>IR information</b>	<b>Value</b>	
Date of creation	9/21/01	-
Time of creation	10:28:57 AM	-
File name	B0921-02.img	-
<b>IR Text Comment</b>	<b>Value</b>	
CUSTOMER	55 BROADWAY	-
EQUIPMENT	CAM CONNECTOR ON NWP	-
<b>Object parameter</b>	<b>Value</b>	
Reference temperature	29.0°C	-
<b>Label</b>	<b>Value</b>	<b>Diff temperature</b>
AR01 : max	42.4°C	13.4°C

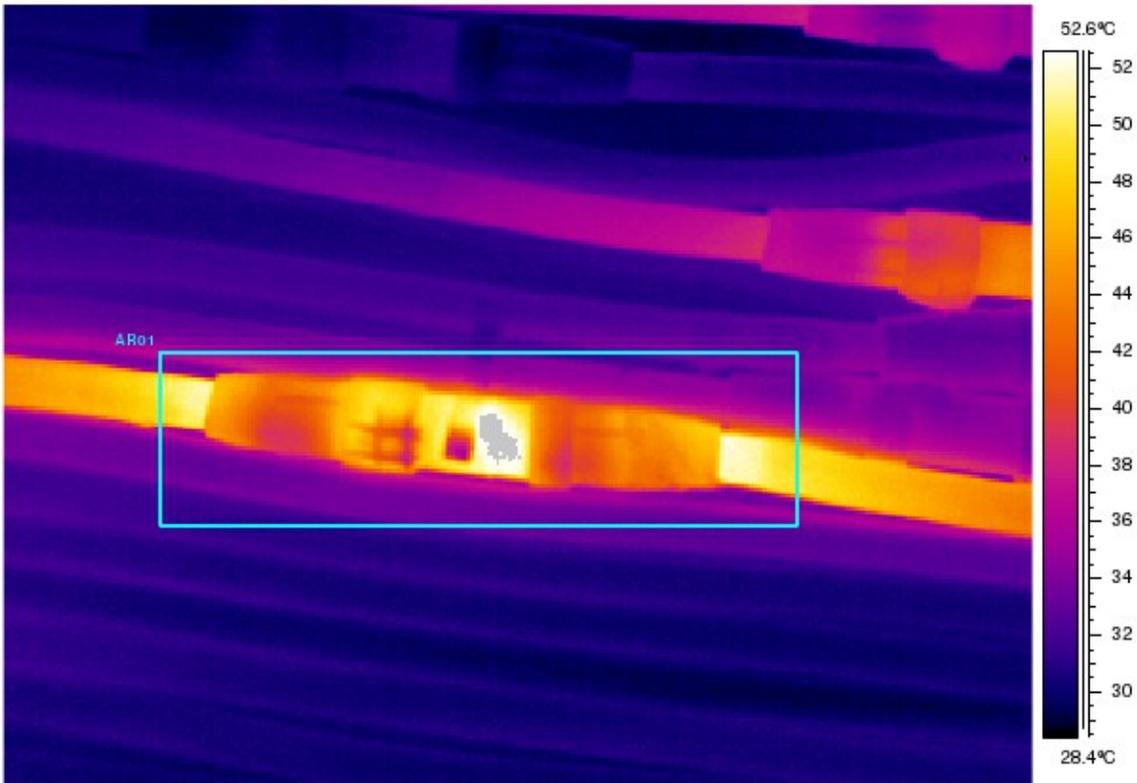
**55 BROADWAY**

IR information	Value	
Date of creation	9/21/01	-
Time of creation	10:31:05 AM	-
File name	B0921-03.img	-
IR Text Comment	Value	
CUSTOMER	55 BROADWAY	-
EQUIPMENT	CAM CONNECTOR SAME CABLE	-
Object parameter	Value	
Reference temperature	30.0°C	-
Label	Value	Diff temperature
AR01 : max	53.9°C	23.9°C

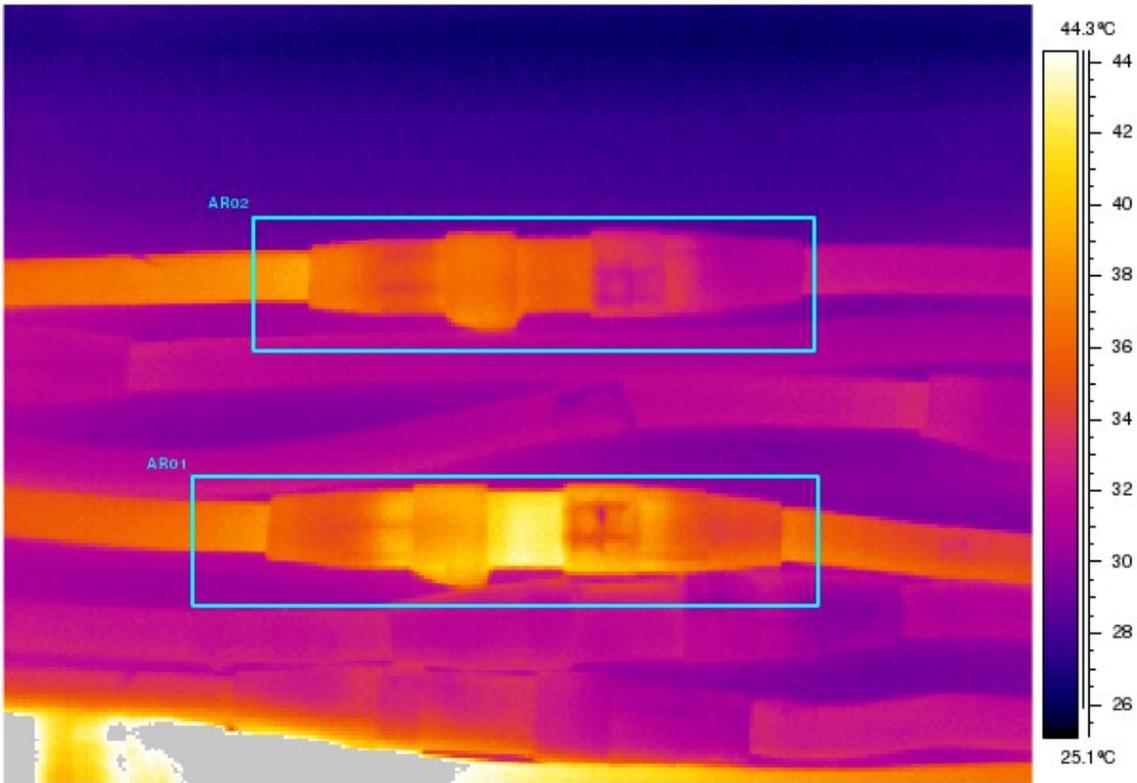
**55 BROADWAY**

IR information	Value	
Date of creation	9/21/01	-
Time of creation	10:31:23 AM	-
File name	B0921-04.img	-
IR Text Comment	Value	
CUSTOMER	55 BROADWAY	-
EQUIPMENT	CAM CONNECTORS	-
Object parameter	Value	
Reference temperature	30.0°C	-
Label	Value	Diff temperature
AR01 : max	43.6°C	13.6°C
AR02 : max	39.2°C	9.2°C

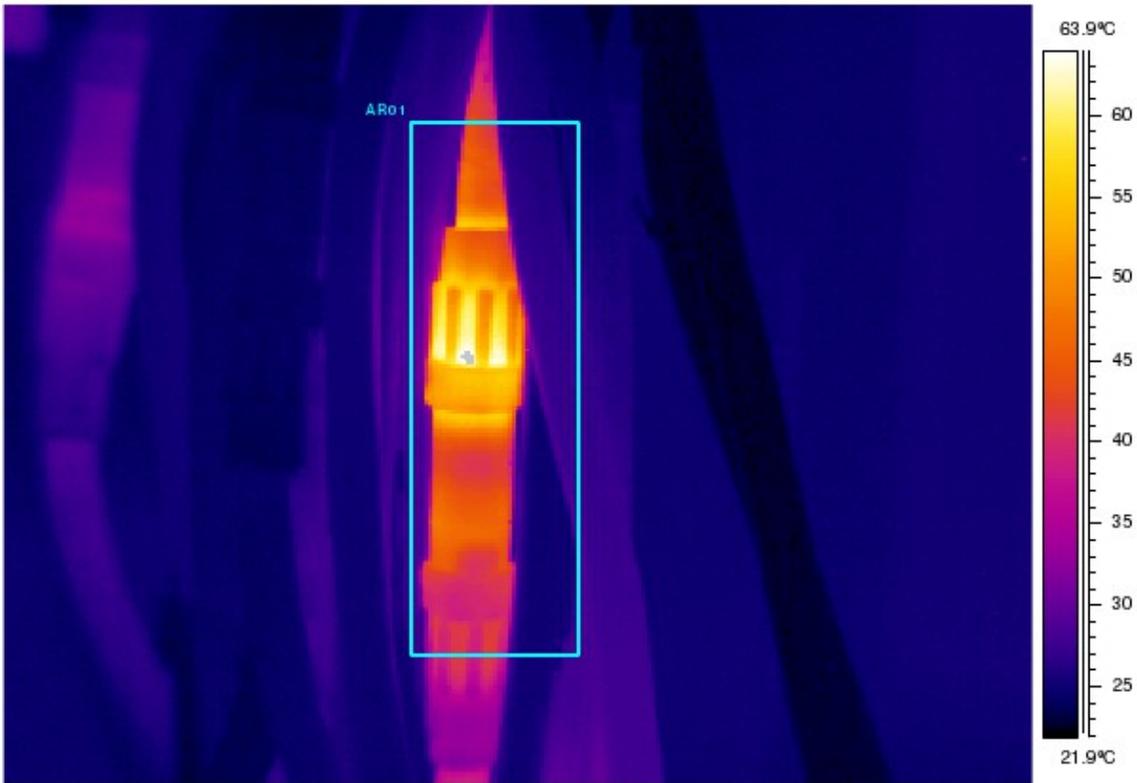
**25 BROADWAY  
GENERATOR 013**

IR information	Value	
Date of creation	9/21/01	-
Time of creation	10:44:13 AM	-
File name	B0921-05.img	-
IR Text Comment	Value	
CUSTOMER	25 BROADWAY/GEN 013	-
EQUIPMENT	CAM CONNECTOR	-
Object parameter	Value	
Reference temperature	30.0°C	-
Label	Value	Diff temperature
AR01 : max	65.4°C	35.4°C

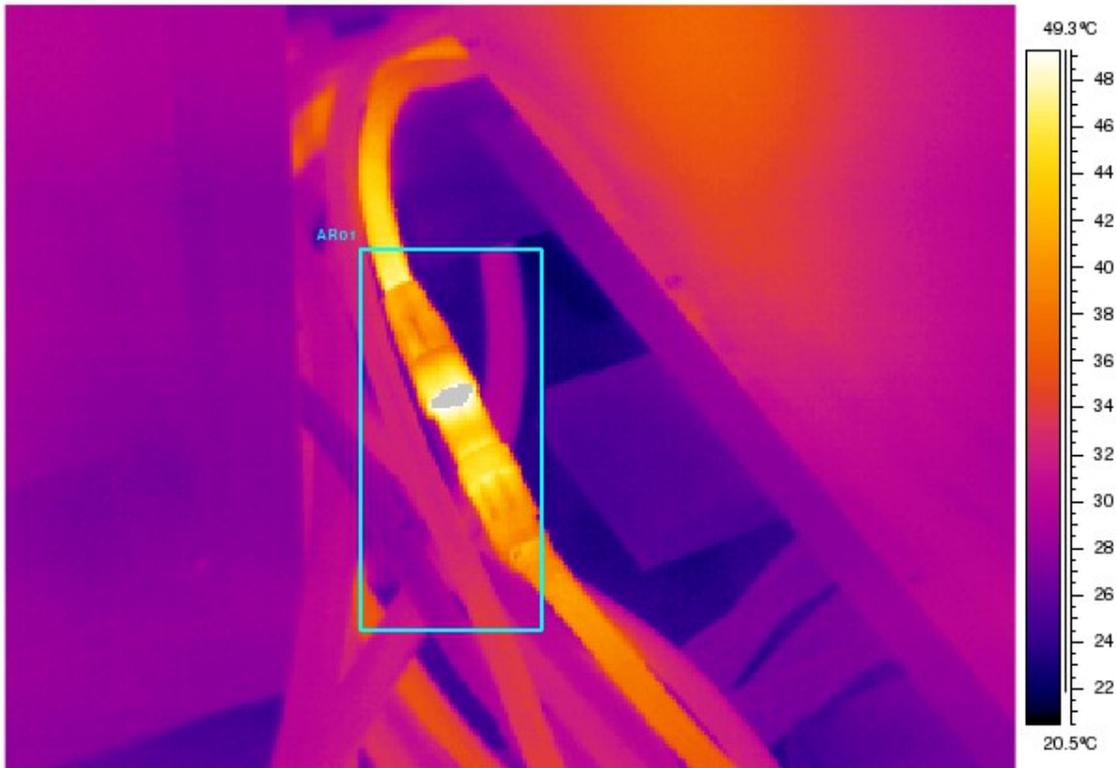
**25 BROADWAY  
GENERATOR 013**

IR information	Value	
Date of creation	9/21/01	-
Time of creation	10:48:59 AM	-
File name	B0921-06.img	-
IR Text Comment	Value	
CUSTOMER	25 BROADWAY	-
EQUIPMENT	CAM CONNECTOR TO XFR #1	-
Object parameter	Value	
Reference temperature	30.0°C	-
Label	Value	Diff temperature
AR01 : max	53.7°C	23.7°C

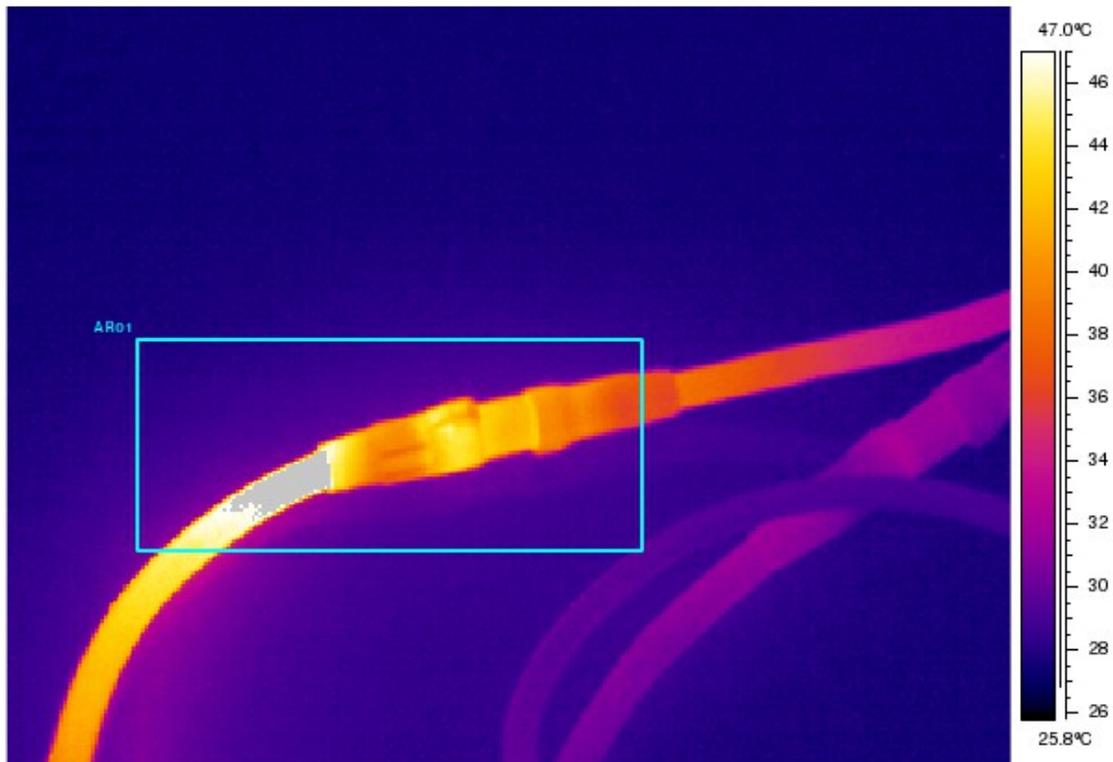
**25 BROADWAY  
GENERATOR 013**

IR information	Value	
Date of creation	9/21/01	-
Time of creation	10:57:57 AM	-
File name	B0921-07.img	-
IR Text Comment	Value	
CUSTOMER	25 BROADWAY/MAIN SW. TO CONTROL CTR	
EQUIPMENT	CAM CONNECTOR	
Object parameter	Value	
Reference temperature	29.0°C	
Label	Value	Diff temperature
AR01 : max	50.1°C	21.1°C

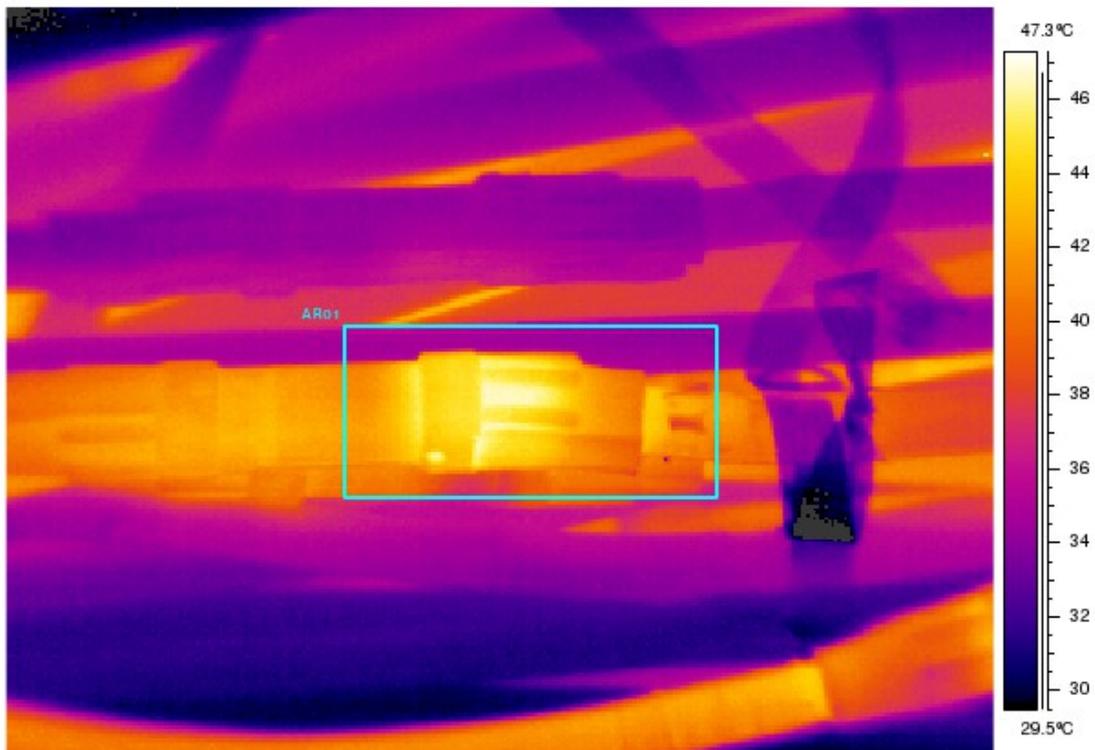
**25 BROADWAY  
GENERATOR 013**

IR information	Value	
Date of creation	9/21/01	-
Time of creation	11:04:12 AM	-
File name	B0921-08.img	-
IR Text Comment	Value	
CUSTOMER	25 BROADWAYFIRST LANDING	
EQUIPMENT	CAM CONNECTOR	
Object parameter	Value	
Reference temperature	29.0°C	
Label	Value	Diff temperature
AR01 : max	46.9°C	18.0°C

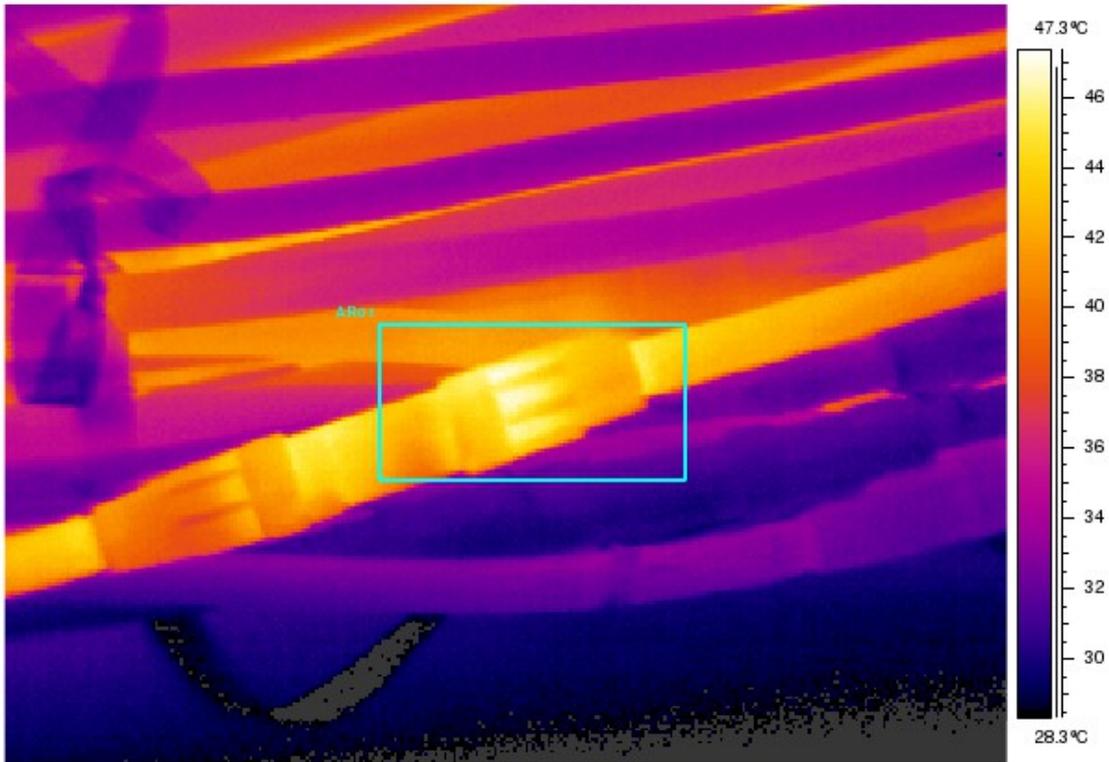
**25 BROADWAY  
GENERATOR 013**

IR information	Value	
Date of creation	9/21/01	
Time of creation	11:04:41 AM	
File name	B0921-09.img	
IR Text Comment	Value	
CUSTOMER	25 BROADWAY/FIRST LANDING	
EQUIPMENT	CAM CONNECTOR	
Object parameter	Value	
Reference temperature	29.0°C	
Label	Value	Diff temperature
AR01 : max	47.3°C	18.3°C

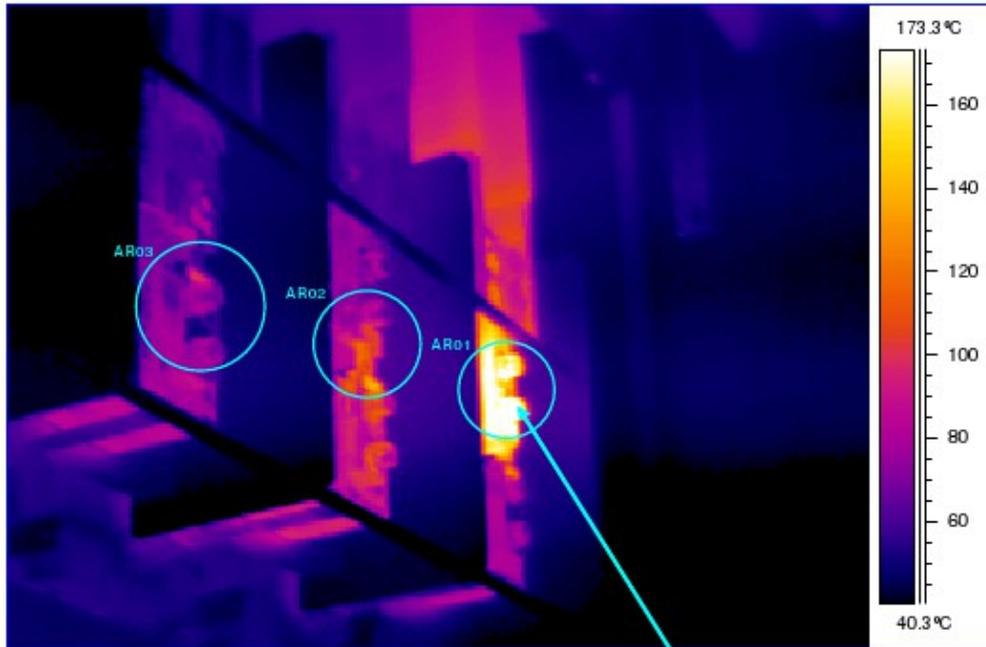
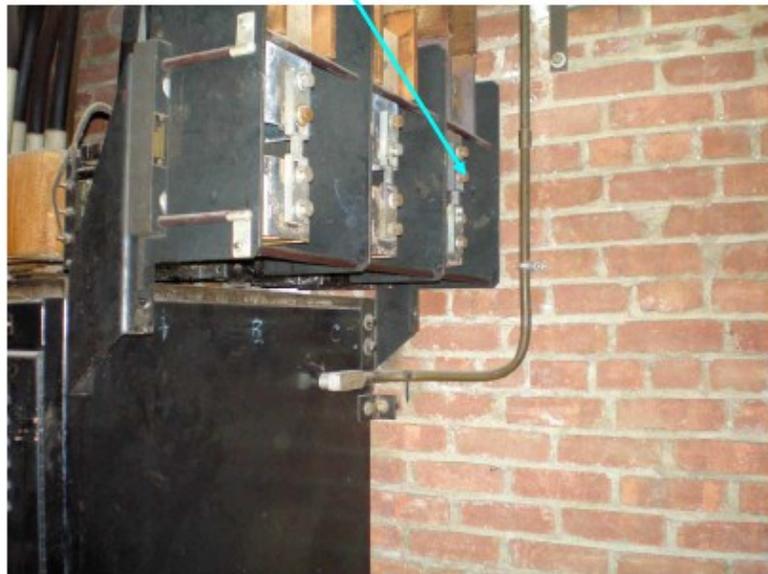
<b>A Phase (AR03)</b>	<b>B Phase (AR02)</b>	<b>C Phase (AR01)</b>
<b>Initial Scan</b>	101o C	139o C	203o C
<b>After fuse change</b>	64o C	85o C	63o C
<b>Max amperes</b>	3400	3400	3400
<b>RMS amperes</b>	2200	2200	2200
<b>Min amperes</b>	1800	1800	1800

**VAULT 3046 NWP  
Z-50 FUSES  
BEFORE FUSES WERE REPLACED**

Label	Value
AR01 : max	203°C
AR02 : max	139°C
AR03 : max	101°C

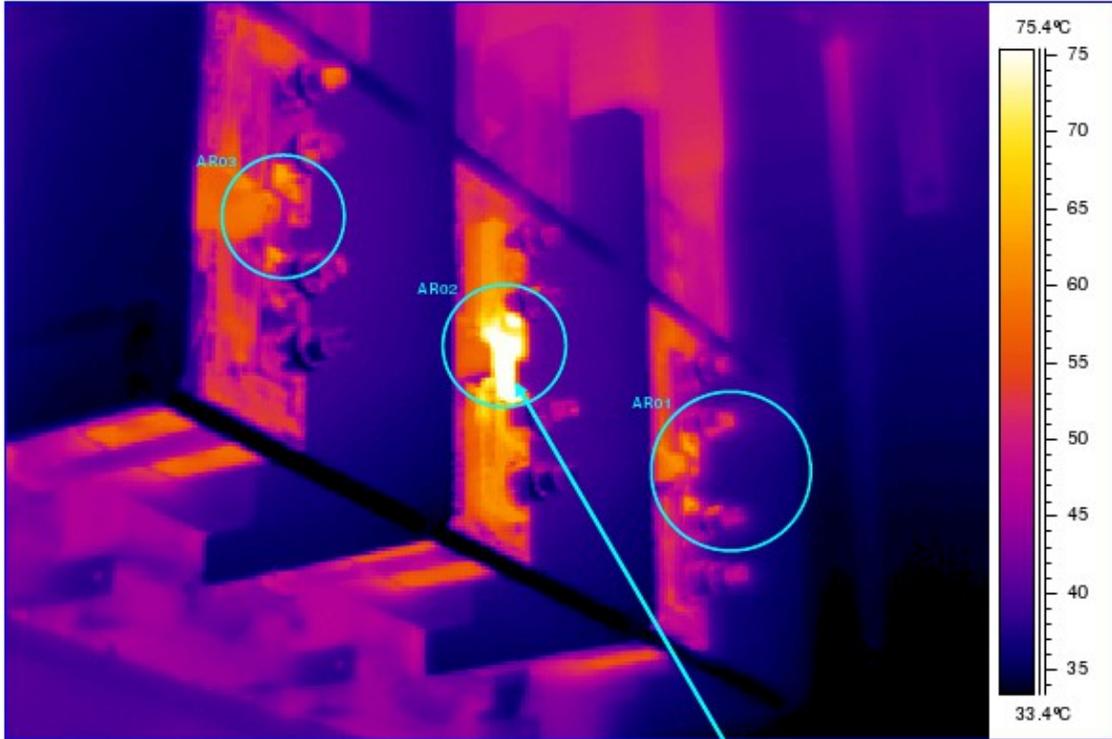
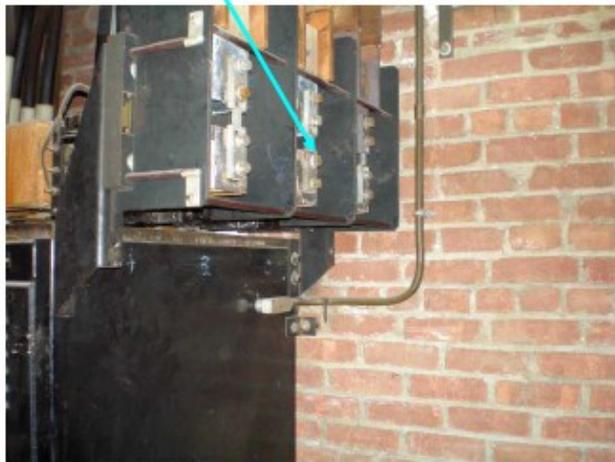
**VAULT 3046 NWP  
Z-50 FUSES  
AFTER FUSES WERE REPLACED**

Label	Value
AR01 : max	63.7°C
AR02 : max	85.3°C
AR03 : max	64.0°C

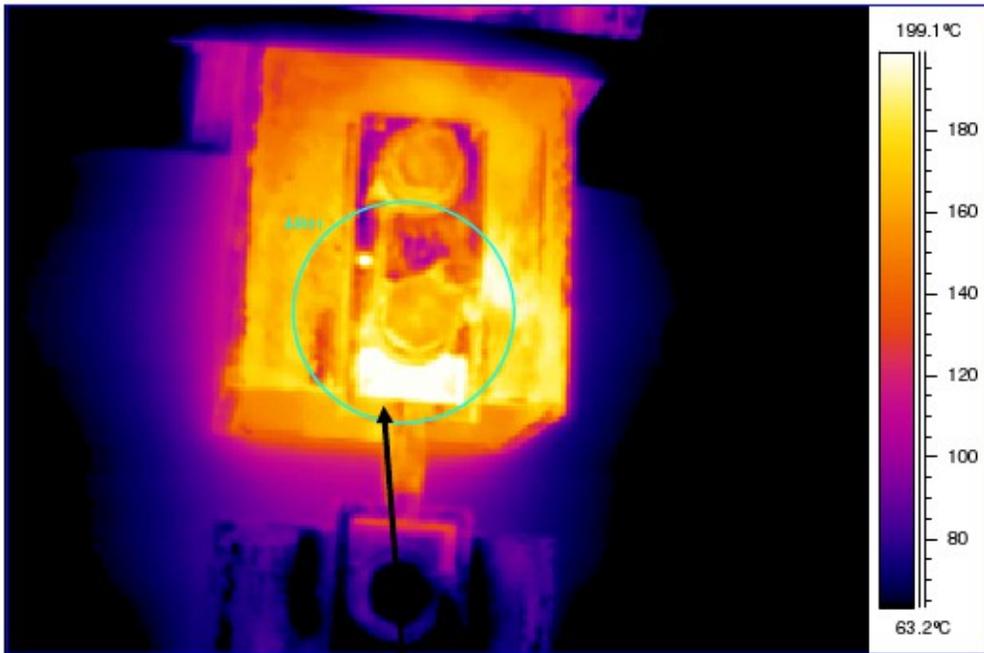
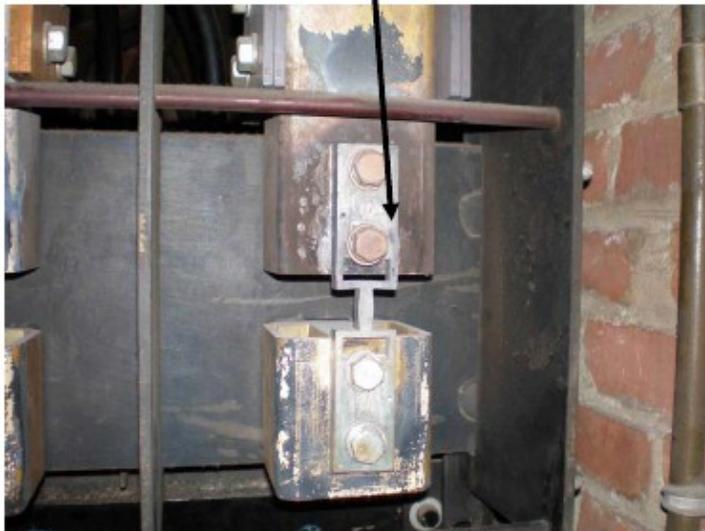
**VAULT 3046 NWP  
C PHASE Z-50 FUSE  
BEFORE FUSE REPLACEMENT**

Label	Value
AR01 : max	216°C

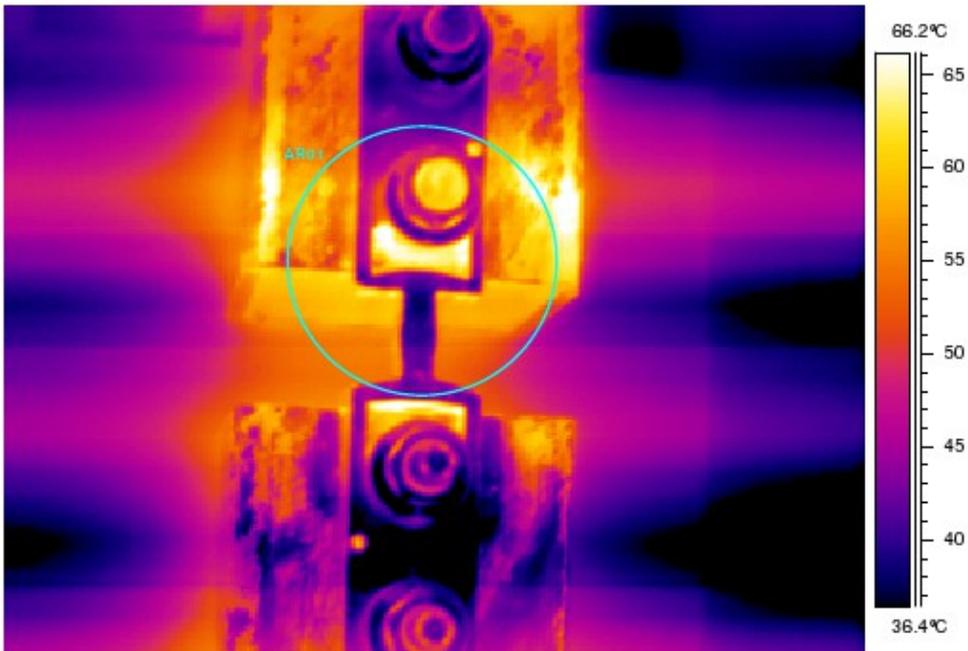
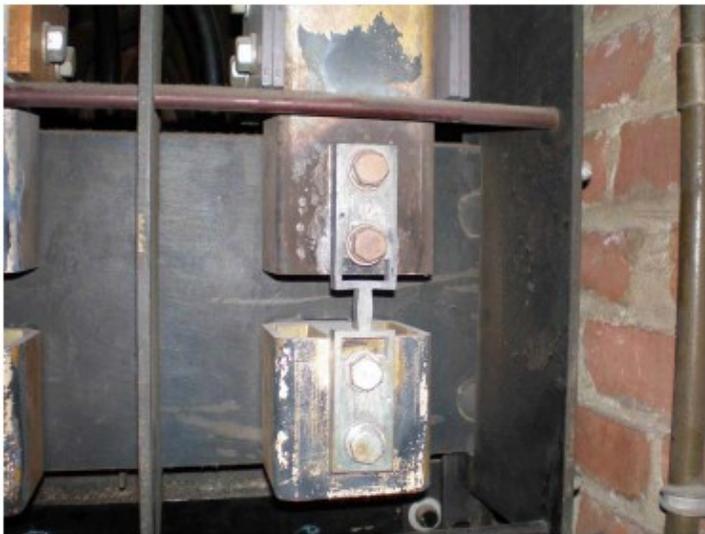
**VAULT 3046 NWP  
C PHASE Z-50 FUSE  
AFTER FUSE REPLACEMENT**

Label	Value
AR01 : max	68.2°C

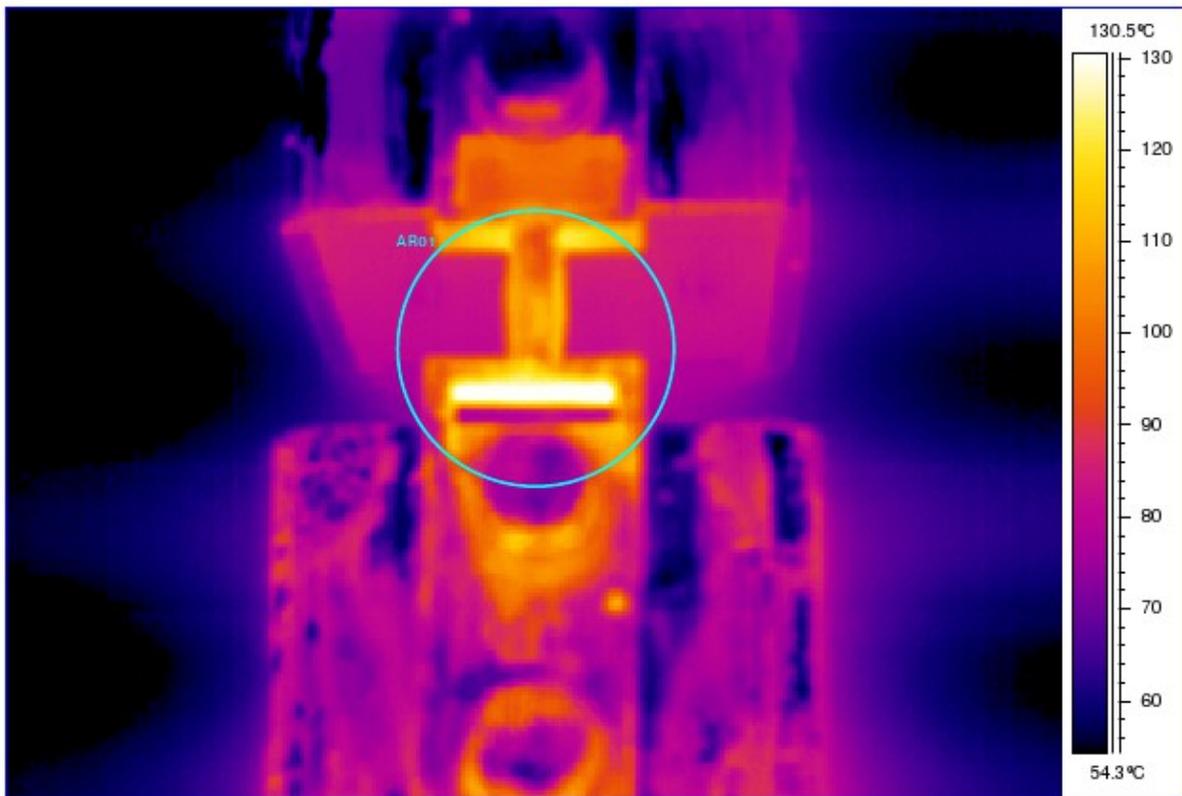
**VAULT 3046 NWP  
B PHASE Z-50 FUSE  
BEFORE FUSE RPLACEMENT**

Label	Value
AR01 : max	138°C

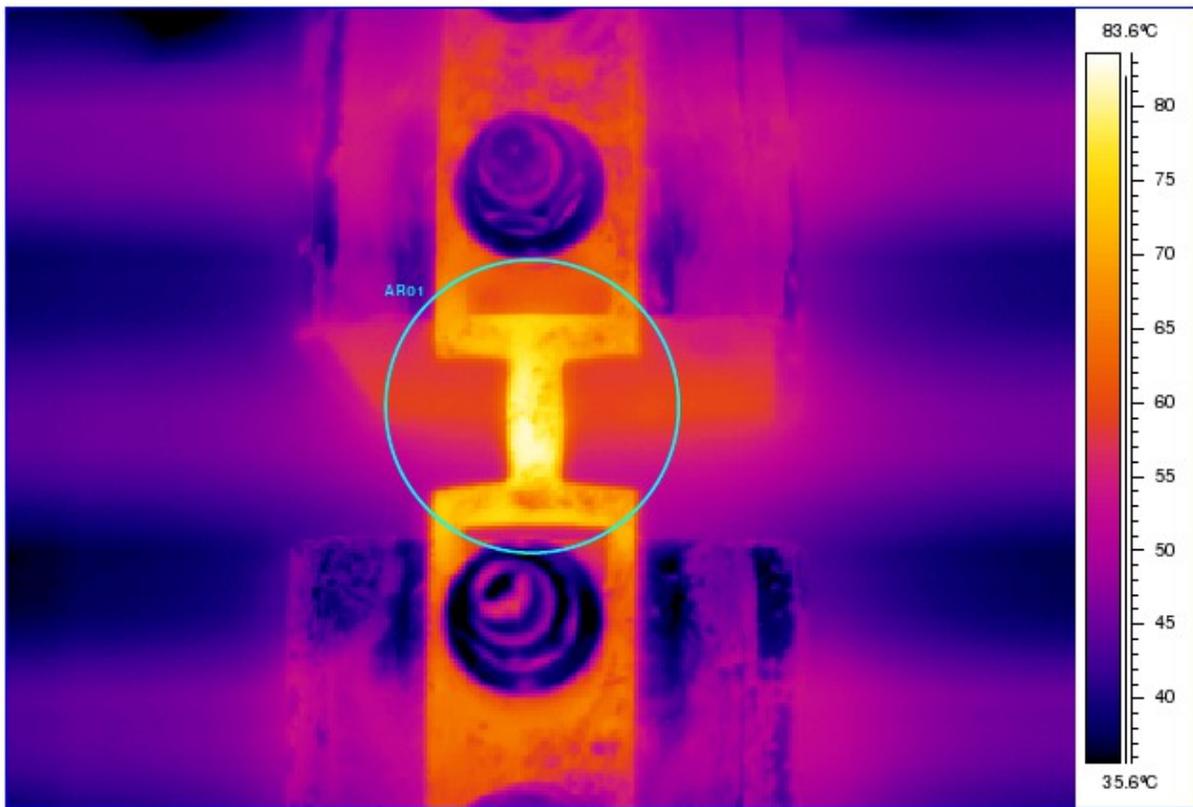
**VAULT 3046 NWP  
B PHASE Z-50 FUSE  
AFTER FUSE RPLACEMENT**

Label	Value
AR01 : max	82.3°C

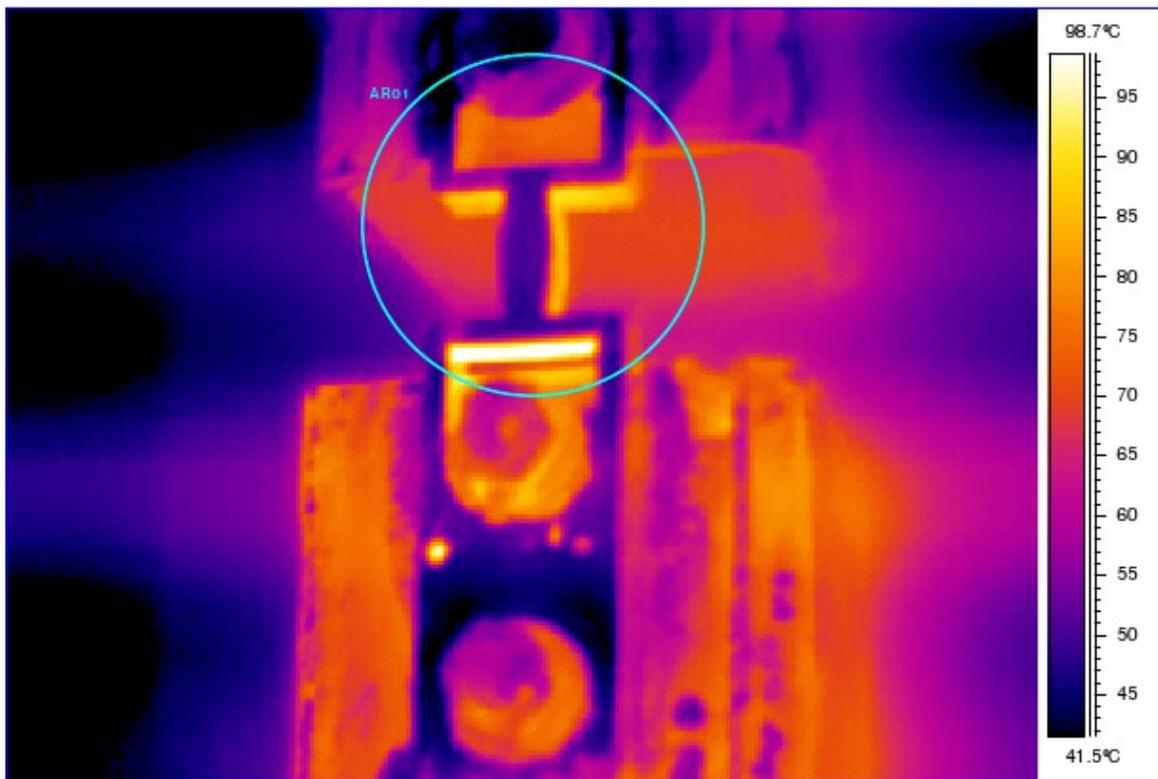
**VAULT 3046 NWP  
A PHASE Z-50 FUSE  
BEFORE FUSE REPLACEMENTS**

Label	Value
AR01 : max	102°C

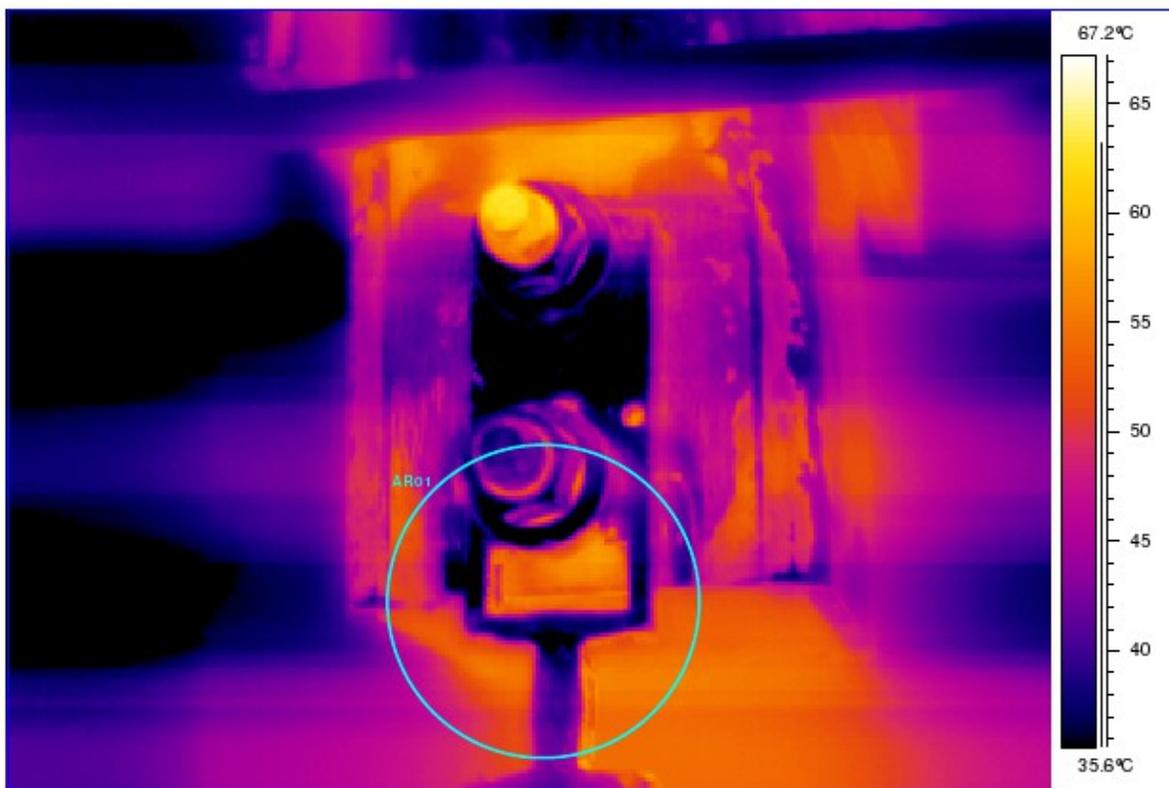
**VAULT 3046 NWP  
A PHASE Z-50 FUSE  
AFTER FUSE REPLACEMENTS**

Label	Value
AR01 : max	57.9°C
