# **Power Quality Case Studies**

Frank Sinicola

GFI  
1414 Outlook Avenue  
Bronx, NY 10465  
Ph: 888-511-8721  
Email: Frank@gfipq.com

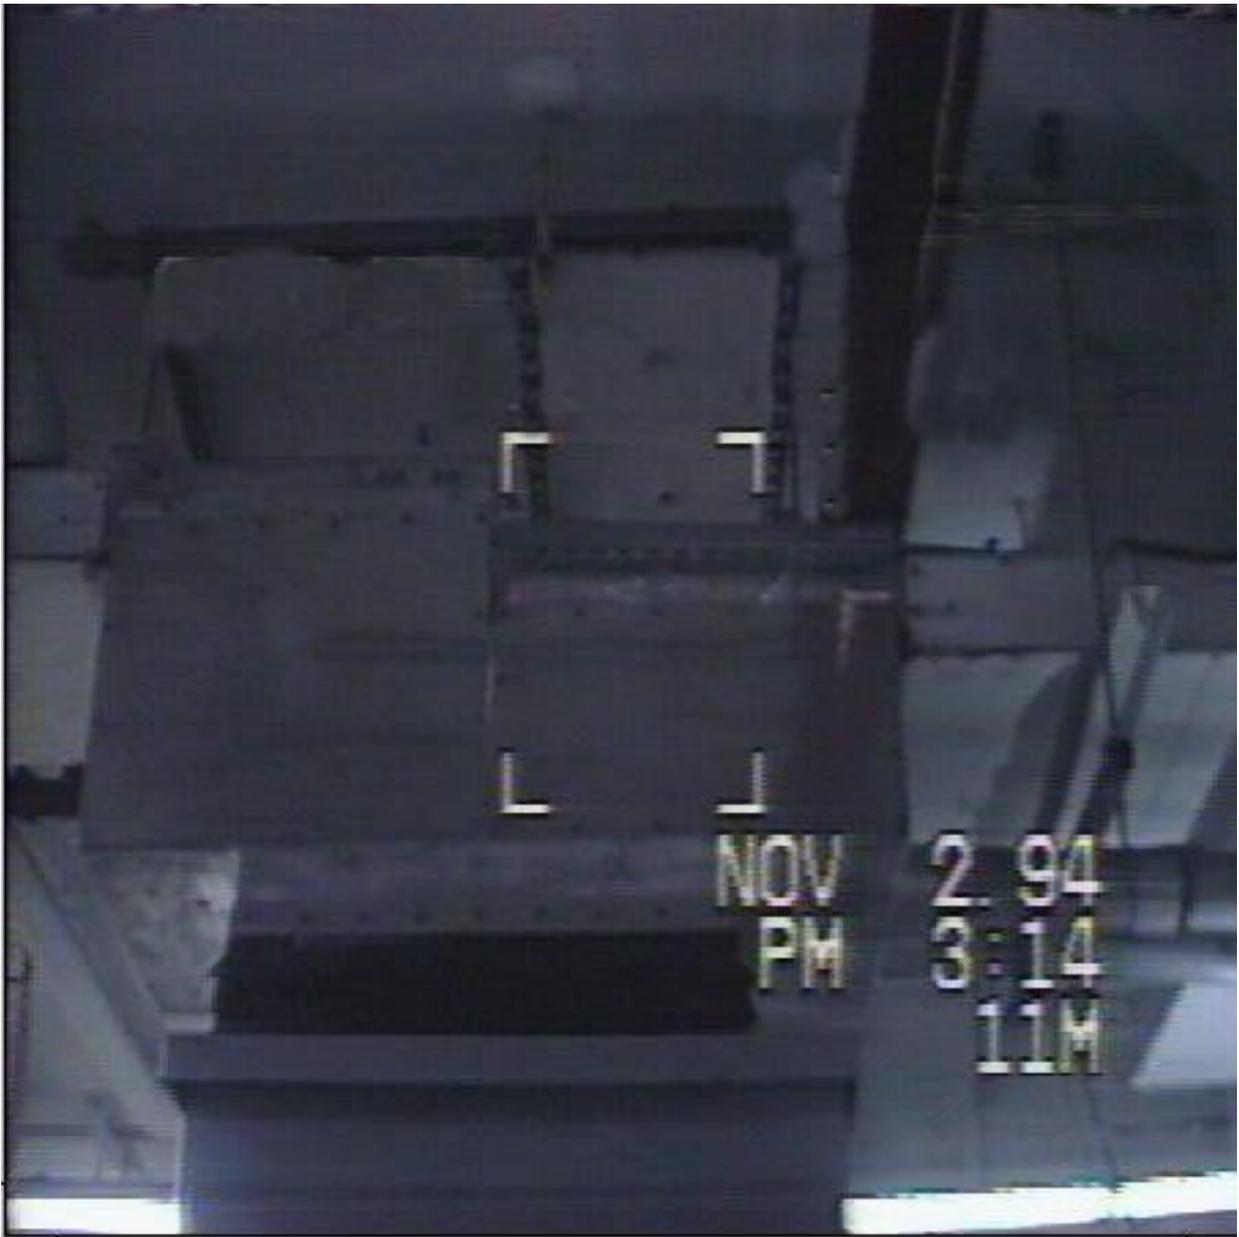
**Transfer Switch**

The ATS location is in the garage area where the supply feeders run from the supply to the ATS and to the load it serves. While the PQ group was setting up for the IR scan, the maintenance attendant started to remove the covering of the Calvert bus raceway and as he was removing the last bolt and panel, sparks flew. IR scans were performed and current readings were taken on a support rod that indicated it was hot and carrying 125 amperes. Further investigation revealed that they had forgotten to attach the grounding bar on the outside of the Calvert Bus. A support rod for the raceway connected to the building steel when scanned was carrying the ground current and the heat signature was captured in the IR scan. There was also a wiring error on the upper floor that contributed to ground current. Both items were corrected, resolving the ground current.

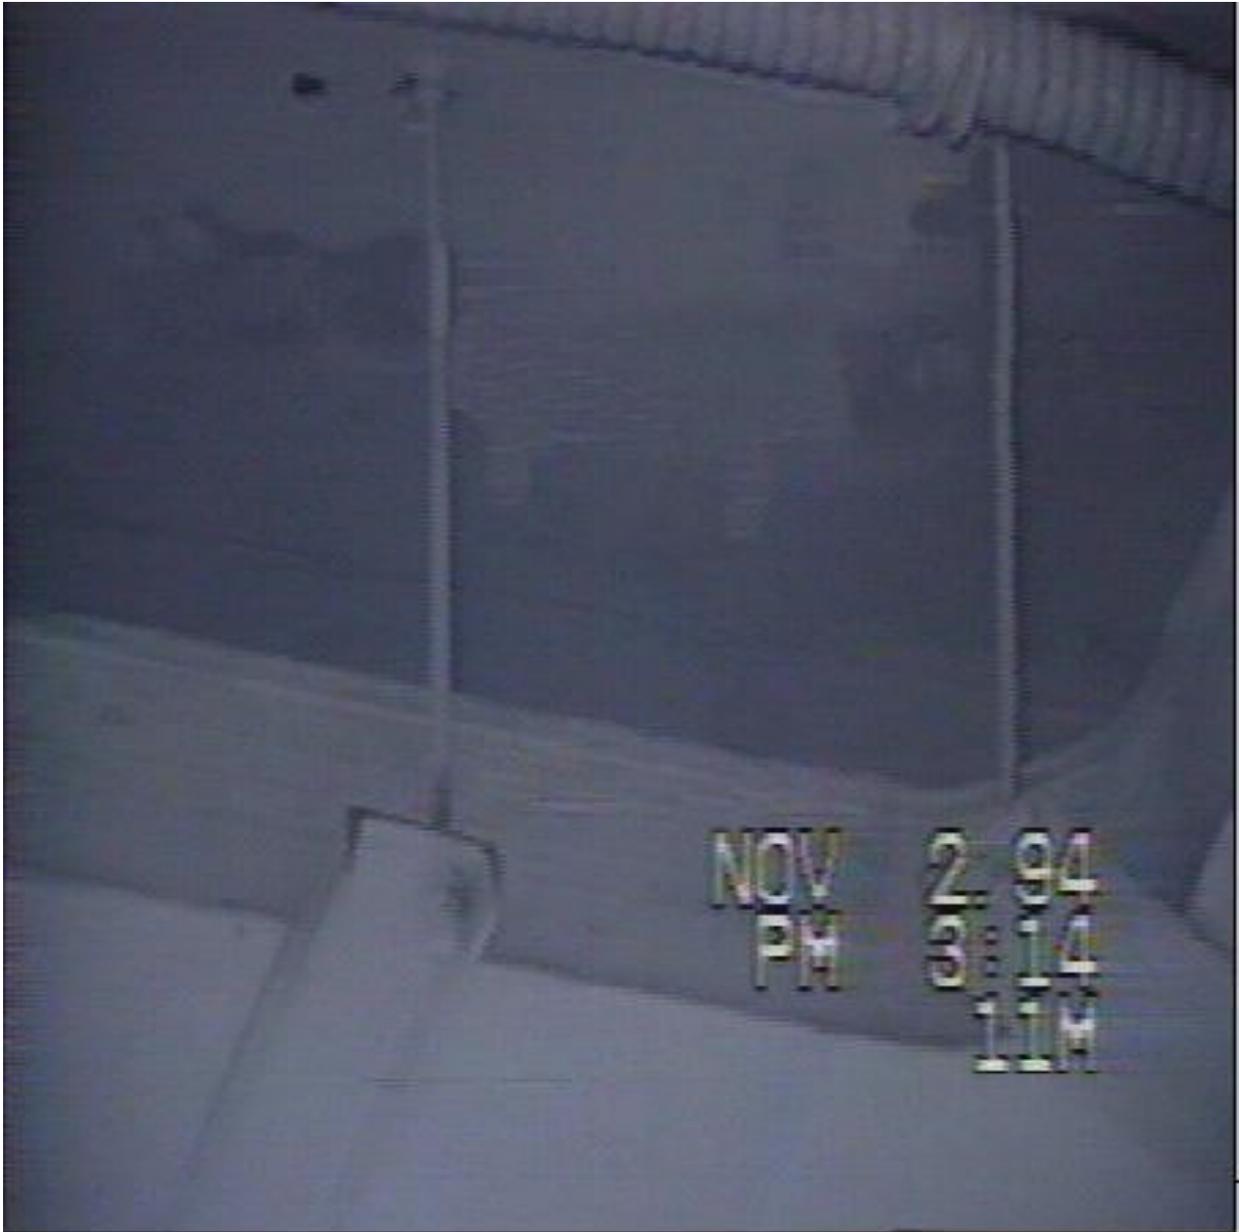
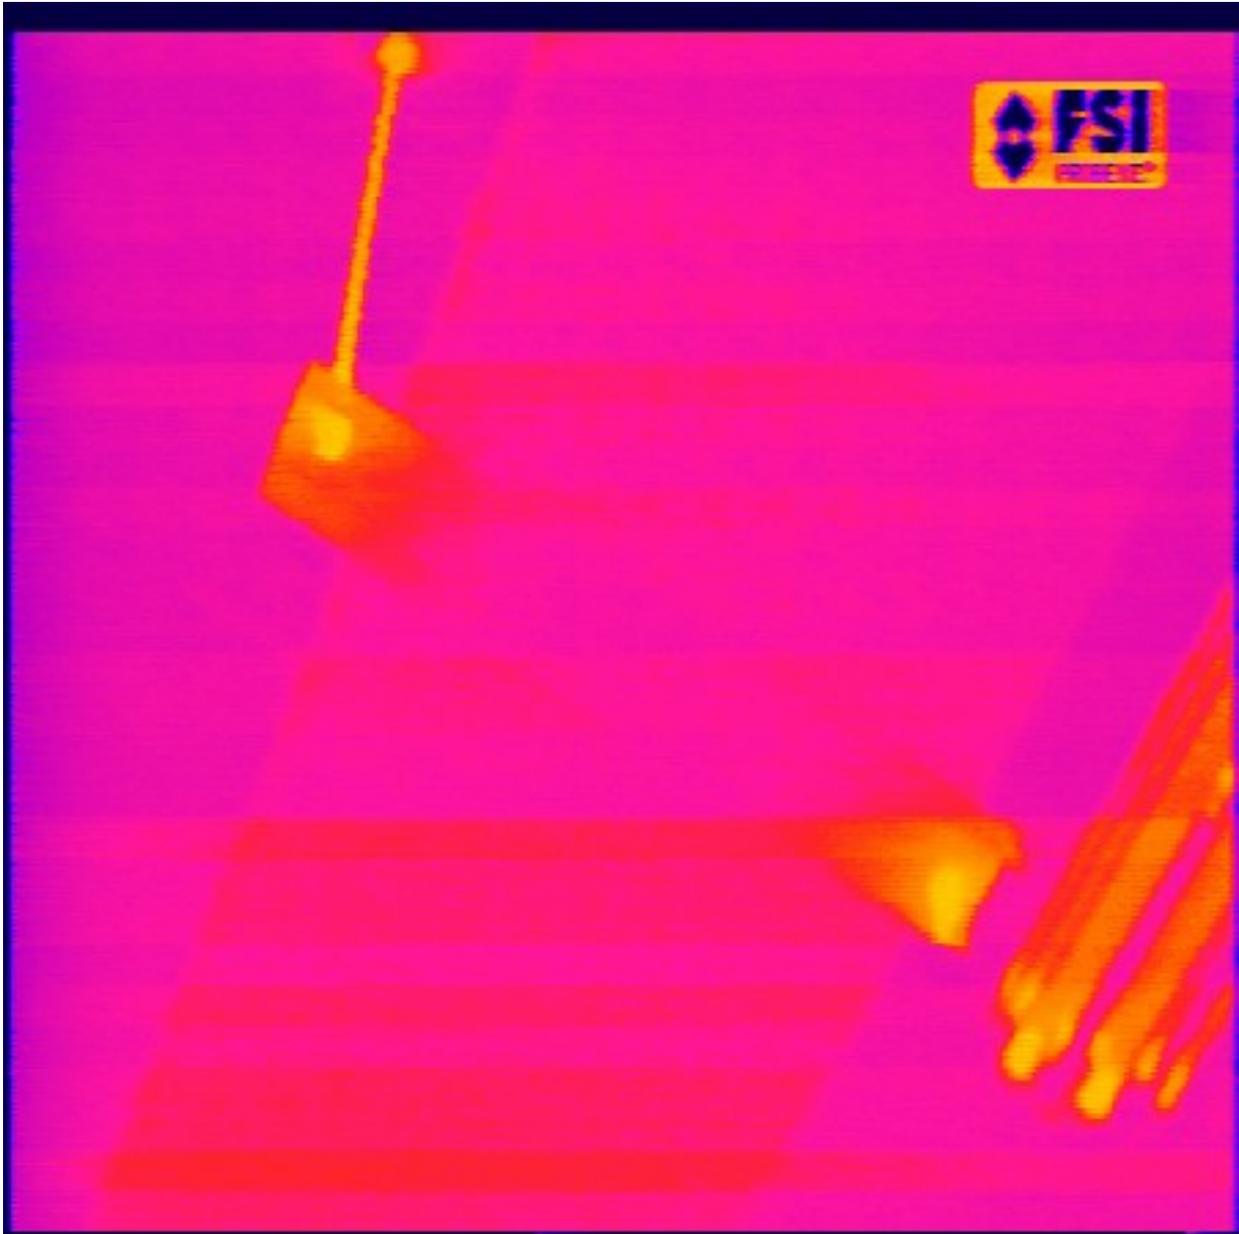
**Calvert Bus Duct**

IR of Calvert Bus
