Thermographic Documentation of Roof and Building Damage Incurred During the 2004 Florida Hurricane Season

James Brady, President, Level-III Certified Thermographer
&
Warren C. Garber, Level-III Certified Thermographer

Abstract

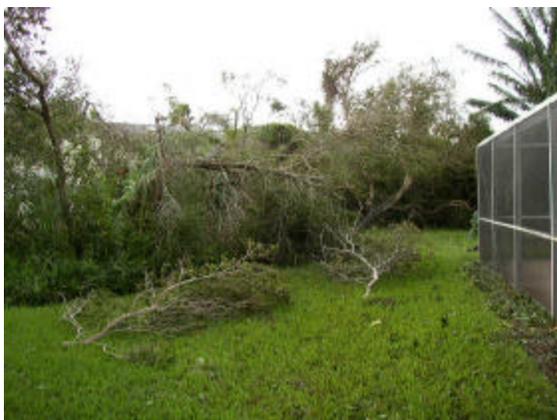
Landscape damage from Frances at author's house

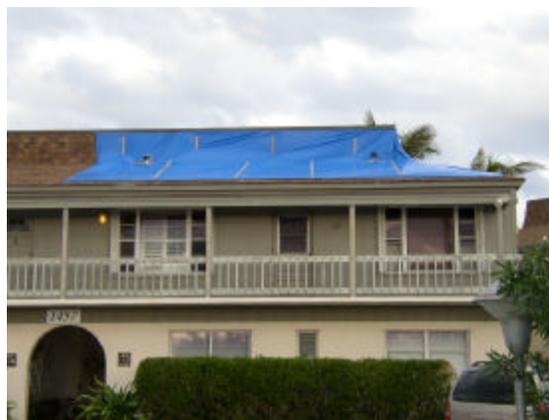
Blue tarp on roof supplied and installed by FEMA

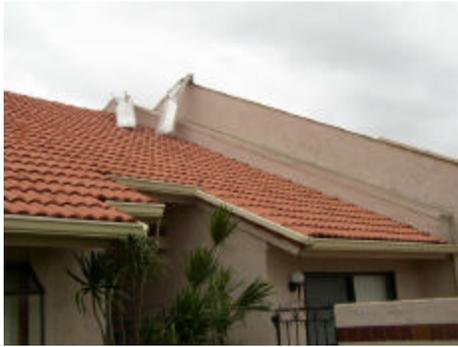
Our first inspection was a residential townhouse that lost a portion of a parapet wall cap and suffered interior water damage. Upon arriving, the A/C thermostat was lowered to cool the room and fans were set up to promote evaporation. A scan of the interior walls and ceiling identified "cold" thermal anomalies interpreted to be water damage. The wall where water had traveled showed a thermal pattern starting from the bottom of the wall and traveling up. Much to my surprise, thermal cold spots were detected several feet in from the primary wall where water had traveled into the room. Both thermal and visual photographs were saved and presented to the client who was working with a mold and interior damage specialist.

Parapet metal blown off from wind

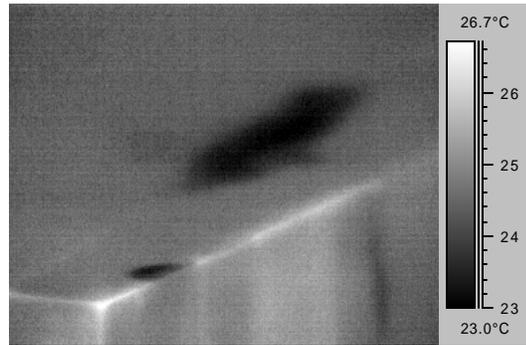
Thermal anomaly detected on ceiling adjacent to wall with main moisture damage

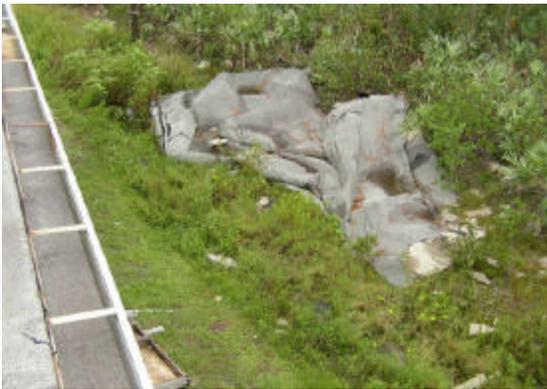
This was a load master roof system with a modified bitumen cap sheet. A large portion of the roof was lying on the ground on one side of the building. Evidently, wind had breached the parapet wall flashing and uplifted the roof. The torn section of roof had already been dried in when we arrived. We found a weak but defined thermal anomaly that spanned the tie-in boundary between the existing and temporary roof. Several other small anomalies were also located within the existing roof field. We were able to complete this roof and one other that night before rain finally settled in.

Uplifted roof section lying along side of building

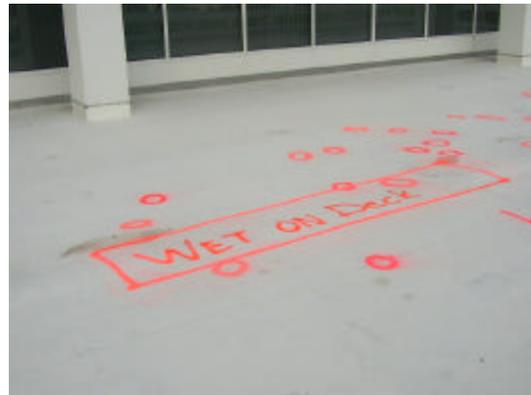
Our first survey commenced at the county library; a single-ply roof system that had suffered multiple punctures from flying roof tiles. Within forty minutes of working, a light rain began to fall. Prior to the rain we found one thermal anomaly along the parapet wall, but not in the vicinity of the punctures. We spent a good deal of that time flagging mechanical damage on the roof.

Wet/damaged roof from airborne roof tiles

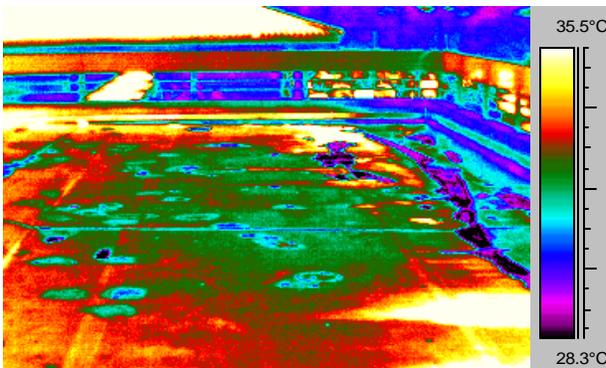
Discussing the chain of events that evening, we decided to revisit the library roof the following morning. It was quite possible we could use the solar loading of the roof to our advantage and capture a “scan window”. As it turned out, we identified a large thermal anomaly located among several punctures. We also delineated a wet section of roof, not correlated to a thermal anomaly but felt under foot, in the area of punctures. It was possible that the water infiltration in this area was a direct result of the recent damage and that the iso-board insulation did not have sufficient time to absorb the moisture. Rather, water was sitting between the insulation panels and directly on the metal deck. A report was generated and delivered to the client that afternoon.

“Cold” thermal anomaly on library roof delineated during daytime scan in area of puncture from roof tiles

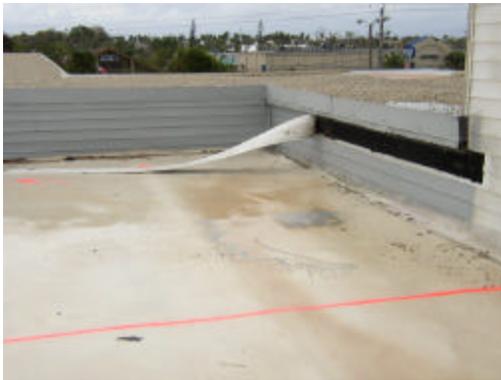
That evening we returned to the Winn Dixie roof. The main roof was a single-ply roof system. Examining a section of roof removed from the storm, we discovered that two separate recovery roof systems had been installed over the original gravel built-up roof; a modified bitumen followed by the single-ply roof. Nearly 80 percent of the entire roof showed signs of moisture damage. Interestingly, only a small portion of this roof had lifted off during the storm but thermal anomalies were widespread. Damage was also documented of missing wall flashings and debris that punctured the roof membrane.

Pulled away wall flashing on Winn Dixie roof

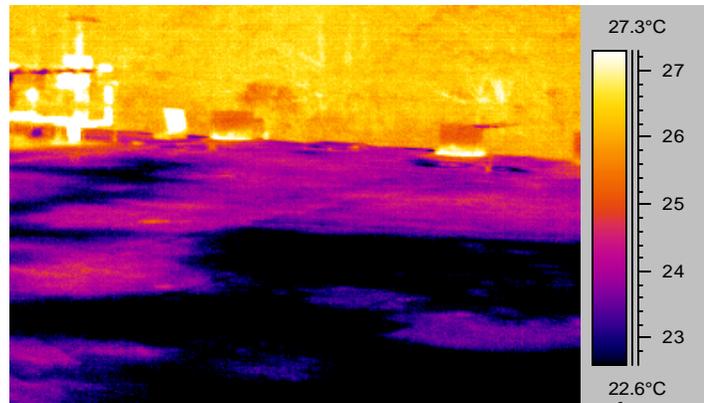
widespread thermal anomalies or trapped moisture in single-ply roof

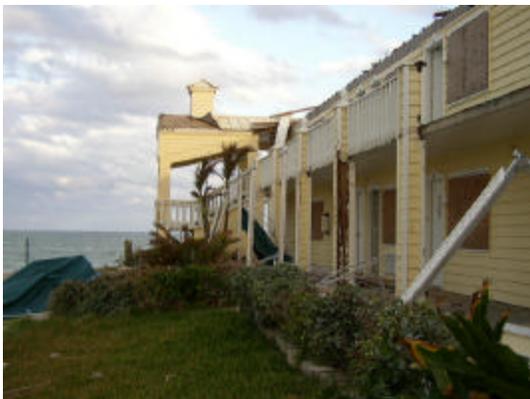
A destroyed inn on Hutchinson Island

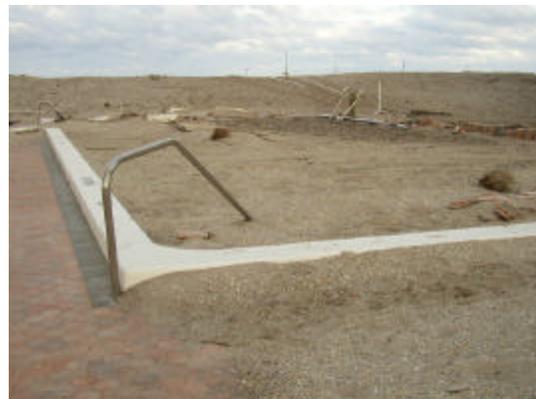
Transported beach sand filled a swimming pool

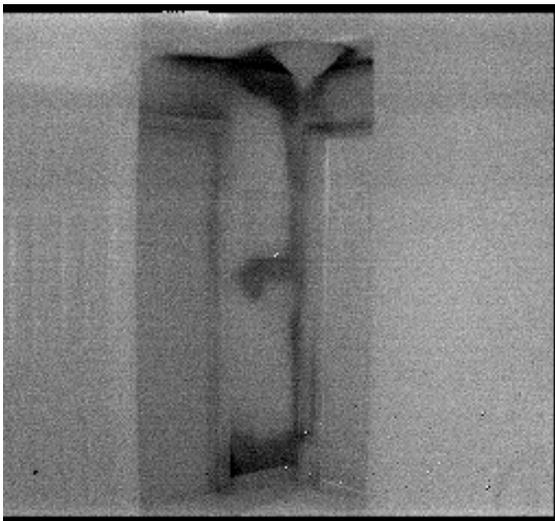
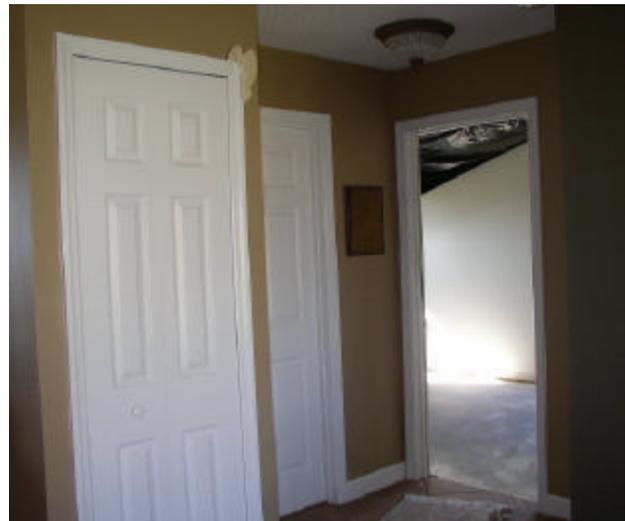
A FLIR ThermaCAM PM390 short-wave camera was used to conduct the inspection. Cold anomalies were documented along baseboards, in ceiling / wall corners, on walls and on the bottom portion of ceiling beams. Visible mold was documented along a few of the baseboards and an inspection, done two days later, by a company specializing in moisture/mold showed extensive mold growth behind many walls. It was interesting to note that mold development was much more extensive than what our findings showed. This could be explained, in part, by the fact that we could not create a high delta-temperature inside the house. Since the power was still out, we could not use the air conditioning system and were forced to use a window mount A/C unit and fans powered by a portable generator to change the interior environment.

A cold thermal pattern on wall and ceiling of a residential home that suffered water intrusion

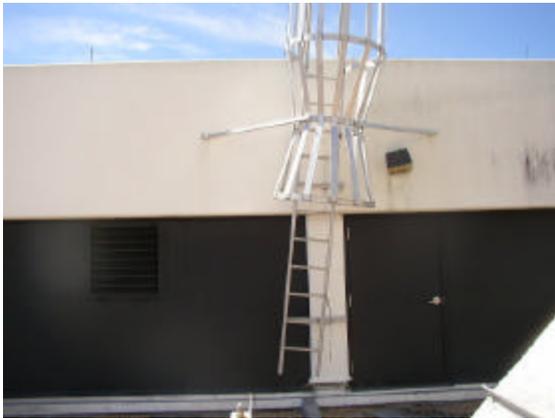
Visible damage on this roof included displaced gravel in the form of drifts against parapet walls, missing roof drains on the fifth floor roof, a bent access ladder, a toppled radio tower, downspouts torn from walls, and a lightning rod impaled into the roof.

Bent access ladder

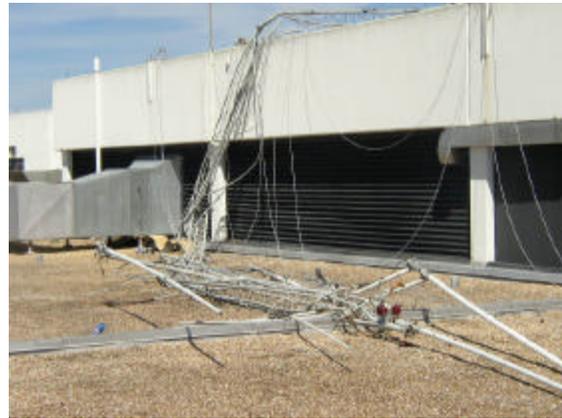
Toppled radio tower

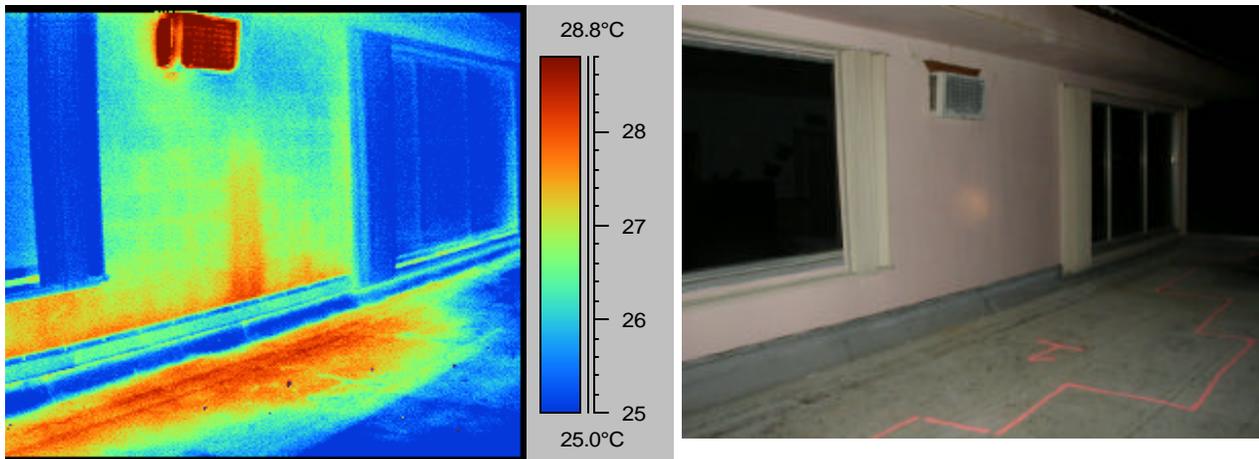
The new roof was absent of thermal anomalies, however, a thermal anomaly was documented on a lower level roof adjacent to one of the penthouse units. The anomaly occurred adjacent to and partially up an exterior cement block wall. A moisture meter was used to verify the presence of moisture in the wall. It is believed that water had entered the CB wall during the storm and traveled vertically down and entered the roof system along a failing wall flashing.

Thermal anomaly that spans roof edge and vertical cement block wall that received water intrusion after roof was lifted off during Hurricane Frances

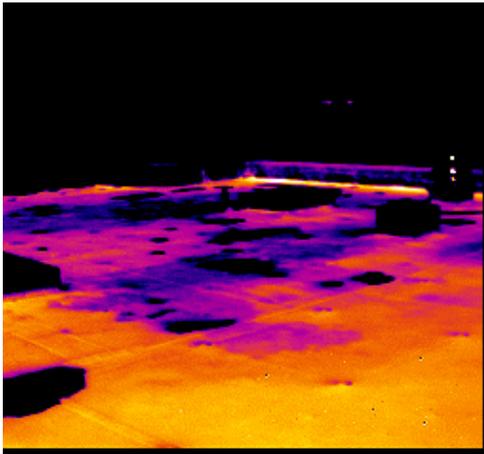
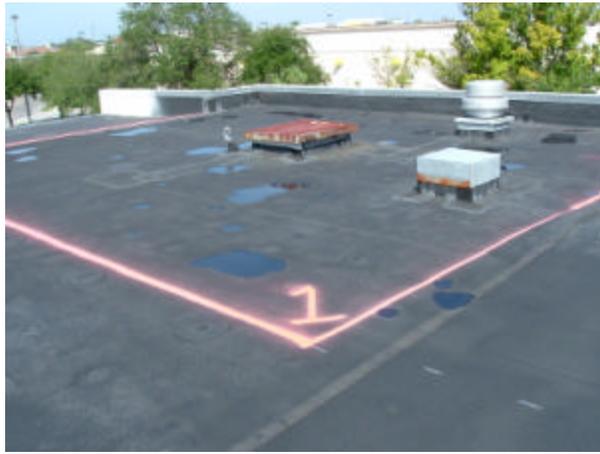
Scheduling issues prompted my associate to visit the second roof the following day to see if a daytime scan could be performed. A FLIR ThermoCAM PM 390 short-wave and a FLIR E2 long-wave camera were used to conduct this inspection. The high emissivity of the EPDM roof system combined with the lack of roof-top equipment and structures that would cause thermal interference and shadows helped to produce excellent scanning results. Two distinct thermal anomalies were traced out.

**“Cold” thermal anomalies imaged on EPDM roof (at left) during daytime scan.
Black areas in thermogram are caused by standing water**
