Thermal Imaging - A Better Solution for Inspecting G10 Laminates

Charles J. Hazouri
Offshore Marine Inspections
500 Mandeville Street, Unit 10
New Orleans, LA 70117
Ph: 504-450-8044

Abstract

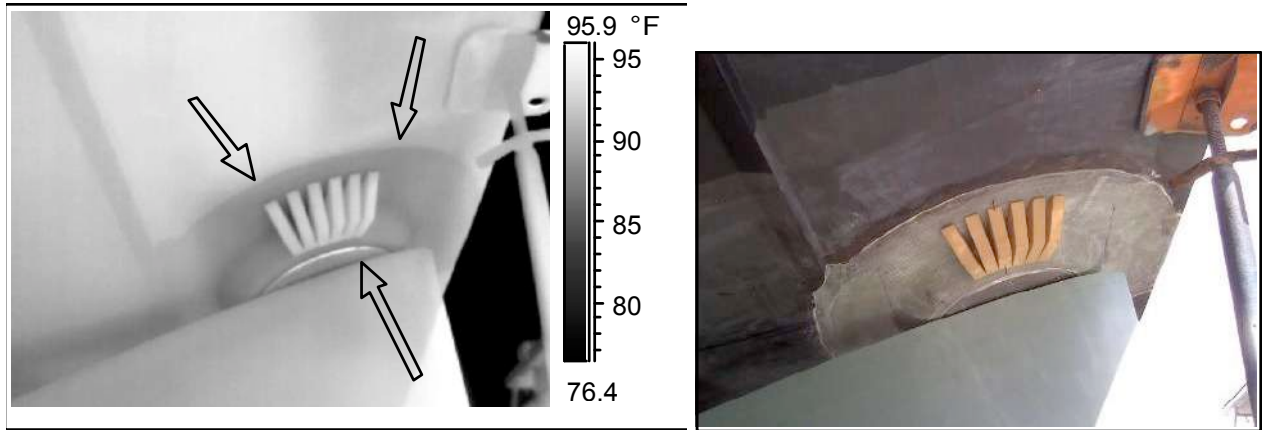
Lead portion of the stabilizer systems mounting and backing installation looking aft.

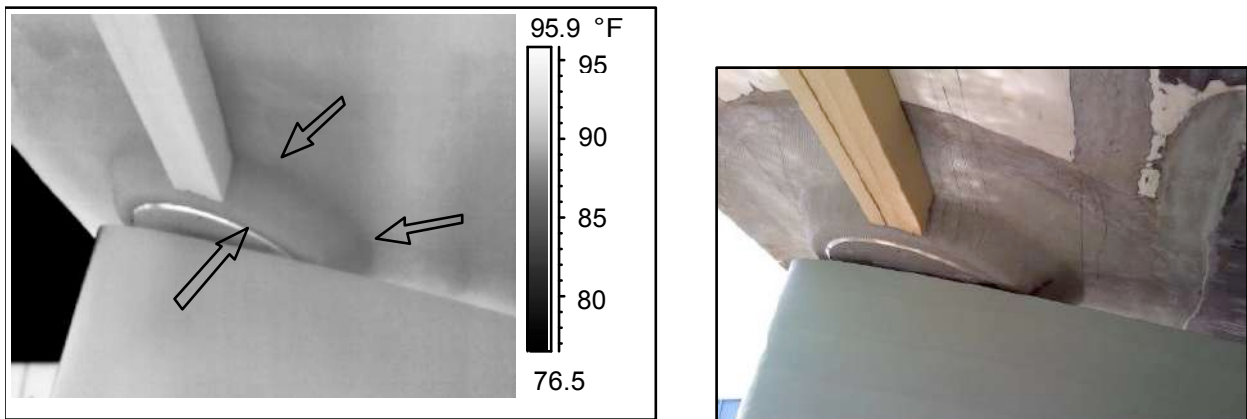
Trailing part of the stabilizer systems mounting and backing installation looking forward.

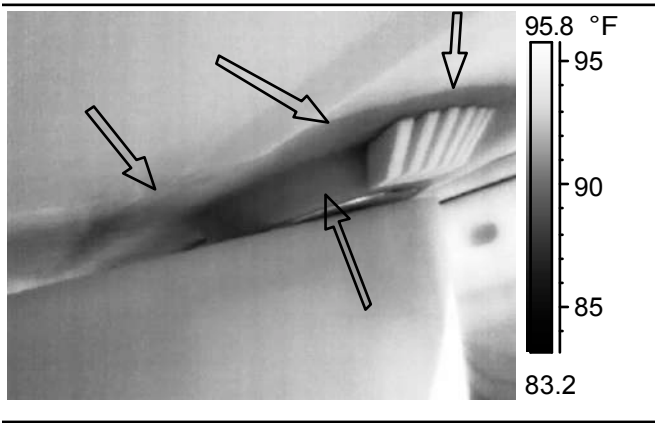
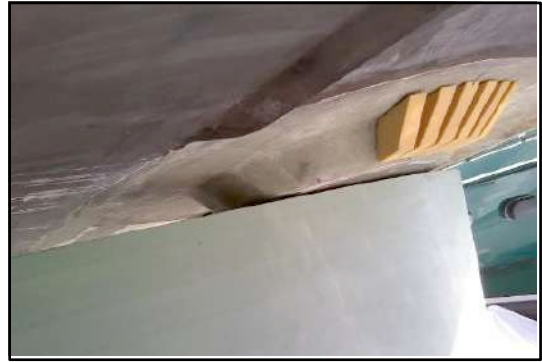
Lead portion of the stabilizer systems mounting and backing looking aft and outboard.

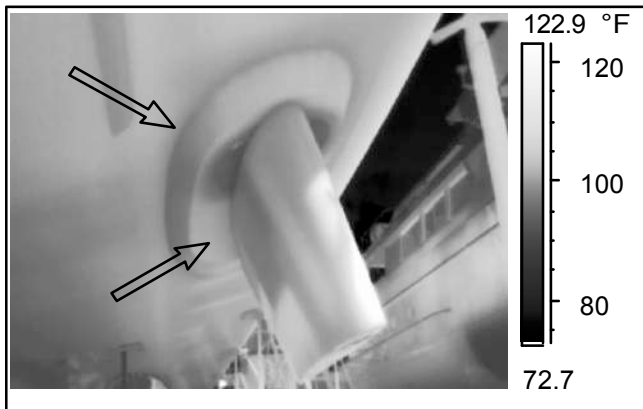
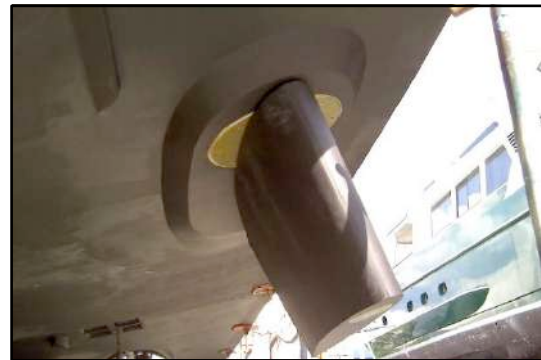
Lead portion of the stabilizer systems mounting and backing installation looking aft after the reconstruction and repairs.

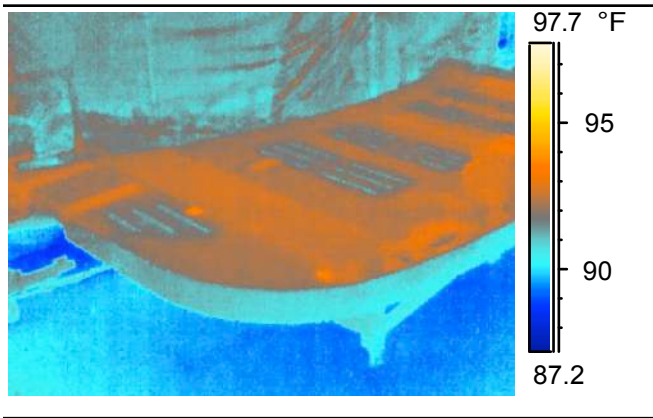
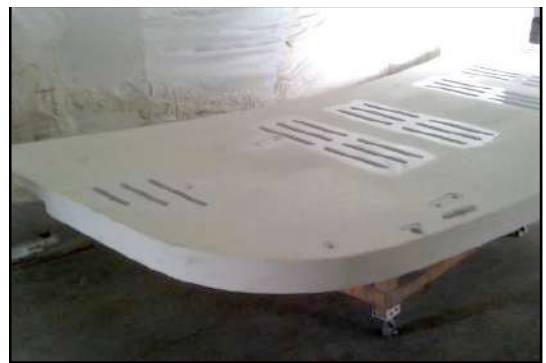
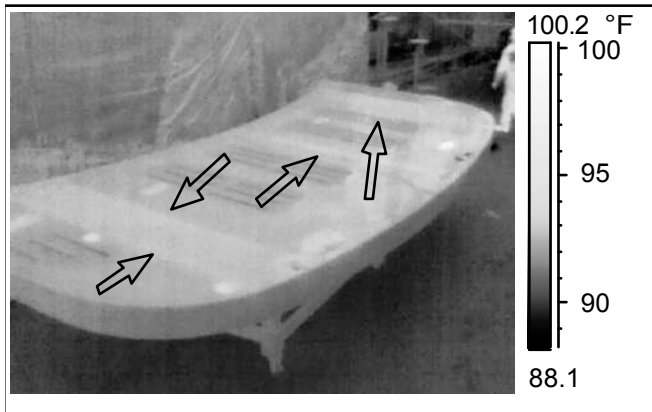
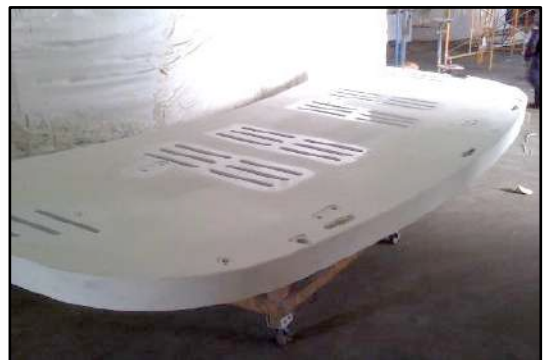
The top section of the swim platform prior to installation.

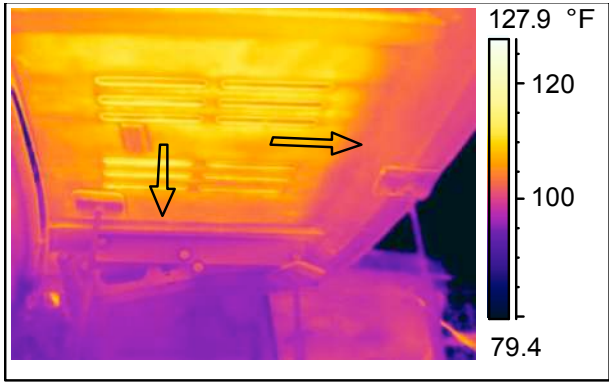
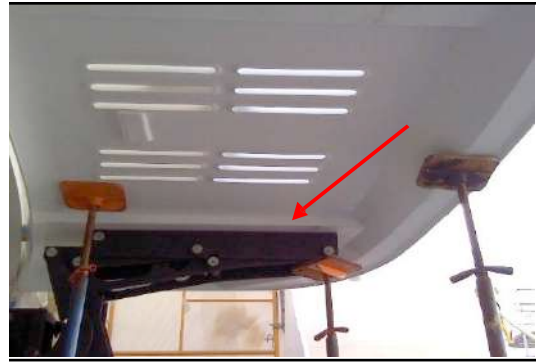
The underside of the swim platform after installation. Take note that using a product with strength and versatility such as G10 allows the contractor to use a non-metallic structural member that can withstand the weight and force of the swim platform's hydraulic rams (indicated by the red arrow in the first digital picture) as seen in this application and in the images above of the underside of the starboard portion of the swim platform.

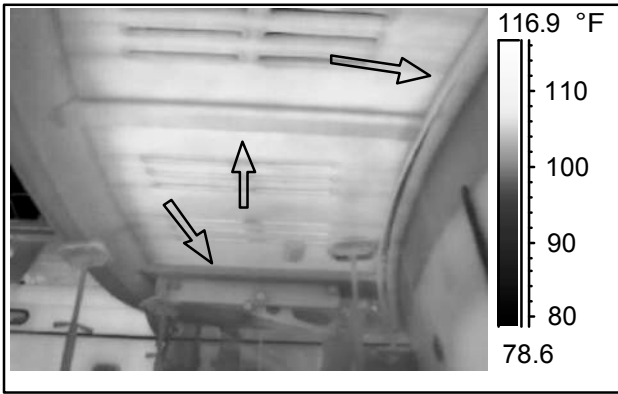
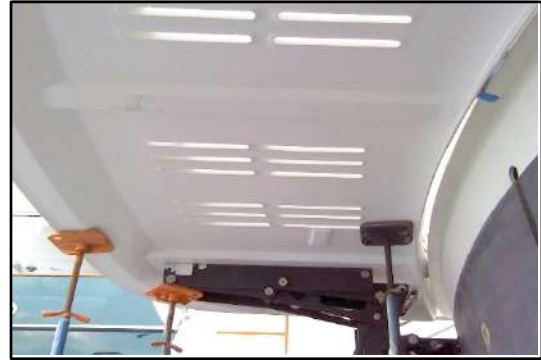
The underside of the port portion of the swim platform.

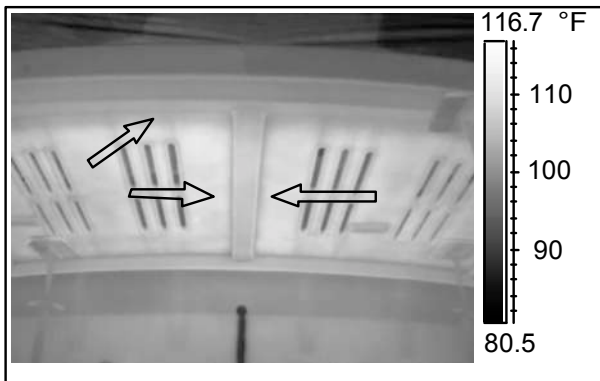
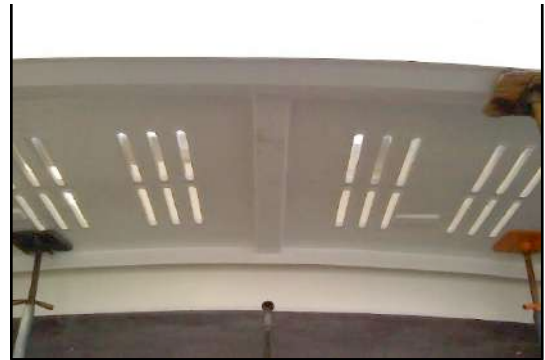
The underside of the center portion of the swim platform.

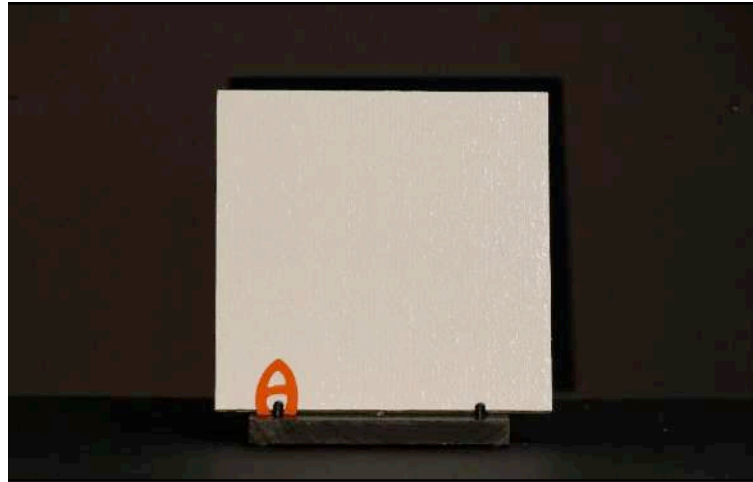
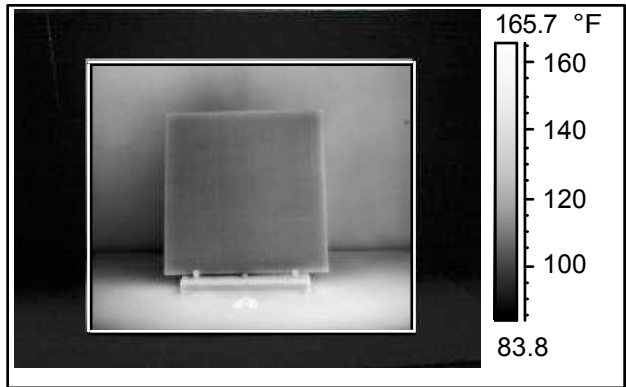
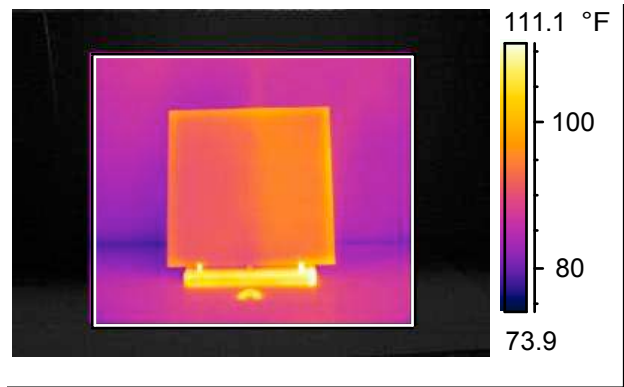
Sample A, which was imaged in Gray and Iron Scales, shows a distinct pattern to the G10 laminate. There were no non-conformities in this image.

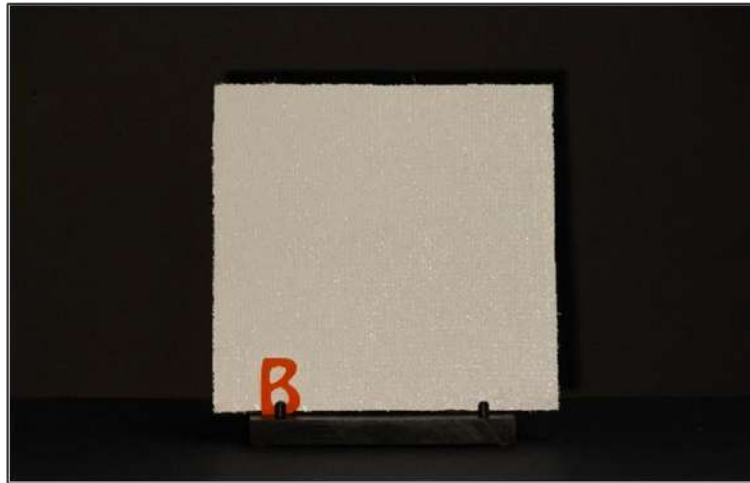
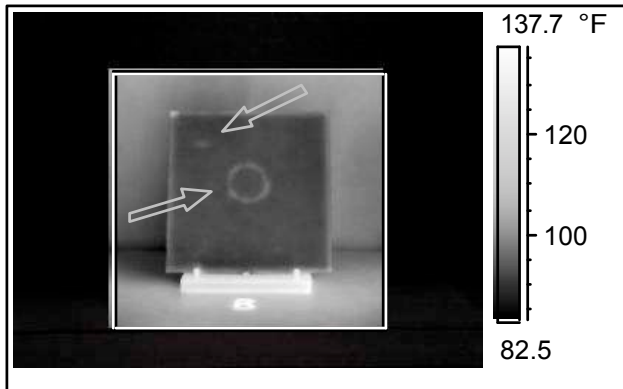
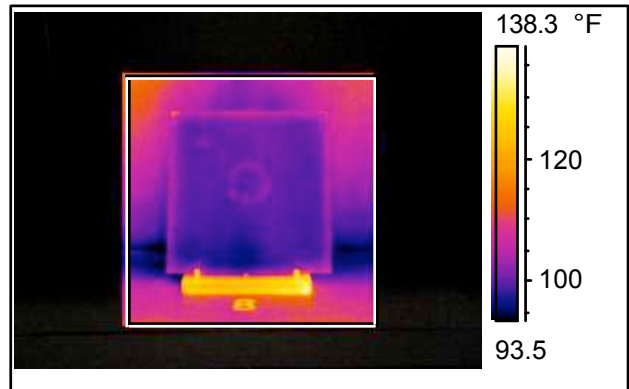
Sample B, which was imaged in Gray and Iron Scales, shows that a distinct and pronounced non-conformity exists within this sample of G10 laminate. The non-conformity is consistent to an area of delamination and/or a small void.

For best results, it's recommended that all areas constructed using G10 as well as all Fiberglass Laminates be Thermal Imaged and documented prior to and after repairs and/or construction.
