The Dangers of Improper Thermal Imager Settings During Thermographic Inspections

Sonny James, Managing Director
Thermal Diagnostics Limited
15 Robertson Street, Les Efforts East
San Fernando, Trinidad & Tobago, West Indies
Ph: 868-653-9343 / 868-657-6572

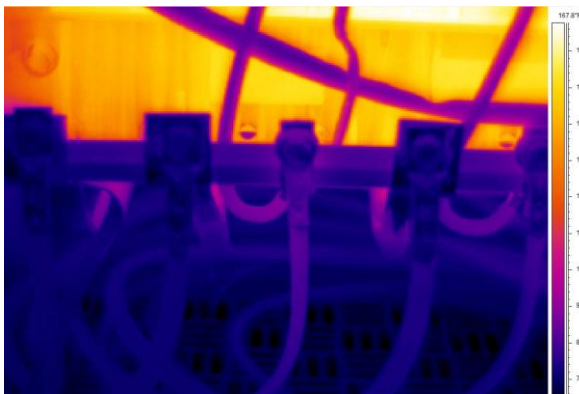
Improper Span and Level using the imager's Auto function.

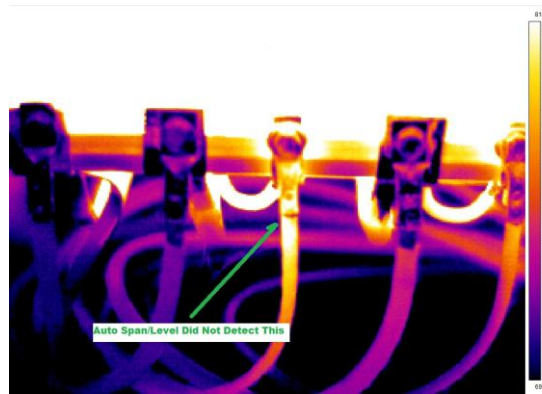
Proper manually adjusted Span and Level, detecting the discontinuity.

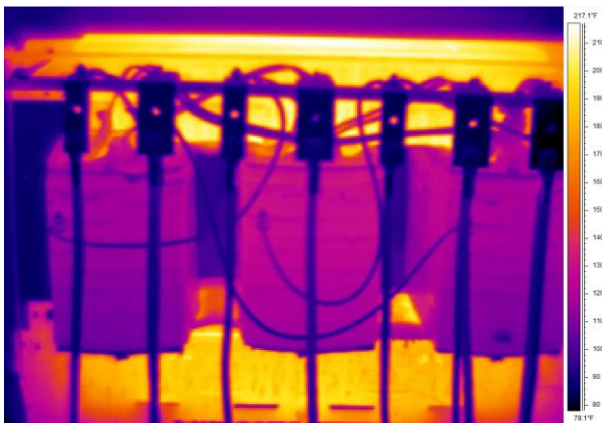
Improper Span and Level using the imager's Auto function.

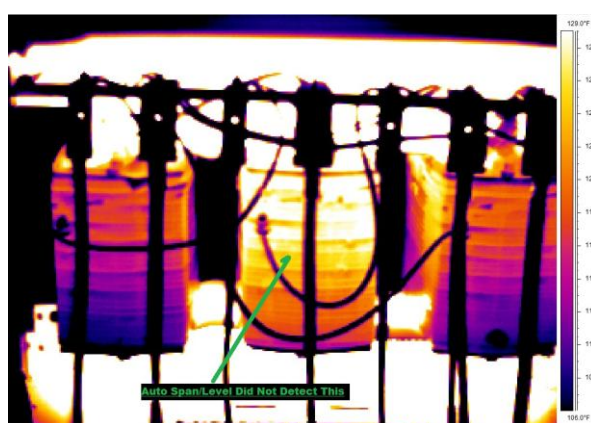
Proper manually adjusted Span and Level, detecting the discontinuity.

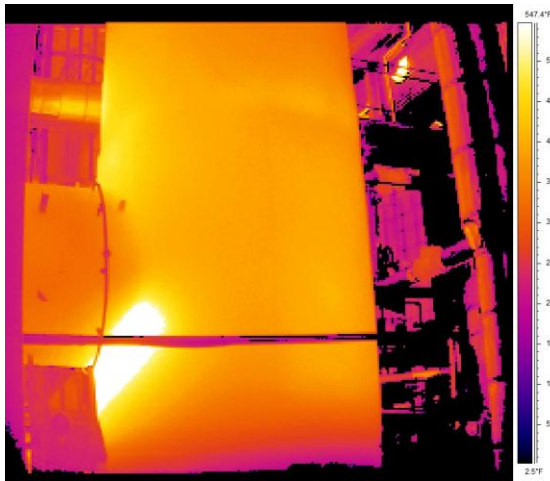
Improper Span and Level using the imager's Auto function.

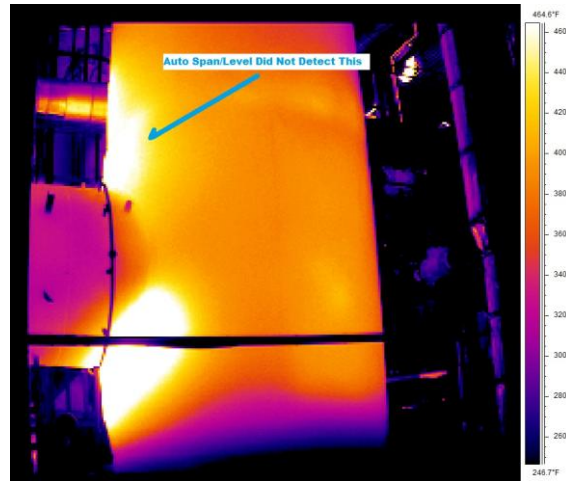
Proper manually adjusted Span and Level, detecting the discontinuity.

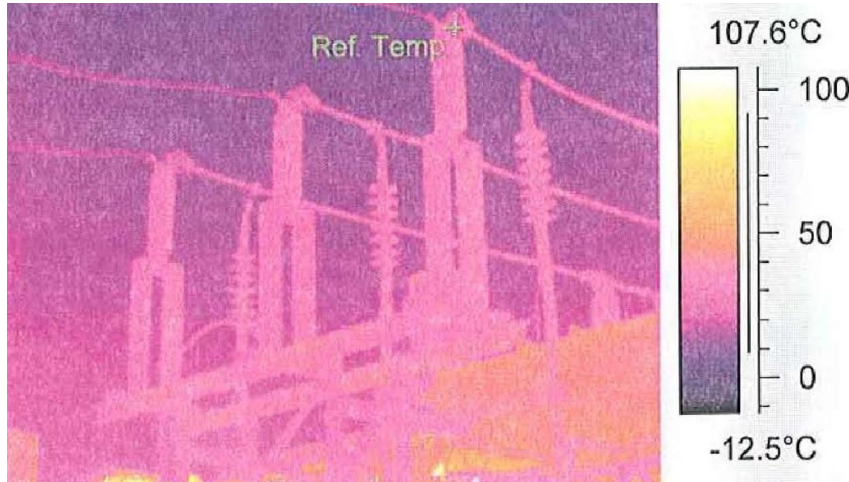
This thermal image is of an outdoor substation. Notice the excessively wide Span setting (-12.5°C to 107.6°C) resulting from using the thermal imager’s Auto function. If there was a hot connection (discontinuity) it would surely have been missed or undetected.

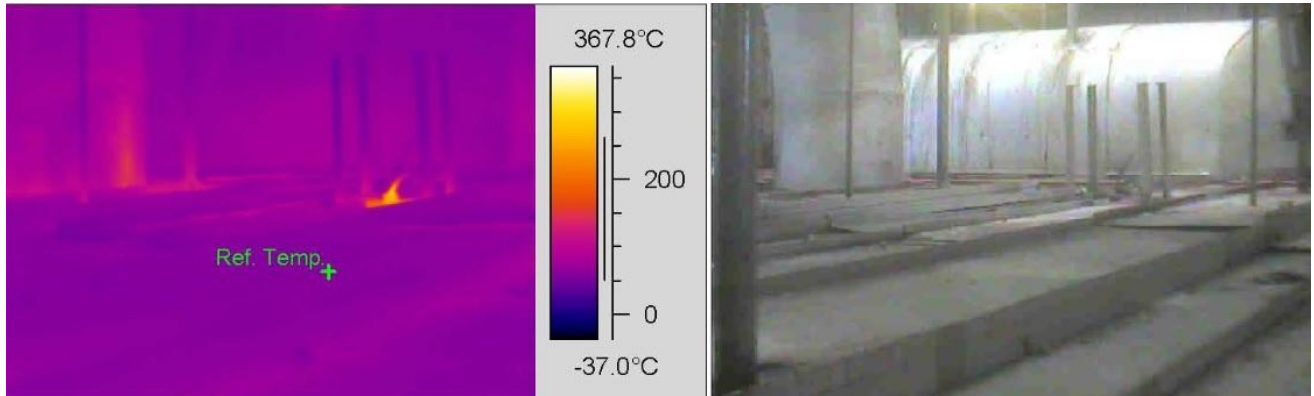
This thermal image is of a refinery's package boiler roof section. Notice the excessively wide Span setting (-37.0°C to 367.8°C) resulting from using the thermal imager's Auto function. If there was insulation failure (discontinuity) it would surely have been missed. A potentially dangerous discontinuity can go undetected by such a survey.

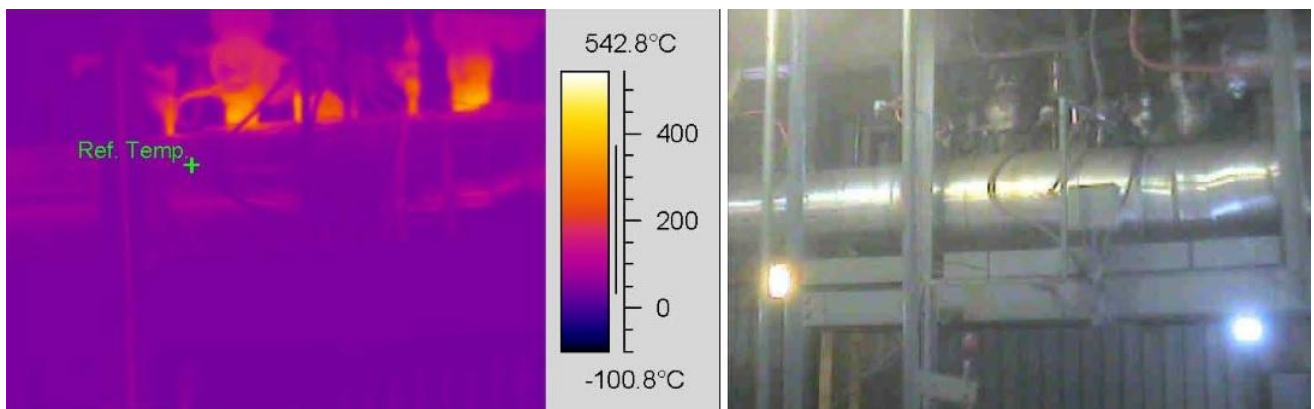
This thermal image is of an insulated and metal clad pipeline in a refinery. Notice the excessively wide Span setting (-100.8°C to 542.8°C) resulting from using the thermal imager's Auto function. More importantly this shows that this "thermographer" does not possess the adequate basic competence for carrying out a thermographic survey as he/she has imaged a section of pipe with extremely low emittance. The uncorrected or unmodified low emittance of the metal cladding makes it impossible for adequate thermal imaging to detect discontinuities.

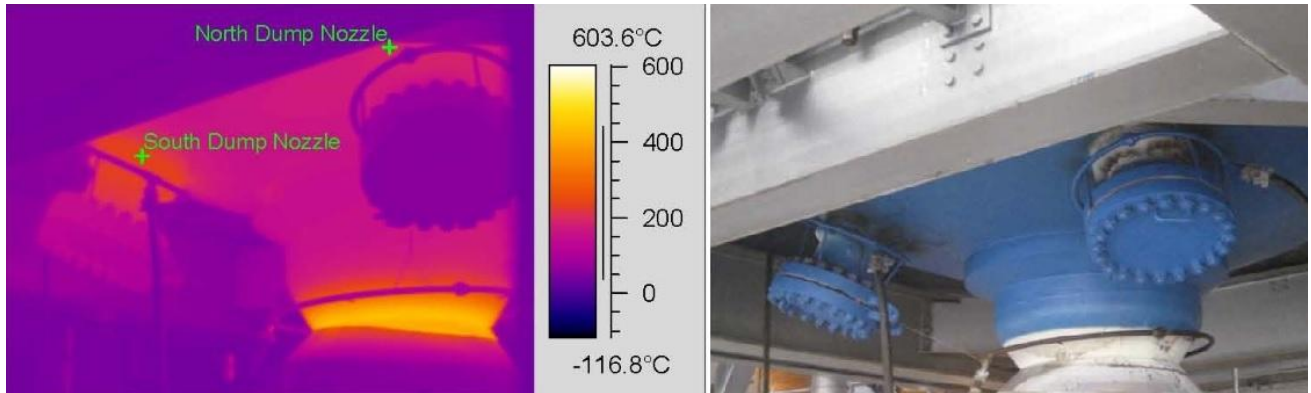
This thermal image is of a refractory lined pressure vessel in a refinery. Notice the excessively wide Span setting (-116.8°C to 603.6°C) resulting from using the thermal imager's Auto function. A potentially dangerous discontinuity located on this domed shell can go undetected. Performing such an inspection can negate the purpose of preventing a catastrophic failure and even loss of life. Clearly the "thermographer" also did not have an understanding of materials and processes (equipment) for this technique.

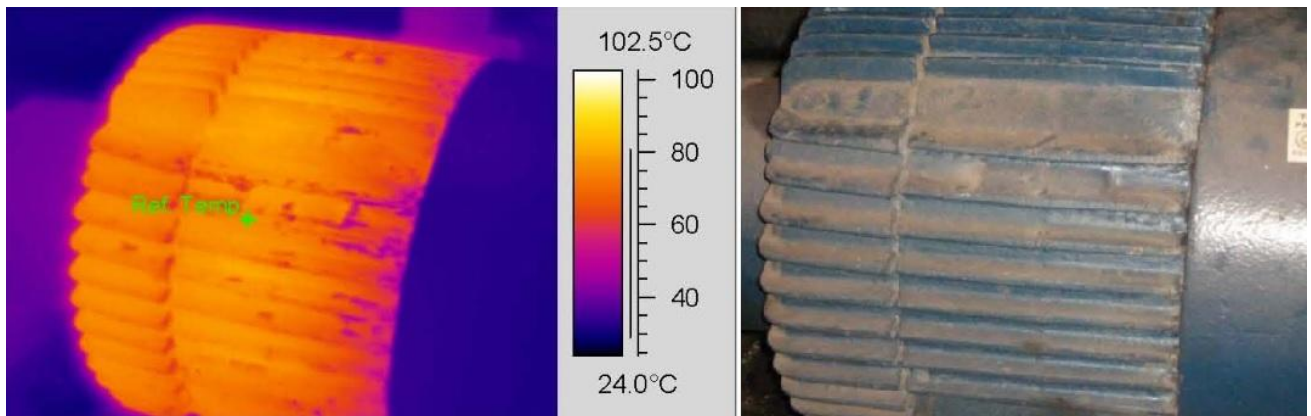
This thermal image is of an electric motor in a power plant. Notice the wide Span setting (24.0°C to 102.5°C) resulting from using the thermal imager's Auto function. Furthermore, although the Auto Span and Level settings are incorrect, it can clearly be seen by any thermographer knowledgeable with motors that there may be a problem with cooling/ventilation of this motor (discontinuity). Clearly the "thermographer" also did not have an understanding of materials and processes (equipment) for this technique (mechanical).
