Thermal Imagers and Marine Inspections

Charles J. Hazouri, Level III Infraspection CIT, Certified Marine Surveyor
Offshore Marine Inspections
500 Mandeville Street, Unit 10
New Orleans, LA 70117

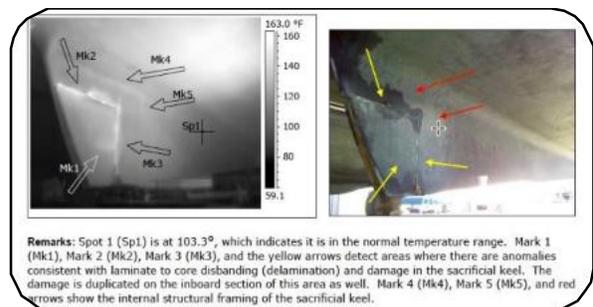
Remarks: Spot 1 (Sp1) is at 103.3°, which indicates it is in the normal temperature range. Mark 1 (Mk1), Mark 2 (Mk2), Mark 3 (Mk3), and the yellow arrows detect areas where there are anomalies consistent with laminate to core disbanding (delamination) and damage in the sacrificial keel. The damage is duplicated on the inboard section of this area as well. Mark 4 (Mk4), Mark 5 (Mk5), and red arrows show the internal structural framing of the sacrificial keel.

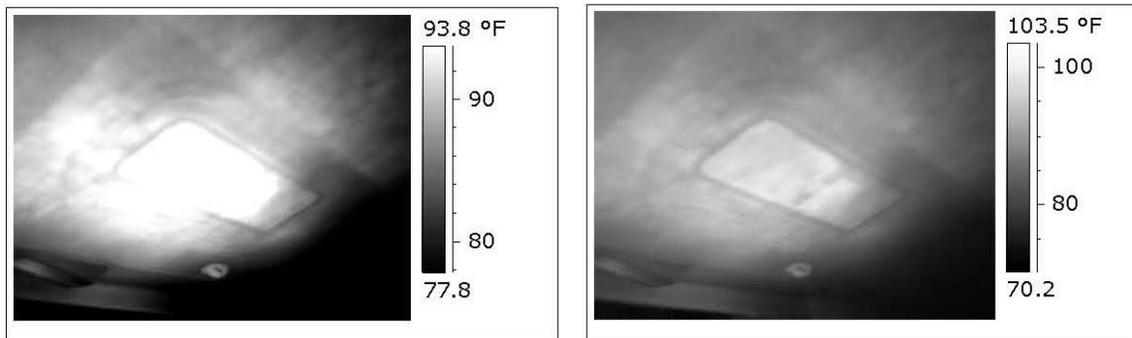
The image on the left is an example of an image from the T440BX that has not been thermally tuned using the computer's software. As you can see, there are numerous areas of reduced contrast, distortion, and some areas that could be mistaken for anomalies, unlike the image on the right, which has been thermally tuned.

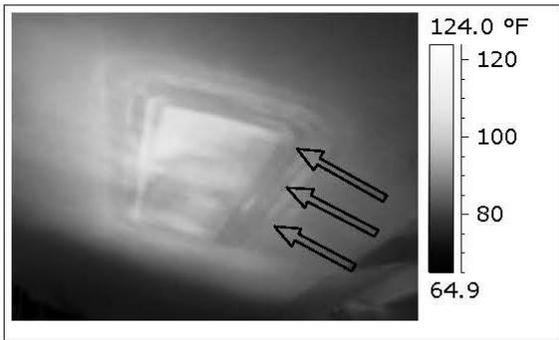
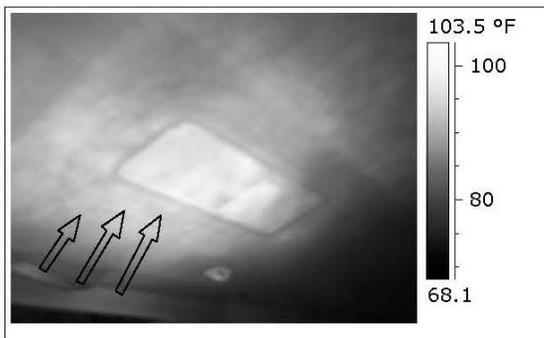
As you can see, the above images show that the T440BX gives you the definition and delineated edges needed for proper inspection. The T440BX actually shows the layers of tabbing for the fiberglass insert, indicated by the black arrows in the images above.

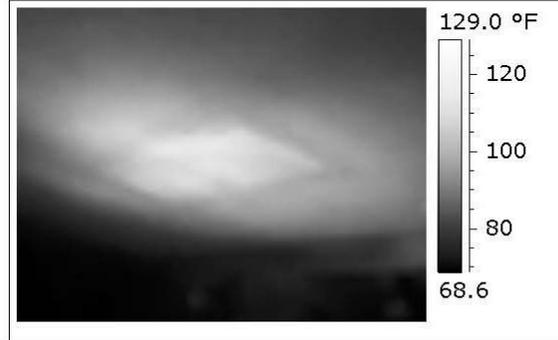
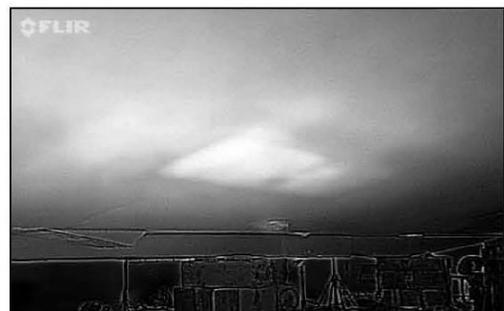
The C2 and FLIR One are too distorted and do not show enough detail and information to do a proper laminate inspection. The FLIR One image could not be thermally tuned using the recommended software in a computer but could be tuned using aftermarket software and the iOS 9.2.1 application. Having an image with specific detail is important for a contractor or boat owner. It documents that repairs are correct and precise.

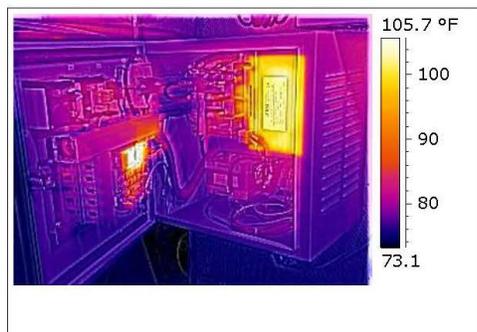
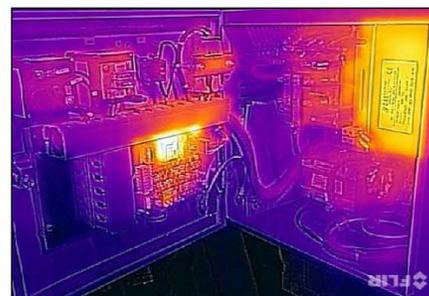
As you can see in these images, the T440BX gives you definition and delineated edges for the electrical inspection. The FLIR One image was slightly distorted. A clearer image is necessary when using MSX[®] so the inspector can identify the problem area with enough detail to provide useful advice and/or information.

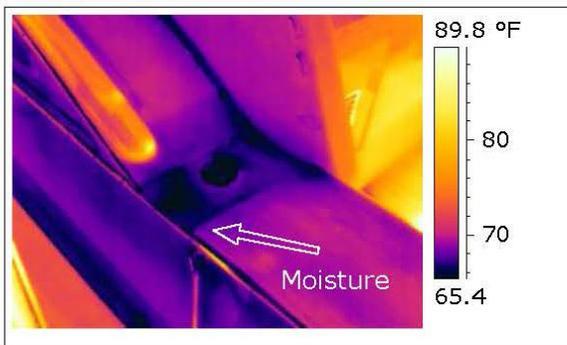
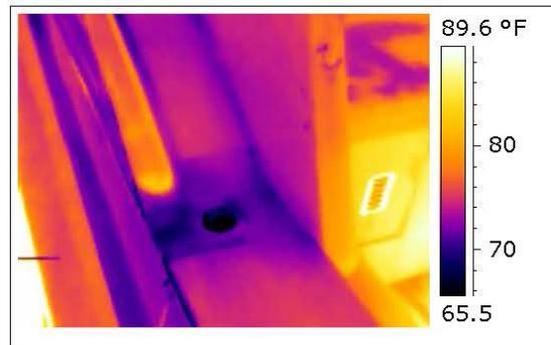
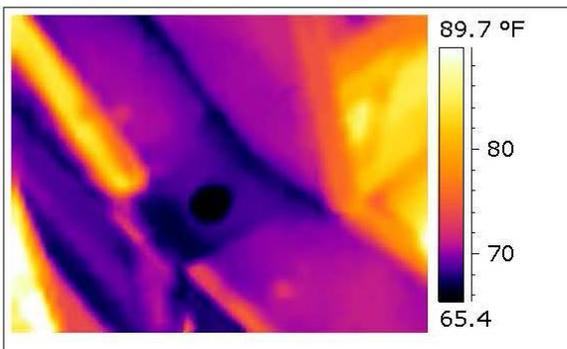
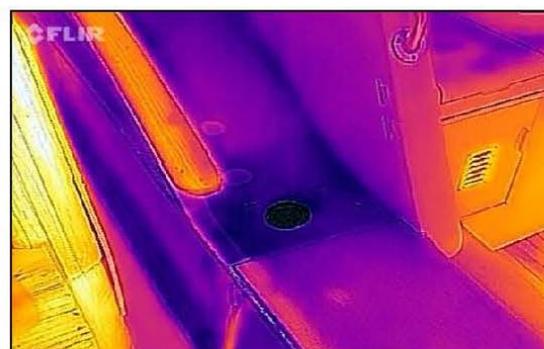
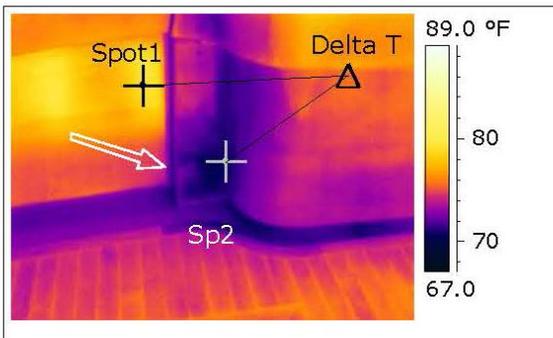
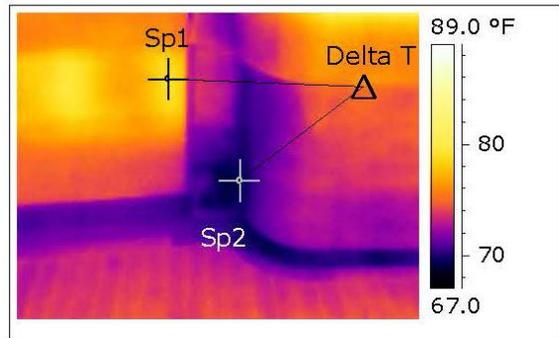
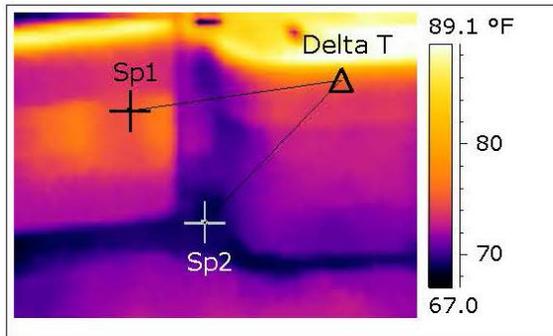
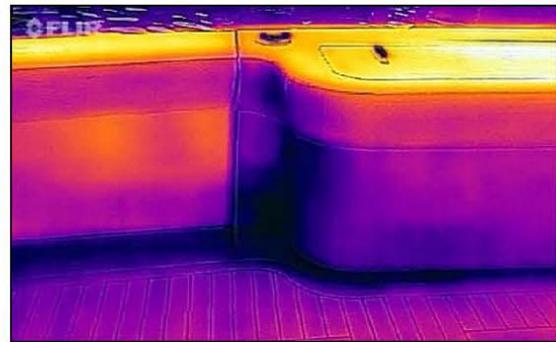
As you can see, the T440BX gives you the best definition and delineated edges for the inspection. With the Spot1 (Sp1) and Sp2 temperature readings, the T440BX and E6 show close to a ten degree Fahrenheit temperature difference, while the C2 showed just under a six degree temperature difference. The E6 is slightly distorted while the C2 and FLIR One are quite distorted and do not show what you need to do a proper inspection by defining the actual area of concern as indicated by the black and white arrows. An actual Delta T could not be determined in the FLIR One image.

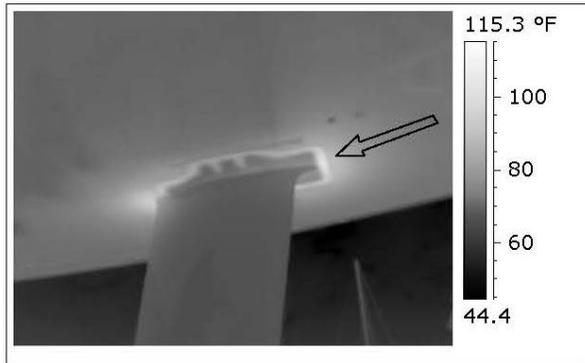
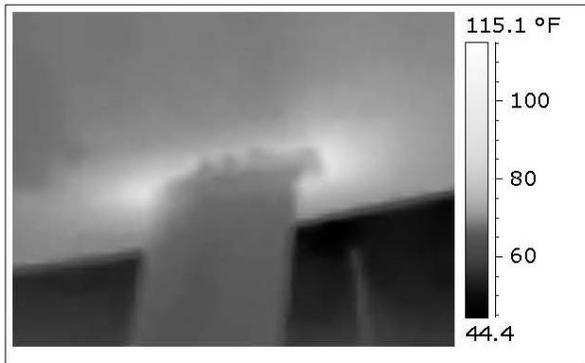
The above images show that the T440BX gives you the best definition and delineated edges for good inspection. The C2 is distorted and does not show what you need to do a proper inspection.
