Predicting Equipment Resiliency Using Infrared Technology

Jim Umdenstock, PE and Dan Keithline, PE

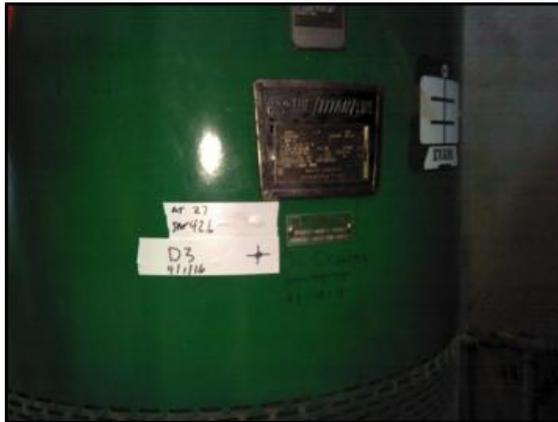
Figure 2 – Motor D3 noting identified hot spot with “+”

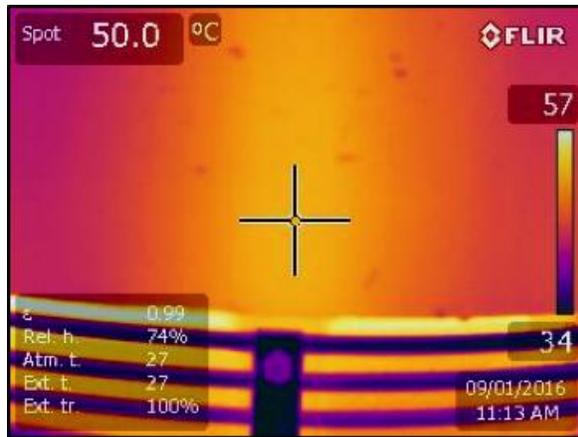
Figure 5 – Motor L2 infrared image over hot spot. Note 50.0 C temperature of hot spot.
