Case Study - The Use of Infrared Thermography to Inspect and Monitor Process Heater Tubes

Robert Richardson, Level-III CIT #1410
Jonathan Scheuerer, Level-III CIT #8858

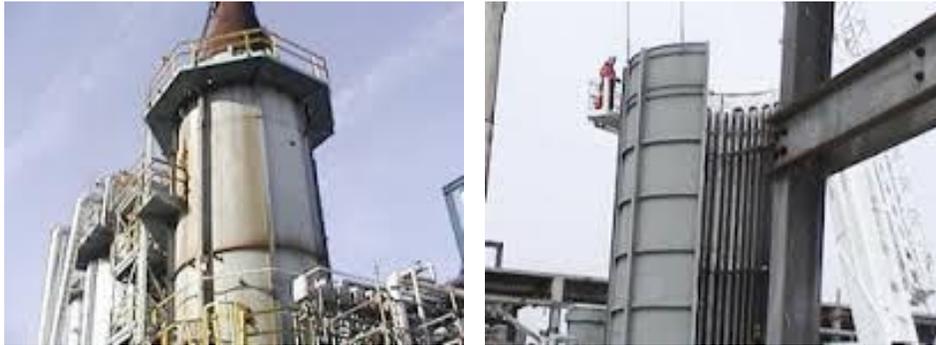
Bottle heaters are cylindrical in shape and range from 10 to 40 feet in diameter. Tubes generally run vertically along the outside wall of the heater.

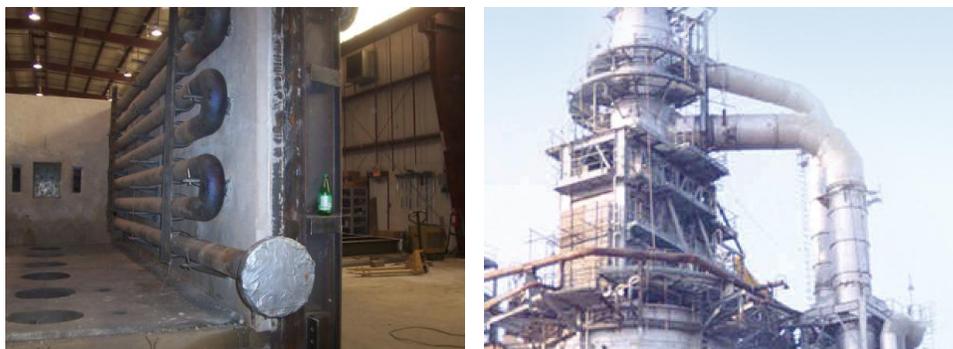
Box heaters, also known as cabin heaters, are rectangular and range in size. Generally they are at least as tall as they are wide. Tubes can run vertically or horizontally; be adjacent to the walls or in the middle of the box; and can be located on the walls, ceiling, and or floor. Although they require more space than a bottle heater, box heaters can handle a larger volume and/or more types of crude oil.

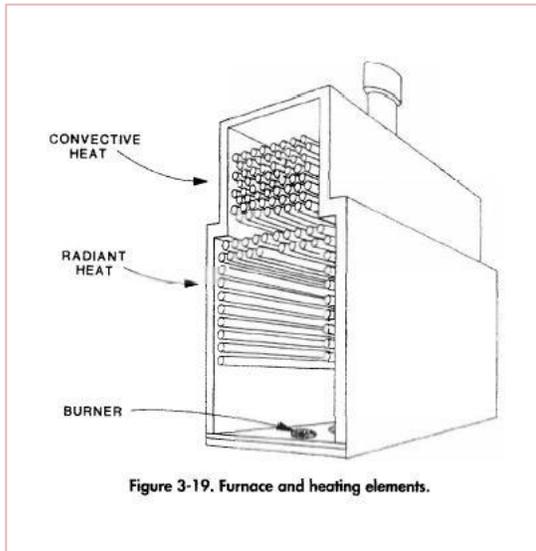
Tube diagram typical of a box heater

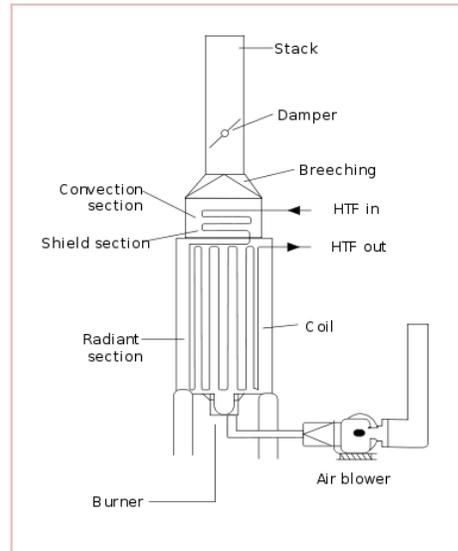
Tube diagram typical of a bottle heater

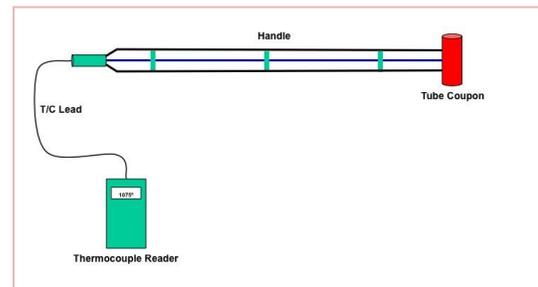
To obtain an accurate temperature, these variables must be identified and calculated for each specific heater, at the time of the survey. The preferred method is to utilize a “coupon”. A coupon consists of a piece of the same material as the tubes to be inspected with thermocouples mounted on the back of the tube. When inserted into the furnace to a depth similar to the tubes to be inspected, variable factors can be identified and accounted for by using the data from the thermocouples.

Schematic drawing of coupon

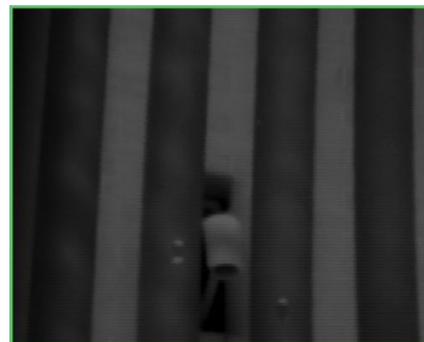
Coupon installed in a heater

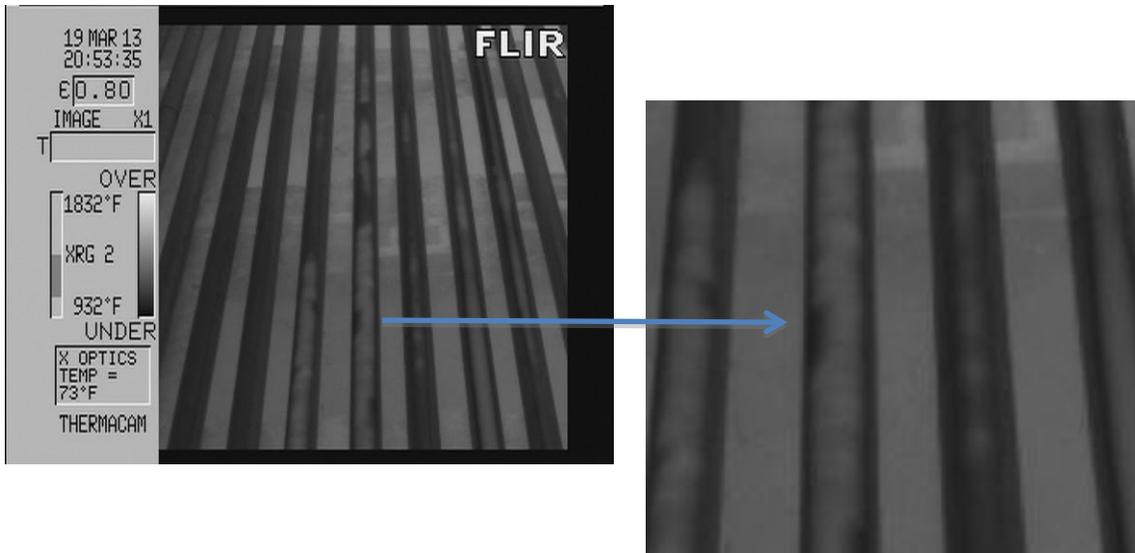
During the Infrared Survey, thermal anomalies consistent with coke patterns were identified in seven to eight heater tubes. Coke patterns are typically described as “half-moon” or “cigar” shapes. Additional concern was raised because the temperatures reported with the infrared imager were approximately 300 F° higher than the heater’s fixed thermocouples were reporting.

The infrared imager temperatures were above the heater's critical threshold and the decision was made to monitor the heater continuously as operational changes were made. Adjustments to the rate of crude flow and the temperature of the burner flames lowered the tube temperatures to within acceptable limits. After about 26 hours, we were released from the site.

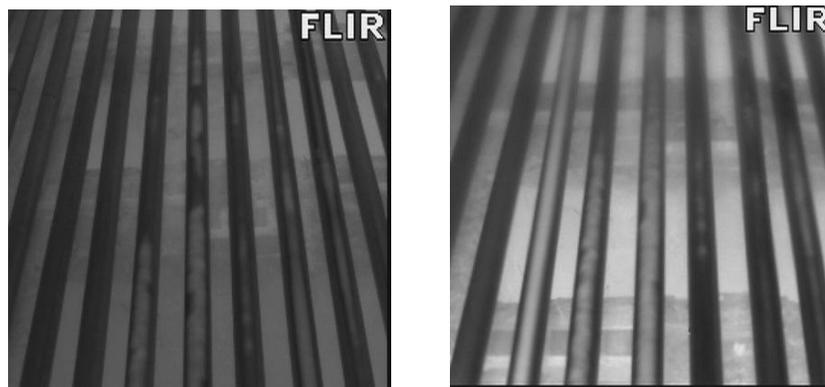
1. Additional thermal anomalies began to appear. Within a short period, thermal anomalies developed on fourteen tubes.

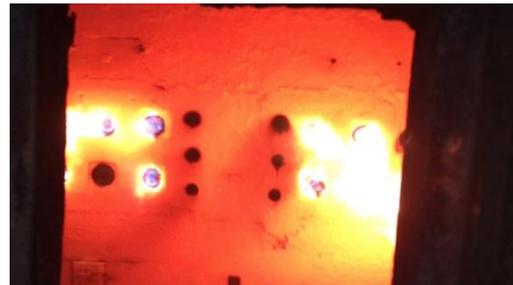
6. Burner tips recently installed were discovered to be too short, preventing the heat from being forced to the center of the heater box. The installation of longer burner tips relieved some of the heat directly hitting the tubes.

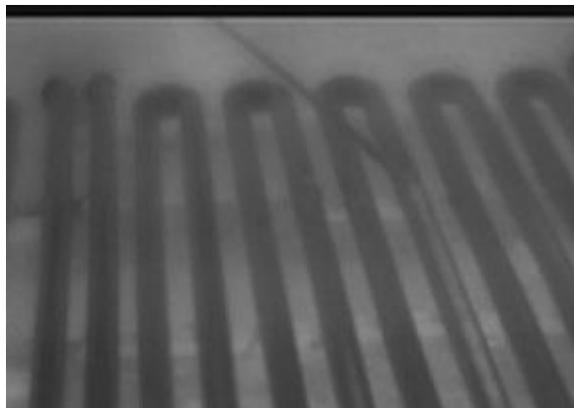
8. Petrochemical facilities commonly use high-pressure steam to control high temperatures. A steam lance was installed to help control the temperature of one area that routinely recorded high temperatures. Due to the configuration of this heater's burners and tubes, additional steam lances could not be added.

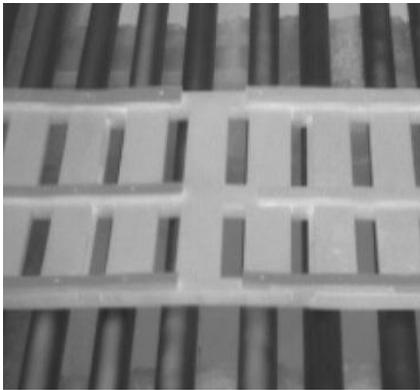
Example of a single tile

One common industry solution to this problem is the use of heat resistant tiles. In a normal installation, the heater is taken offline, a support system is built and installed around the heater tubes, and heat resistant tiles are placed in the heater. The heater is then brought back online and production resumes.

Since a shutdown was not an option, plans were made to install the tiles while continuing to run crude oil through the heater. Large openings were made in the walls of the heater and specially designed blankets of heat resistant tile were slid into place on top of the tubes running on the floor of the heater. Since this operation was performed with the heater

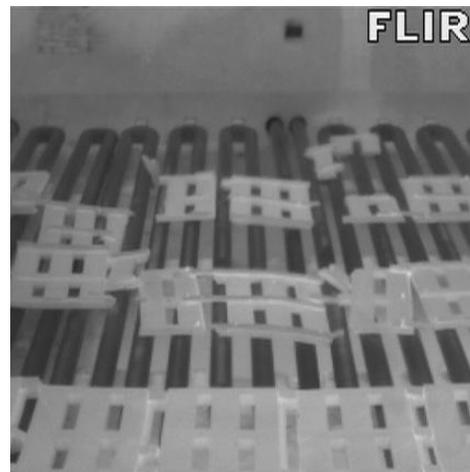
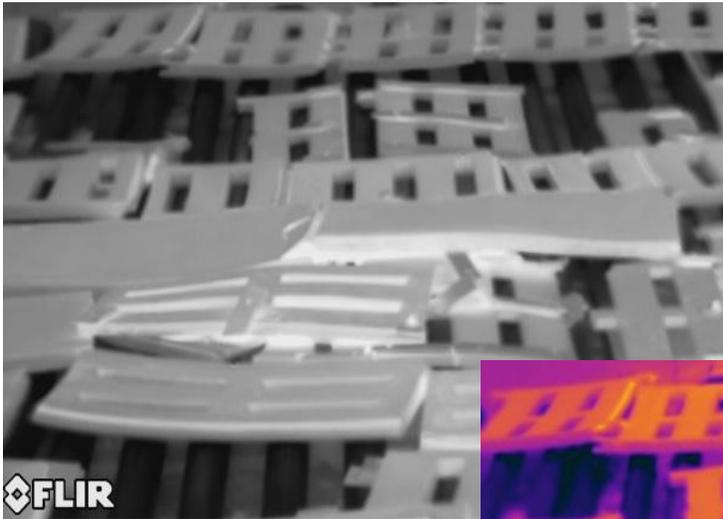
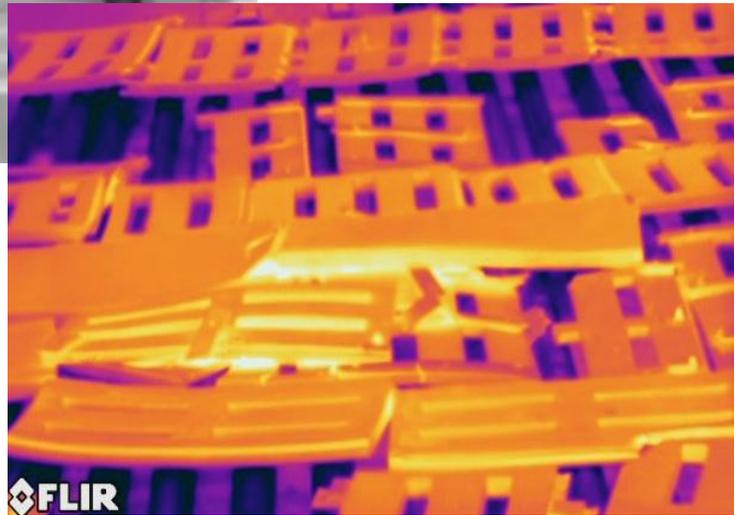
The downside to this operation was that the infrared imager was not able to see through the tiles, resulting in limited access to the condition of the tubes. Designed spaces in the tiles, and areas of the tubes above and below the tiles were still monitored. Temperatures in these areas continued to fluctuate. In addition, the location and severity of the thermal anomalies located in the tubes on the heater floor continued to change.

Although the installation of the tiles did deflect direct heat from the floor tubes, continuous monitoring of the heater tubes was still required. Over a period of time the extreme and changing conditions required the addition of more tiles.
