Back to Reality: Infrared Thermography (IRT) as an Objectifier of Equine Back Pain and Saddle-fitting Problems

Joanna L. Robson, President, DVM, CVSMT, CMP, CVA, SFT, CIT

Inspiritus Equine, Inc.
8 Golden Gate Circle
Napa, CA 94558
Ph: 707-738-7110

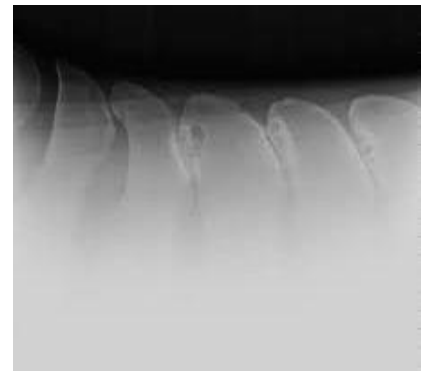
Radiograph of “Kissing Spine”

Diseases of the equine back may range from mild muscle soreness, to significant spinal arthritis, ligamentous tears, or extruded disks. Over-riding spinous processes (often called “kissing spine”), chiropractic lesions, and nerve damage are also omnipresent. IRt plays a significant role in detecting back inflammation that may be associated with these listed conditions, and in helping with saddle-fitting. Many clients are unaware of their horse’s back problems until seeing the objective evidence in the images.

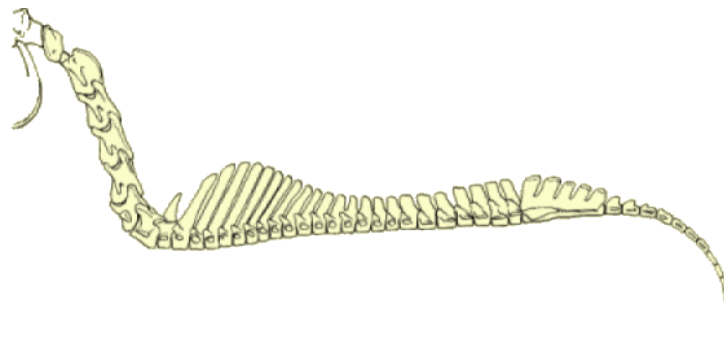
The Equine Skeletal Formula: C7-T18-L6-S5-Cd20

The equine spine is comprised of 7 cervical vertebrae, 18 thoracics, 6 lumbar, and 5 fused sacral bones. The tail is typically 18-20 smaller connected bones, similar to the bones in the human digit. These bones are connected through a ligamentous and muscular bridge. The nuchal ligament, a thick fibrous band, extends from the back of the skull to the withers, and then continues as the dorsal spinous ligament to the tail. When the horse moves in harmony, this suspension bridge allows the bones, joints, and soft-tissues to move fluidly, absorbing shock and dissipating forces. When pain or pressure occurs over the nerves, bones, or muscles, this bridge fails and collapses, causing strain and inflammation of soft-tissues and joints. Over even short periods of time, permanent damage may ensue, shortening or ending equine athletic careers.

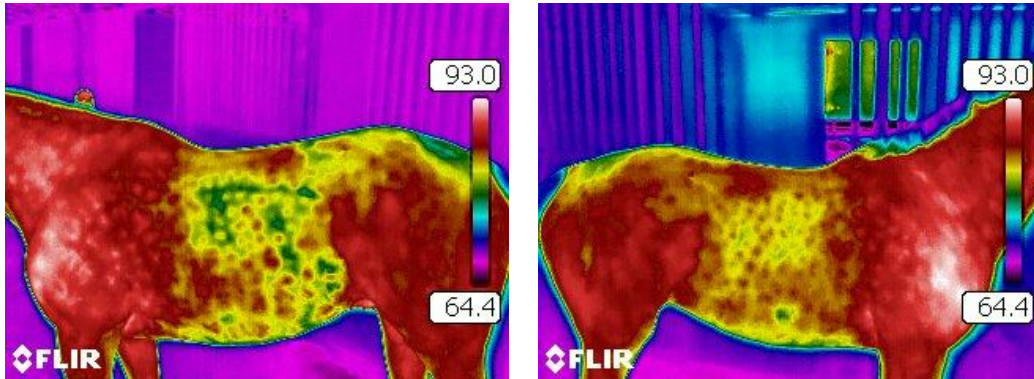
Left and right lateral views showing heat in the loins and a panel outline consistent with bridging. Behavioral issues prevented “over the back” imaging.

Case One: Eight year-old European Warmblood gelding with behavioral issues, lead-swapping, and problems with jumping. His owner had his saddle fitted twice by a “saddle-fitter” who assured her that the saddle was not the horse’s problem. He continued to have issues, and was imaged to participate in an un-related thermography study. Thermal images showed significant inflammation in the horse’s back, with an apparent saddle-outline through the shoulders and loins. The owner reported that she had not ridden her horse for 3 days prior to his being scanned.

Outcome: Based on these images, the horse’s owner sold her current saddle and quickly sought a correctly fitting saddle. The horse had appropriate rest and therapy for 30 days, and returned successfully to jumping and competing. Follow-up images confirmed the completed resolution of focal heat in the back.

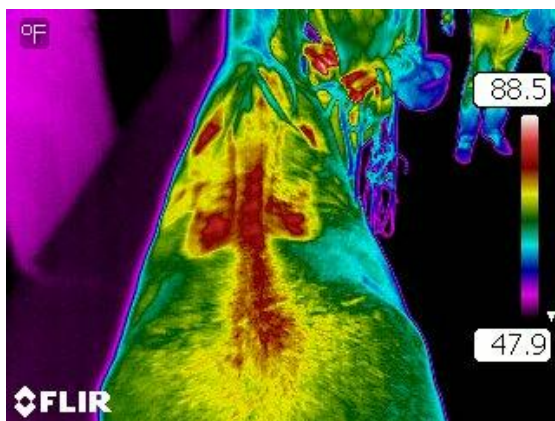
Dorsal view showing a distinct bridging pattern created by a bridging saddle – there is focal pressure at the front and rear of the panels, with no contact in between.

Case Two: Sixteen year-old swayback Quarterhorse used in a therapeutic riding program. His saddle is always shifting, and the group is worried that his back may be injured by the saddle.

Outcome: Based on the images and a gross saddle evaluation, the saddle was determined to be bridging and putting uneven pressure on the horse’s back. A different saddle was selected with improved fit, and a pad to equalize the swayback was utilized.

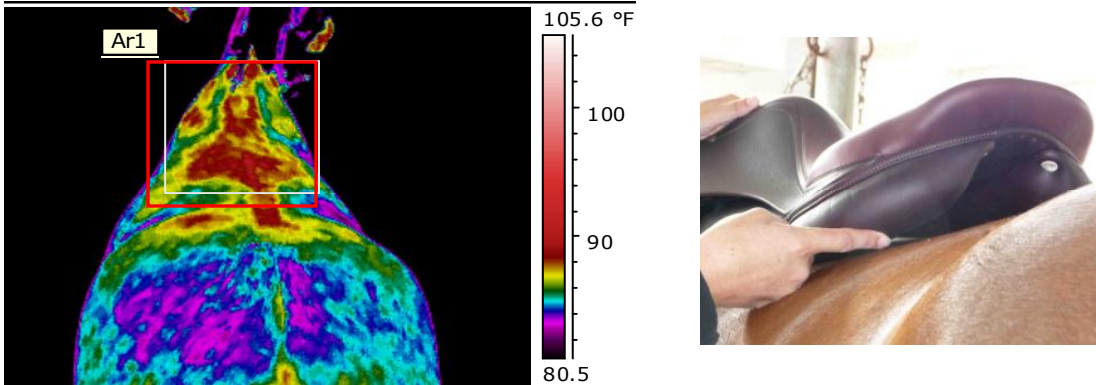
Dorsal view of the patient showing asymmetrical pressure from the saddle on the horse's back. There is increased pressure over the left shoulder and shoulder-hole, withers, and left paraspinal muscles. This indicated a saddle that was shifting or falling, too tight through the tree and channel, and could represent a rider sitting heavier on one side.

Case Three: International level Hunter gelding with a tight back and diminished performance. Palpation over the withers and low back would cause the horse to drop down in pain. The saddle was an older saddle in the barn being used while a new saddle was being made. The owner had concerns that saddle-fit was an issue, and had been in an argument with the trainer on this point.

Outcome: Based on image evidence, the owner elected not to ride the horse until her new saddle was delivered. The new saddle was also determined to be an improper fit. The owner and trainer conflict escalated, and the owner elected to move to a new barn.

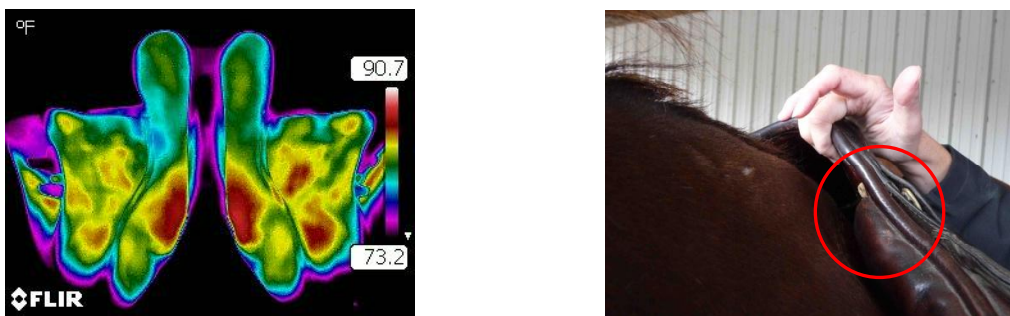
The underside of the saddle upon removal from the horse's back. Note the red pressure points at the front of the tree, and the interrupted pattern through the left panel. The picture at right shows the common site of pinching over the horse's shoulders from a saddle tree that is too narrow.

Case Four: Saddle too narrow and bridging on the left side. Leather saddles will show a nice mirror pattern to the horse's back when the procedure is carried out correctly. Synthetic saddles are harder to evaluate, but are still imaged as part of a saddle-fitting evaluation.

Outcome: This saddle is too narrow through the tree and is pinching the horse's withers and shoulders. Because it sits too high on the horse, there is uneven contact through the panels. There is more pressure along the right panel and flap, and the left panel shows a bridging pattern.

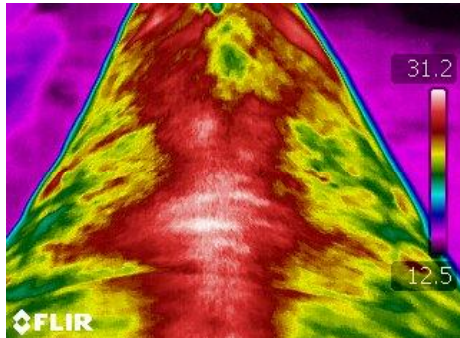
Case One: Generalized Inflammation and Over-riding Spinous Processes in the Low Thoracics

The red region correlates to paraspinal muscle inflammation, with white focal heat over spinal arthritis caused by “kissing spines”.

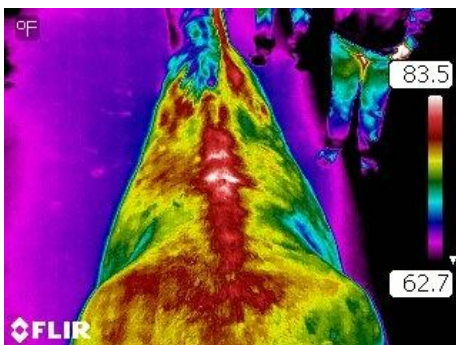
Case Two: Over-riding Spinous Processes

Heat in the dorsal midline can be typical, but the focal white spots and radiating red are classic thermal patterning for Kissing Spines. The diagnosis, however, must always be confirmed with anatomical imaging.

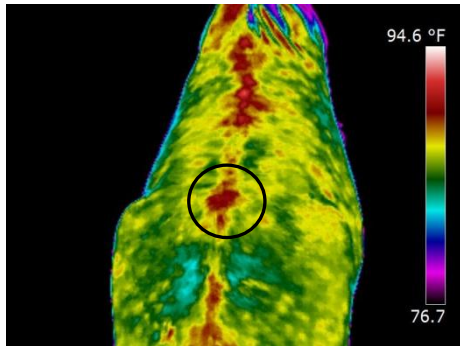
Case Three: Chiropractic Lesions – Vertebral Rotations and Posterior Sacrum

Focal hotspots over the dorsal spinous processes clearly outline a misaligned spine with associated inflammation.
