**“What else can I inspect?”**  
**John F. Keane and Robert P. Madding**  
**FLIR Systems, Inc.**

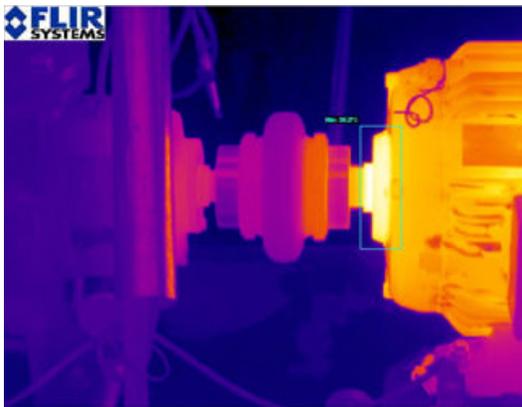
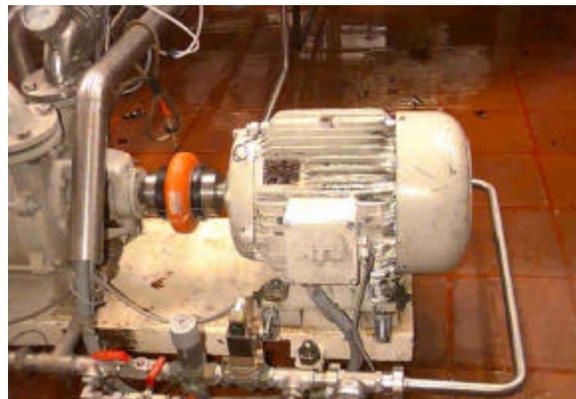
Inboard bearings are overheated on the motor below. Run to failure or fix? The decision depends on its criticality. In this case, the motor is critical and its loss could result in thousands of dollars of lost production.

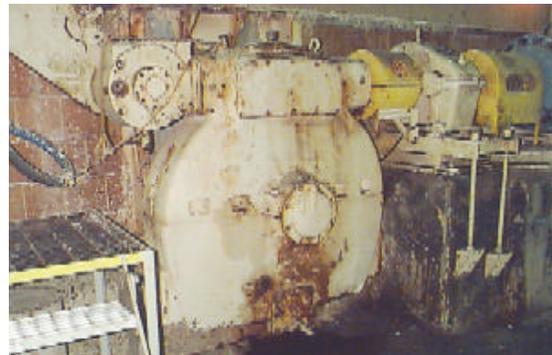
Gear boxes and other low frequency devices often do not lend themselves readily to vibration or oil testing. Thermography can be the only method for finding problems prior to failure. Below, this gearbox external temperature exceeds its company's guidelines of 60 degrees C maximum temperature. This is an indirect reading as the gears are internal and certainly much warmer than the surface temperature of 90 degrees C.

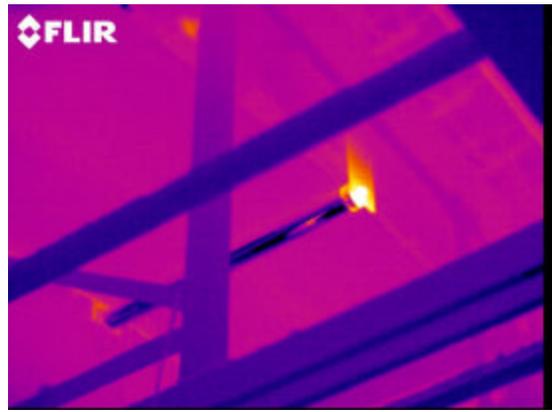
The images below are of a bad conveyor bearings. The only way to find these before failure is with infrared. There are 79 miles of conveyor with a bearing set every 8 to 10 feet. You do the math. OK, I will - let's see, carry the 2...that's over 40,000 pairs of bearings!

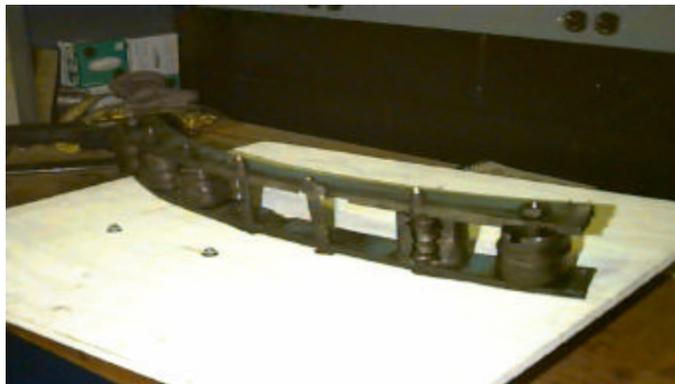
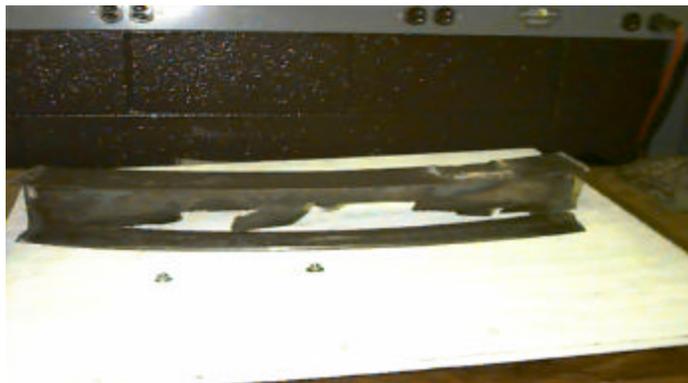
To the right is a picture of the dismantled roller bank. Just how bad was it? Notice the two missing rollers in the center of the turn also; the roller next to each one was worn flat on one side. The backside of the rail had been worn paper thin. Clearly the lack of access to the equipment was part of its neglect. Although this was a long time materializing, fortunately infrared detected this in time. This is an example of where inspecting beyond a predefined route, and simply looking up, prevented a costly production stoppage.

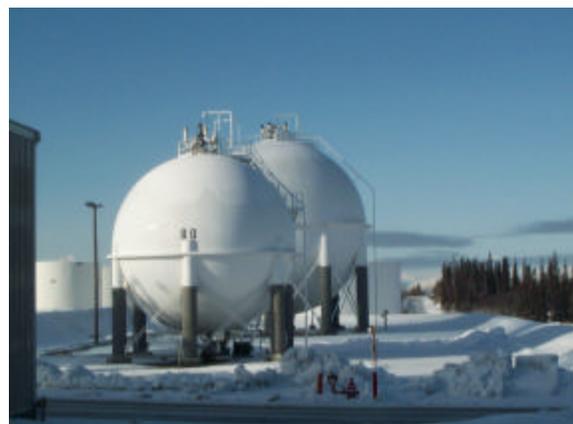
Determining liquid level in tanks is another application. Below are petrochemical tanks showing fluid levels. Note that in the right hand tank, 3 distinct regions are discernable. Tank liquid levels depend on transient thermal heating/cooling such as the diurnal (day/night) cycle. For example, you will have difficulty determining the liquid level in an indoor tank where the liquid is the same temperature as the ambient environment without applying some type of thermal “stress”, such as a hot air gun, etc.

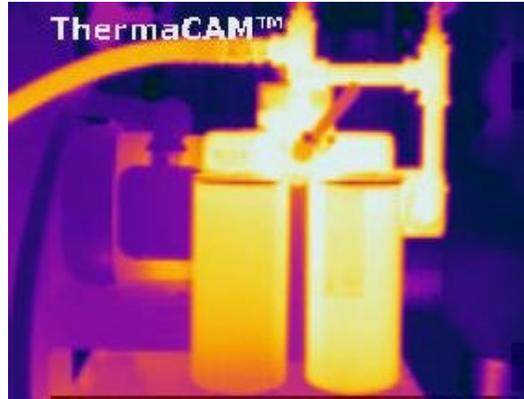
The thermal images below are from the Deer Island, Massachusetts sewage treatment facility. The oil lubricates bearings on a centrifuge that further separates solids from liquids. Warm oil is pumped from the sump, filtered and sent to the motor bearings. It returns to the sump and the cycle repeats. The image pair shows two sets of filters. Each set has two filters with an accompanying valve used to select one of the filters. The valve handle can be seen in the center just above the filter cans. In the left hand image, one filter is cool, the other warm. This shows proper operation. In the right hand image, both filters are warm. This means the valve is leaking and needs repair/replacement. Note that we did not need temperature measurements here.

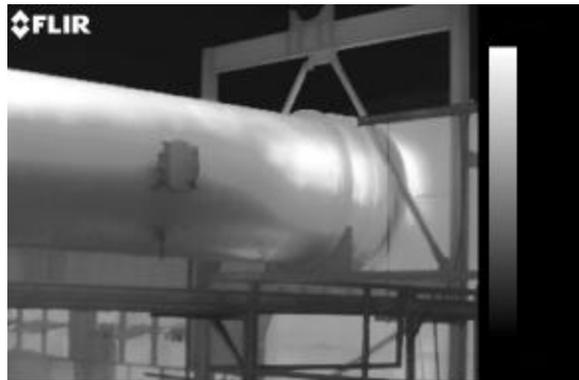
Pumps and piping can range anywhere from oil process heaters where crude oil is being heated, to leaking steam drain line valves, to pulverized coal feed lines, to other process piping. This thermal image shows a restricted product inlet, which could be coal. It has restricted the airflow in the pipe and the particulate has drifted towards the bottom. To get this image you have

to adjust the thermal contrast by tightening the span. For restricted airflow in coal lines, a plug can overheat and spontaneously combust, causing an explosion.
