# **Infrared Thermography Goes Underground:**

## **How a Major Metropolitan Subway is Using Thermal Imaging to Help Improve Reliability**

Mary F. Molle, Vice President  
Jersey Infrared Consultants

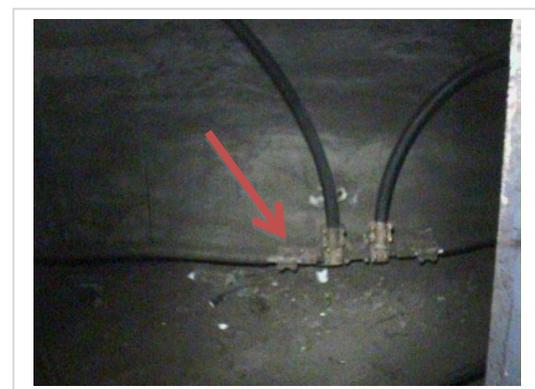
**Thermogram shows an increased temperature (white) at a cable termination.**

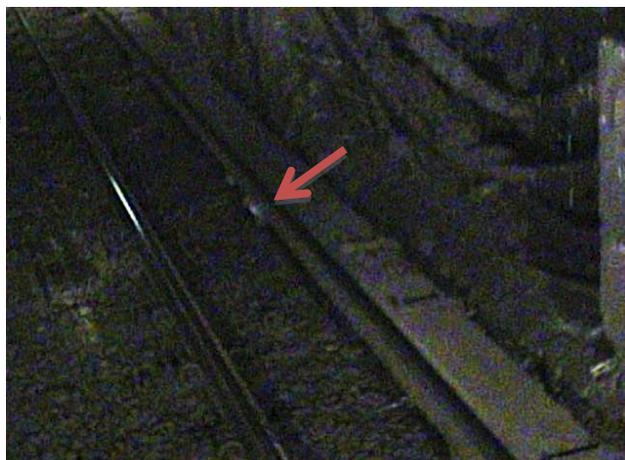
**This thermogram shows a typical third rail problem. At the time this image was taken, there was a 41°C temperature differential between rail sections.**
