Thermal Imagers and Marine Inspections

Charles J. Hazouri, Level III Infraspection CIT, Certified Marine Surveyor
Offshore Marine Inspections
500 Mandeville Street, Unit 10
New Orleans, LA 70117

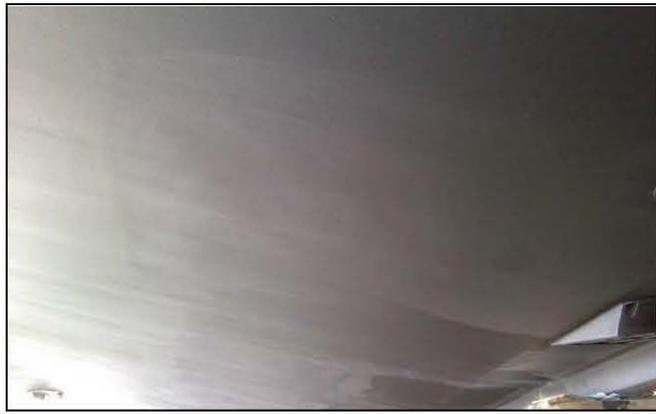
Looking Forward

Inspections and Test: The following four grayscale thermal images were taken of a recent repair to the hull of an 80' Viking Sport Fisherman. These images will demonstrate the different quality of images obtained by using a higher hertz and resolution imager in comparison to an imager with lower hertz and resolution.

As you can see, the above images show that the T440BX gives you the definition and delineated edges needed for proper inspection. The T440BX actually shows the layers of tabbing for the fiberglass insert, indicated by the black arrows in the images above.

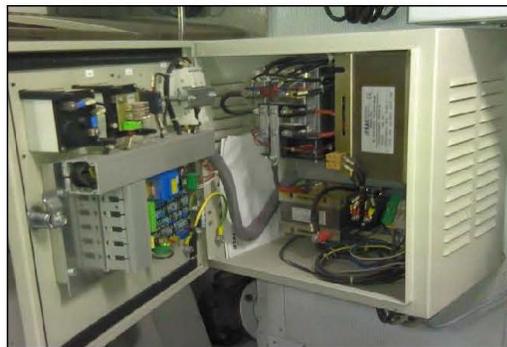
The following two iron scale thermal images taken of a normal operating battery charger imaged with Multi Spectral Dynamic Imaging or MSX[®]. MSX[®] adds key details from the visible light camera to the entire thermal infrared image,^v This shows which imager gives enough visual information to do a proper inspection. MSX[®] does require that you have good visible light for the imager unless you can thermally tune the image using the proper computer software.

As you can see in these images, the T440BX gives you definition and delineated edges for the electrical inspection. The FLIR One image was slightly distorted. A clearer image is necessary when using MSX[®] so the inspector can identify the problem area with enough detail to provide useful advice and/or information.

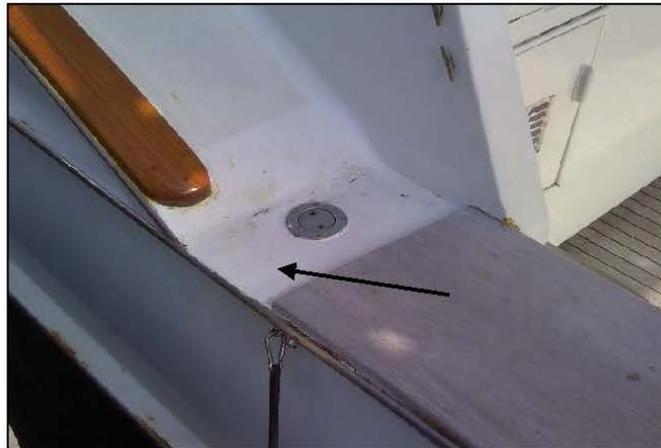
The following eight iron scale thermal images taken of the port side deck fuel fill and cockpit bulwarks of a 72' Blackwell Boatworks Sport Fisherman will outline and demonstrate which imager is best for moisture ingress and/or water intrusion in fiberglass laminates.

As you can see, the T440BX gives you the best definition and delineated edges for the inspection. With the Spot1 (Sp1) and Sp2 temperature readings, the T440BX and E6 show close to a ten degree Fahrenheit temperature difference, while the C2 showed just under a six degree temperature difference. The E6 is slightly distorted while the C2 and FLIR One are quite distorted and do not show what you need to do a proper inspection by defining the actual area of concern as indicated by the black and white arrows. An actual Delta T could not be determined in the FLIR One image.

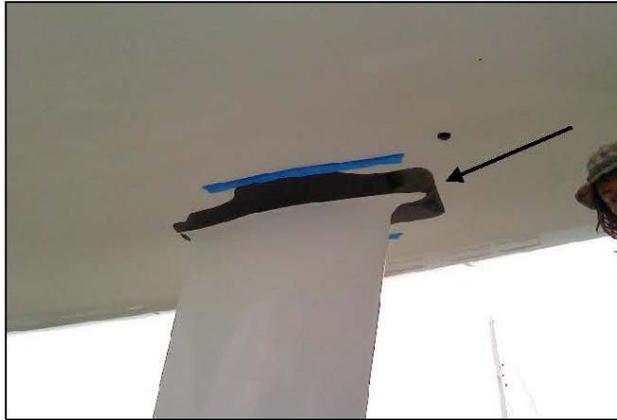
The following two grayscale thermal images taken of the carbon fiber keel flange of a 52' Transpac TP52 Sailboat will outline and demonstrate which imager is best for vessels constructed of carbon fiber.

The above images show that the T440BX gives you the best definition and delineated edges for good inspection. The C2 is distorted and does not show what you need to do a proper inspection.
