Thermographic Documentation of Roof and Building Damage Incurred During the 2004 Florida Hurricane Season

James Brady, President, Level-III Certified Thermographer
&
Warren C. Garber, Level-III Certified Thermographer

Abstract

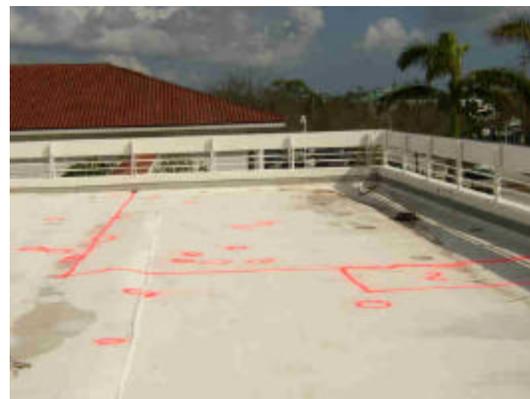
That evening we returned to the Winn Dixie roof. The main roof was a single-ply roof system. Examining a section of roof removed from the storm, we discovered that two separate recovery roof systems had been installed over the original gravel built-up roof; a modified bitumen followed by the single-ply roof. Nearly 80 percent of the entire roof showed signs of moisture damage. Interestingly, only a small portion of this roof had lifted off during the storm but thermal anomalies were widespread. Damage was also documented of missing wall flashings and debris that punctured the roof membrane.
