Thermal Imaging - A Better Solution for Inspecting G10 Laminates

Charles J. Hazouri
Offshore Marine Inspections
500 Mandeville Street, Unit 10
New Orleans, LA 70117
Ph: 504-450-8044

Abstract

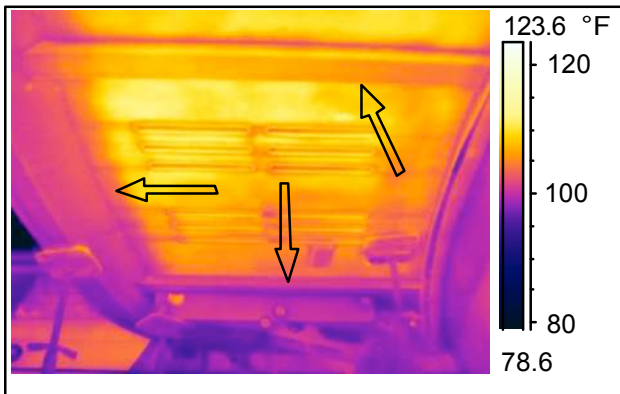
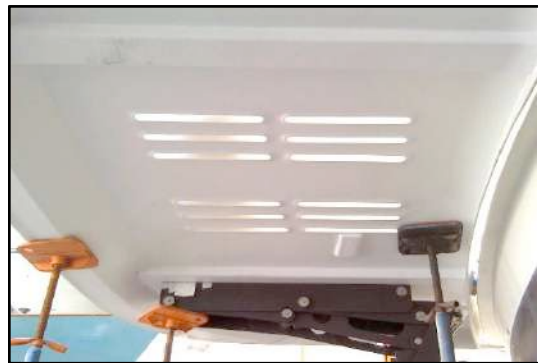
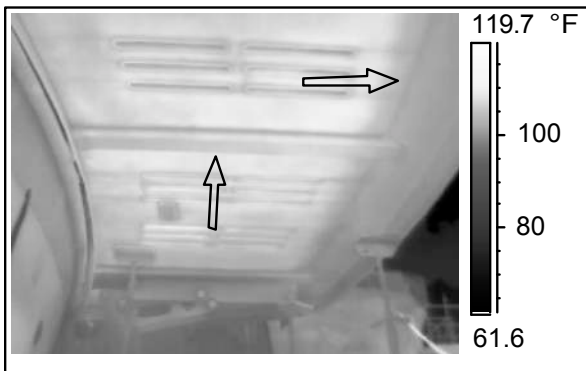
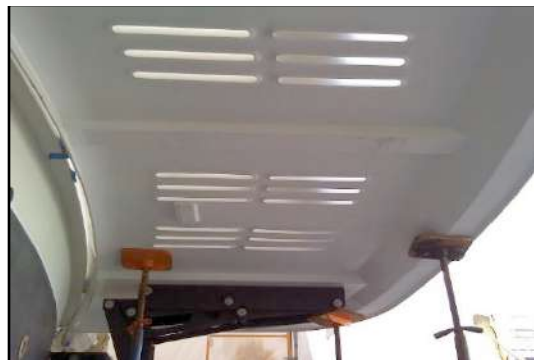
The underside of the swim platform after installation. Take note that using a product with strength and versatility such as G10 allows the contractor to use a non-metallic structural member that can withstand the weight and force of the swim platform's hydraulic rams (indicated by the red arrow in the first digital picture) as seen in this application and in the images above of the underside of the starboard portion of the swim platform.

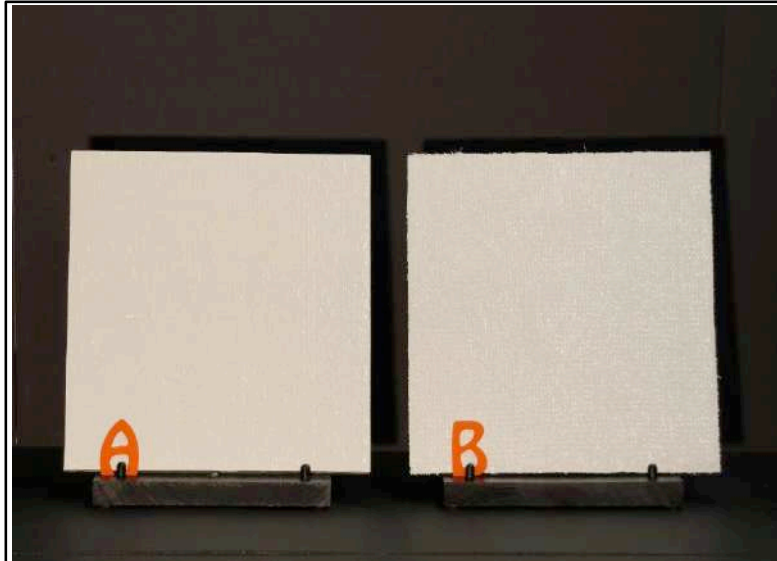
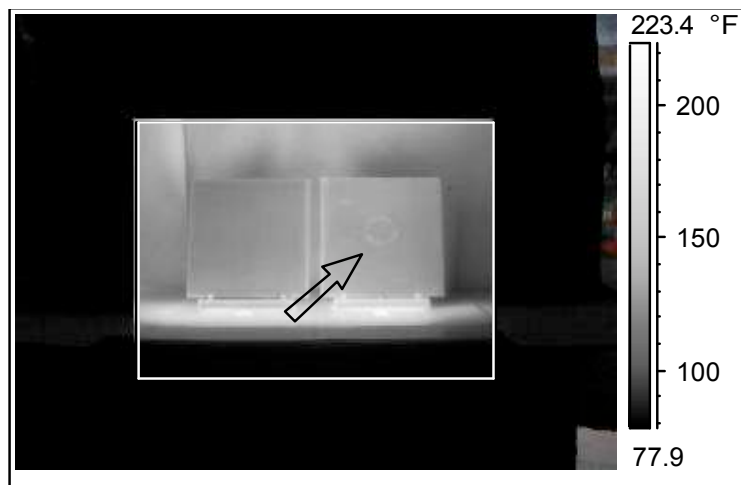
In the next test, two samples were independently heated and then imaged using thermal infrared technology. Sample A is a standard piece of G10 with no anomalies and Sample B, as you will clearly see, is a G10 sample with an anomaly consistent with an area of delamination and/or a small void.

Delamination is an area of separation within or between two plies in a laminate or within a bonded joint caused by contamination, improper adhesion during processing, or damaging interlaminar stresses.ⁱⁱ

A small **Void** refers to a situation where air or gas has been trapped and cured in a laminate during the manufacturing process.ⁱⁱⁱ

Samples A and B together show that there is a defined pattern when imaging G10 laminates and that any non-conformity can be easily identified using thermographic inspection techniques.

For best results, it's recommended that all areas constructed using G10 as well as all Fiberglass Laminates be Thermal Imaged and documented prior to and after repairs and/or construction.
