Thermal Patterns Associated with Walk-on Roof Inspections of Insulated Flat Roof Systems

James Brady
Level III Certified Infrared Thermographer

Scott Eves
Level III Certified Infrared Thermographer, LEED AP

Brady Infrared Inspections, Inc.
935 Pine Castle Court
Stuart, FL 34996
Ph: 772-288-9884

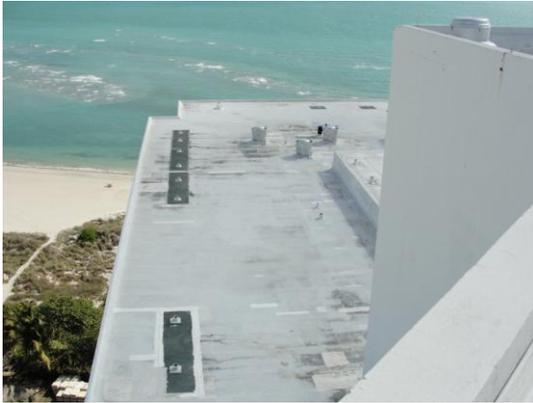
Figure 1: Ocean front condo with very low parapet wall on a flat roof system. Roofs like this can cool very quickly shortly after sunset, if there is wind coming off the water.

Wind can also affect the time at which the scanning window opens and the length of time the window stays open. We conduct a number of roof inspections close to and on the ocean. Some of these roofs have very low to no parapet walls (Figure-1). Under these conditions, roof surfaces cool very quickly, especially when the sun goes down. As can be expected, being on these types of roofs just before sunset is the ideal time to start scanning.

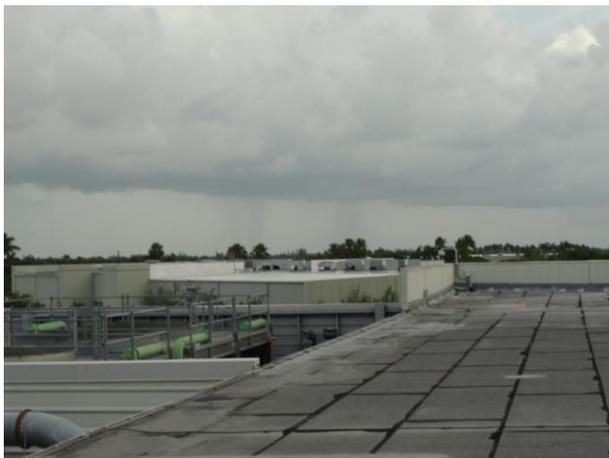
Figure 2: Overcast skies with rain showers around job site created an early and short-lived scanning window on this roof. Scanning took place between 3:30 PM and 5:30 PM.

Ideally, most roof inspections are conducted shortly after sunset during a cooling stage to avoid daytime shadowing and solar reflection issues on the roof. However, optimal conditions are not always available for scanning and adjustments need to be made in order to capture relevant data. For example, we were asked to perform a survey on a roof measuring over 200,000 square feet during early July in south Florida. For several days, rain and overcast skies dominated the regional weather pattern (Figure-2). Although we were rain free for a couple of days at the site, overcast skies prevailed from early afternoon until dark, which triggered a cooling cycle well before dark. We actually started scanning at 3:30 PM and lost our scanning window by 5:30 PM. The large size of the roof forced us to work extra days to complete the inspection, due to the short-lived scanning window, but we gathered meaningful information despite the not-so-perfect weather conditions. Other factors that may cause early cooling on sections of roof include parapet walls, wind screens, cooling towers, equipment penthouses and other surrounding structures.

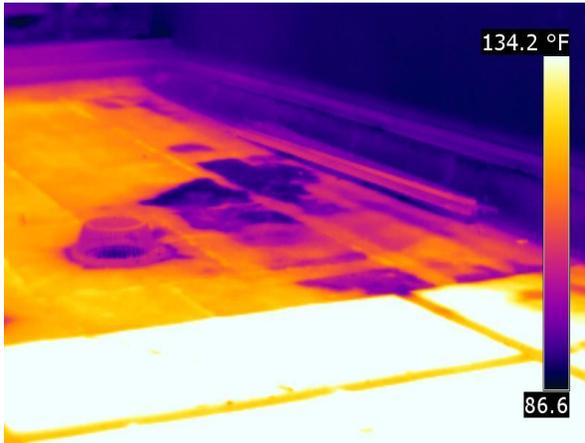
Figure 3: Thermogram showing cold anomaly marking trapped moisture in roof between penthouse wall and roof drain. Image was captured at 11:30 AM while the roof was heating up. Note hot thermal signature (>130-degrees F) from traffic pads in foreground on thermogram.

Scanning under cooling conditions generally produces best results, as shadowing and time delayed warming of roof sections is avoided. However, scanning under warming conditions can be done with remarkably good results, as long as the roof area is open and not blocked by objects that produce shadows (Figure-3). Also required is a non-reflective roof surface and plenty of solar loading.

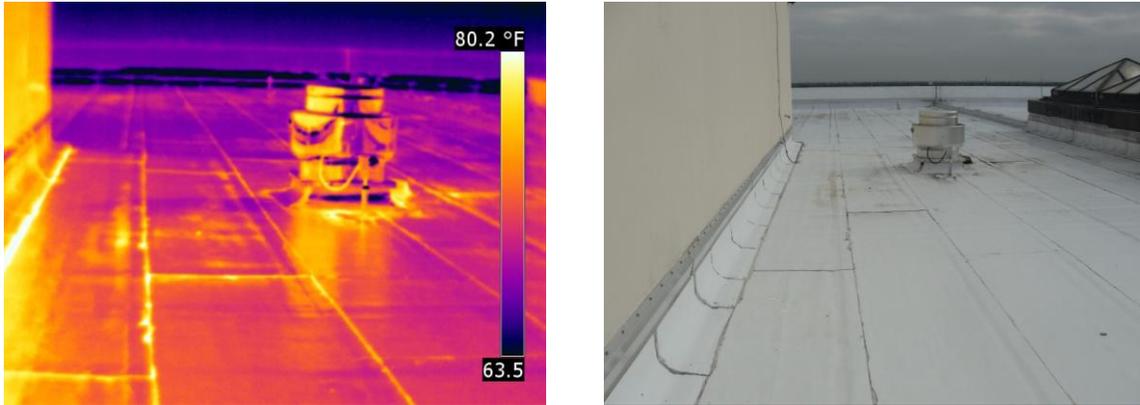
Figures 4: White modified torch-down roof membrane that is highly reflective when imaged. Note hot thermal signature produced by penthouse wall and roof exhaust fan, while a cold pattern dominates background from the sky's reflection.

roofs, and most single-ply PVC / TPO materials (some are somewhat reflective when new, but over time they scan fairly well) provide excellent imaging with both short/mid- and long-wave thermal imagers. Low emissive (low-E) roof surfaces include aluminum coated roof surfaces, metal panels, some EPDM membranes with high graphite content, and the newer white, smooth, torch-down modified membranes (Figures-4).

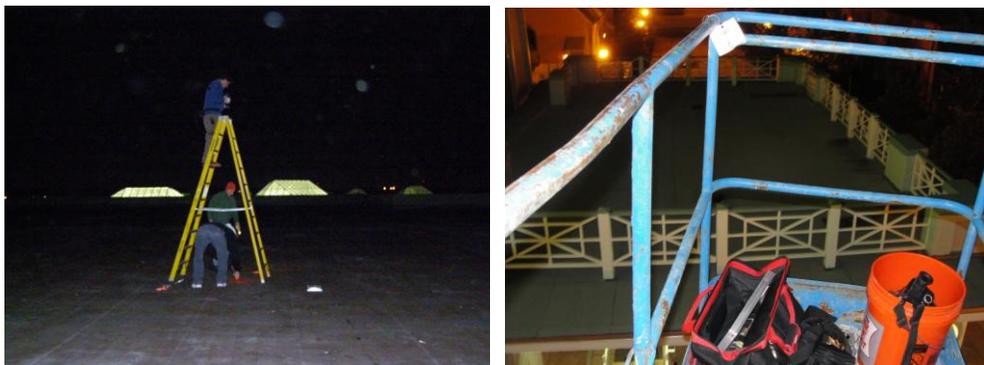
Figures 5: Using ladders and aerial lifts to overcome reflection and hard-to-reach roof areas can be time saving and dictate the success of a job.

When scanning low E roofs, anomalies are not always well defined. Cold clear skies exacerbate reflection issues making the roof appear very cold. Likewise, warm walls and other objects will cast warm anomalies on the roof, especially one's thermal shadow. The best approach for dealing with reflection on low-E roofs is to use a short/mid-wave imager and to reduce the angle of incidence between the images and roof surface; try to become as close to perpendicular to the roof surface as possible. One way to do this is by using ladders and/or aerial lifts to elevate you off the roof surface (Figures-5). Another way is to scan from high vantage points above the roof. All roof surfaces become more emissive with age. However, roofs do not weather uniformly and therefore it can be expected to see a mix of high and low emissive roof areas, which can be very challenging to scan. When confronted with this situation, it is important to see how anomalies match with surface conditions. Anomalies that do not closely mimic high-E areas should be considered as possible areas of trapped moisture.

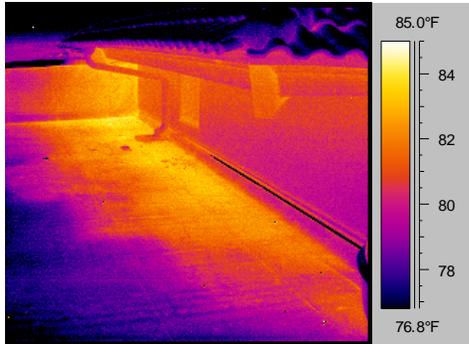
Figure 6: Anomaly on roof surface located below an overhanging soffit and the corner of a parapet wall.

Other types of reflections that can produce false thermal anomalies are derived from roof mounted piping, penthouse and vertical walls, overhanging soffits, roof mount equipment (exhaust fans, AC units), and other features that trap and/or produce thermal energy on the roof surface (Figure-6).

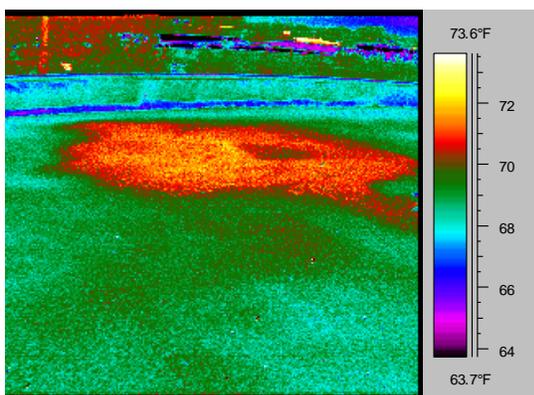
Figure 7: A circular shaped thermal anomaly that mimics an area of flood coated asphalt used to make a roof repair. Gravel covering this area makes it less obvious to spot during a survey, but walking over this area reveals a built-up section of roof. Another obvious indicator for this not representing trapped moisture is that the roof insulation is board stock perlite, that if wet, should show a straight edge boundary at least in part, on some area of the anomaly.

Over-built sections of roof will also add mass to a roof surface and produce thermal anomalies. One of the most common we see is areas of over-thickened asphalt used to repair roof leaks or areas of uneven floodcoating during installation. On gravel roofs these areas may not be very apparent because gravel is sometimes broadcasted back over the area. When viewed with a thermal imager these areas appear hot and mimic the area of extra asphalt (Figure-7). It is important to walk over anomalies and physically feel for raised or uneven sections of roof that may turn out to be over-thickened areas of asphalt and not wet insulation. Other features that provide extra mass to a roof surface are layers of counter-flashing materials (commonly seen around parapet wall transitions, and on equipment curbs and skylights), leaf debris, algae/pond scum, traffic pads, temporarily placed buckets and other objects used to tote inspection equipment around the roof during and survey, and one's own body heat if standing or sitting in any one particular place for any length of time.

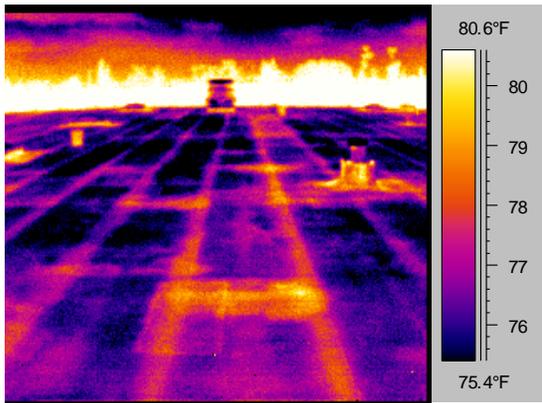
Figure 8: Thermal anomalies associated with poorly sealed roof membrane laps. This roof suffers from numerous blisters that are forcing laps to open and allow surface water to migrate into the inter-ply system of the roof.

Even though most roof surfaces are non-absorbent, their layering characteristics between base-sheets, inter-ply, and cap sheet can trap and hold moisture. Poorly sealed laps, failing flashing details, and surface moisture trapped in the roof system during installation are the main causes of this defect. In extreme cases of interply moisture, surface blisters will develop on a roof. Inter-ply moisture can be observed with a thermal imager and appears as linear anomalies that parallel roof laps.

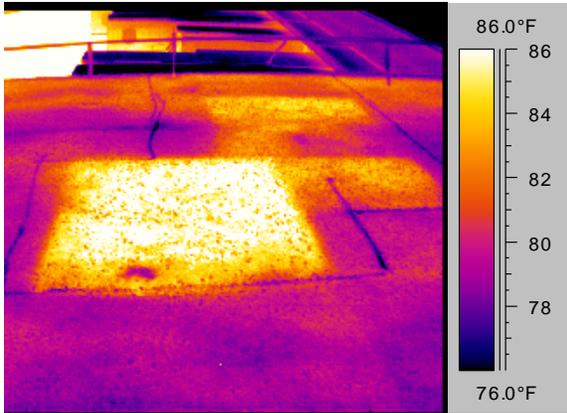
Figure 9: Thermal anomaly of wet fiberglass insulation showing classic board pattern anomaly. Note the contrasting levels of heat of the boards in the foreground versus those in the background; correlating to the varying amounts of moisture present in the insulation.

Thermal anomalies that arise from board insulation are the classic square-shaped and window-pane patterns (Figure-9). Depending upon the absorbency and amount of infiltrated water, the patterns will have slight variances in their appearance, especially poly-iso board, which when new, holds little water, but with age produced strong anomalies at the edges of the boards (Figure-10). Other thermal patterns associated with poly-iso board can be rather nondescript or blotchy, possibly highlighting the wet backing paper present on the top side of this insulation.

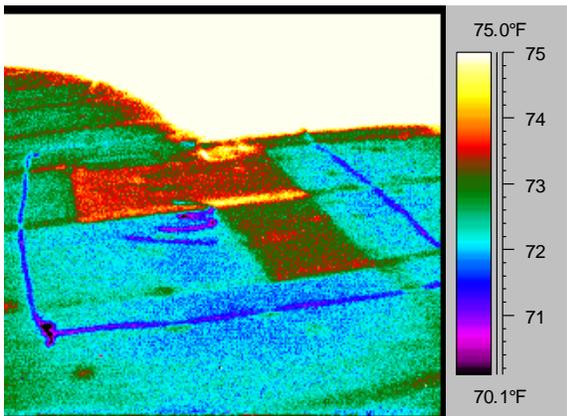
Figure 10: Thermal anomaly associated with wet poly-iso board. Note the strong thermal signature along the edges of the board.

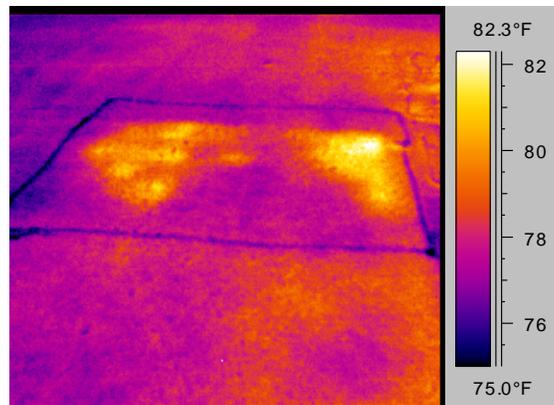
Figure 11: Thermal anomaly associated with wet perlite board. Although the anomaly does not completely depict a square board, the right part of the anomaly shows a 90-degree square corner; a dead give-a-way of wet board insulation.

When scanning roofs with board insulation, thermal anomalies, as a general rule, will have well defined straight edge patterns. The anomaly may not be completely developed into a 90-degree corner-edge shape, but some part of the anomaly should appear straight (Figure-11). If you are observing something different, it is possible that other factors are causing the anomaly rather than moisture. It is possible that a different type of insulation material is present, possibly installed during a roof repair. Furthermore, reroofing and phased assembly of large roof sections can create completely different roof assemblies that tie-in to one another.

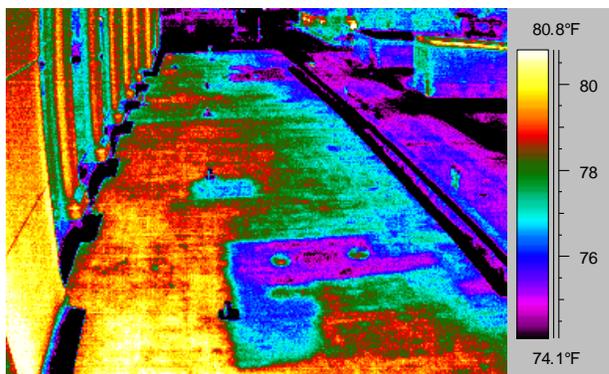
Figure 12: Typical thermal pattern of roof with newly installed LWIC.

Even with these built-in drying features, newly installed LWIC roof systems are challenging to survey because of the numerous thermal anomalies found that depict varying levels of inherent moisture (Figure-12). We have limited success scanning new LWIC roofs to track down known leaks. The best method we have found is to adjust the level and span on our camera to tune out background thermal noise and hunt for the strongest thermal anomalies (Figure-13). This is extremely difficult scanning and is not recommended in most cases. Generally, when asked to scan new LWIC roof systems we are upfront with our client and discuss the limitations of using infrared technology.

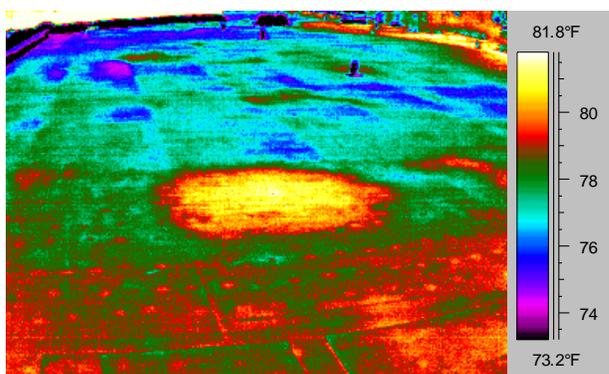
Figure 13: A strong, circular shaped thermal anomaly, that marks a roof leak, amongst a diffused warm thermal pattern typical on newly installed LWIC roof system.

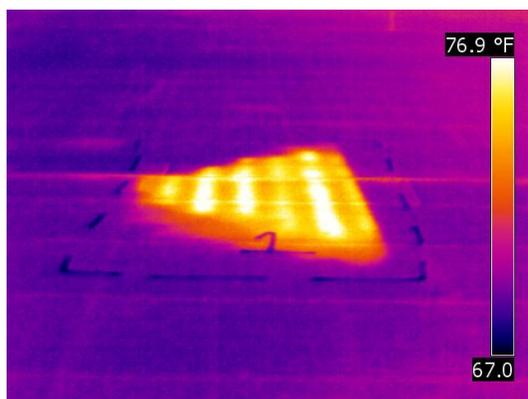
Figure 14: Banded thermal pattern of wet perlite insulation over a corrugated metal roof deck with air conditioned spaced below.

The deck is the main support and foundation to the roof system. Most common deck types found in roof construction include structural concrete (either poured or pre-cast), corrugated metal, wood sheathing, gypsum, LWIC concrete, tectum panel/planks, and newer composite panels like Dens-Deck and high-density gypsum-like panels. Wood and gypsum-based decks can hold moisture and may influence thermal anomalies. Corrugated metal decks can act as heat sinks and provide striking thermal patterns on a roof if there is a sharp contrast between interior and exterior temperatures (Figure-14).

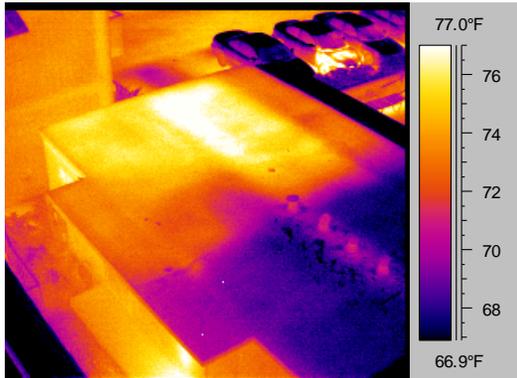
Figure 15: Strong thermal anomaly produced by an electrical room partition below this section of roof.

mass construction. Heat absorbed throughout the day by these structural features can conduct heat up to the roof surface during cooling stages and produce thermal anomalies on the roof surface directly over these structural features (Figure-15 & 16). When scanning roofs of this nature, it is always useful, if possible, to visually inspect the underside of the roof deck to see how it is being supported. Look at the key support beams and trusses and note which direction they span in comparison to the roof system as a whole.

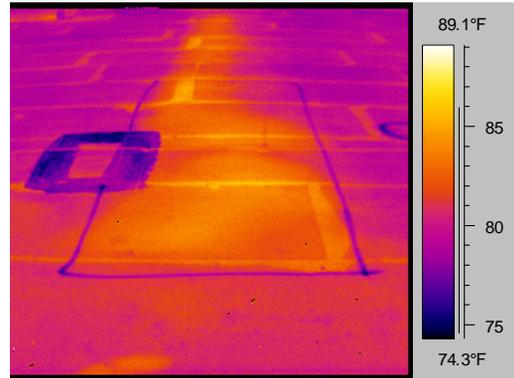
Figure 16: Weak but long and linear thermal pattern that mimics a metal girder truss beam supporting a metal deck, polyiso board, and modified membrane roof system. Thermal anomaly tested negative for moisture.

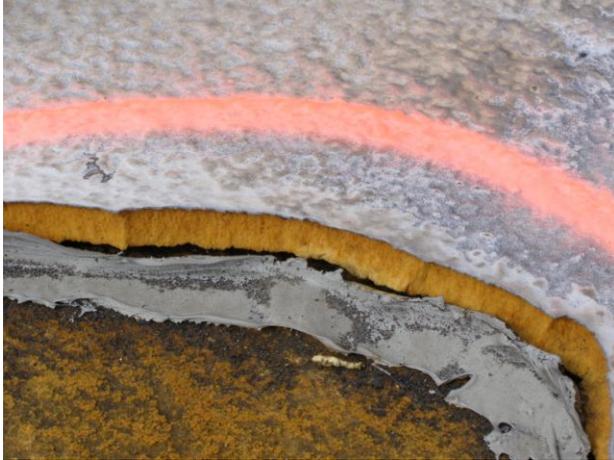
Figure 17: A too-thin final foam layer installed over, a most likely moist surface, lead to widespread blistering and layer separating. Silicon was used as a temporary repair but that too has failed to stop the foam layer from separating.

The most common defect that plaques SPF roofs are blisters that are caused from applying foam over moisture (a common problem in Florida when dew is present or a light rain sprinkles occurs late in the day when the roof is almost completed). Other internal moisture application problems are separation of foam layers especially if a final layer of foam is applied too thin (<1-inch; Figure-17). Finally, SPF roofs are vulnerable to physical damage caused by bird pecking, extended foot traffic, sharp debris and dropped objects such as tools and AC units. Repairs to SPF roofs include mastic, silicone and caulk material, and re-foaming damaged areas.

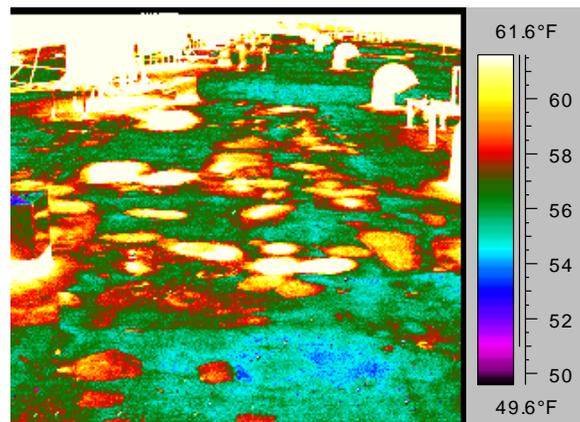
Figure-18: Typical thermal pattern of trapped moisture in SPF system; round shaped anomalies that coalesce with one another.

Water intrusion can occur in SPF systems. Thermal patterns appear as small round anomalies and progress in size and coalesce as moisture intrusion intensifies (Figure 18). If de-bonding between foam layers is present or intact blisters are observed, water can migrate and be trapped in these places. Trapped inter-layer moisture appears as large amorphous anomalies, while air and water-filled blisters can be difficult to detect. Because of the trapped air in the blister they warm and cool quickly and therefore have short-lived thermal signatures. We have seen large amounts of water trapped in blisters that have very weak thermal anomalies yet when stepped on warm water evacuates. Therefore, it is important to walk over anomalies and feel for trapped moisture (care should be taken on blisters as to not break them open and allow water to enter the roof system).

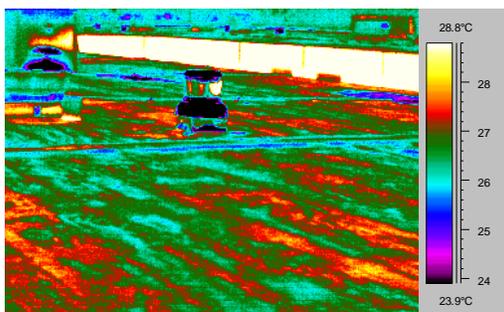
Figure 19: Thermal pattern of inter-ply moisture trapped between two roof systems with no separating insulation layer.

Thermal patterns associated with recovery roof systems vary from classic thermal patterns associated with wet insulation of the new roof, to very chaotic thermal patterns created by trapped moisture between the two roof systems that lack an absorbent separation layer (Figure-19). These anomalies are very difficult to resolve and pinpoint the exact location of trapped moisture.

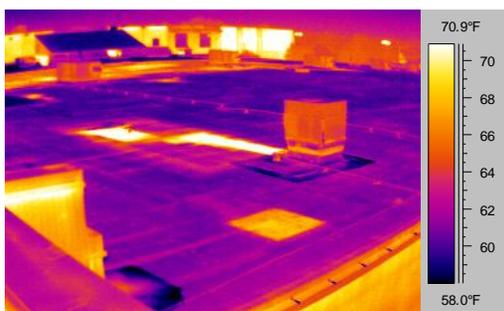
Figure 20: Strong and weak thermal anomalies on a roof surface. The large anomaly in the background shows two strong anomalies (upper roof moisture) superimposed over a broader and weaker one (lower roof moisture).

Finally, old trapped moisture in the lower roof system can sometimes be detected with a thermal imager. Depending upon the original insulation material, anomalies may appear as faint or shadowy signatures. When trapped moisture occurs in the lower and upper roof systems, the lower trapped moisture usually produces a weak thermal signature that contrasts with a stronger signature of the top roof moisture (Figure-20).
