# Techniques for Finding & Documenting Moisture Intrusion in Buildings with an Infrared Imager

## Abstract

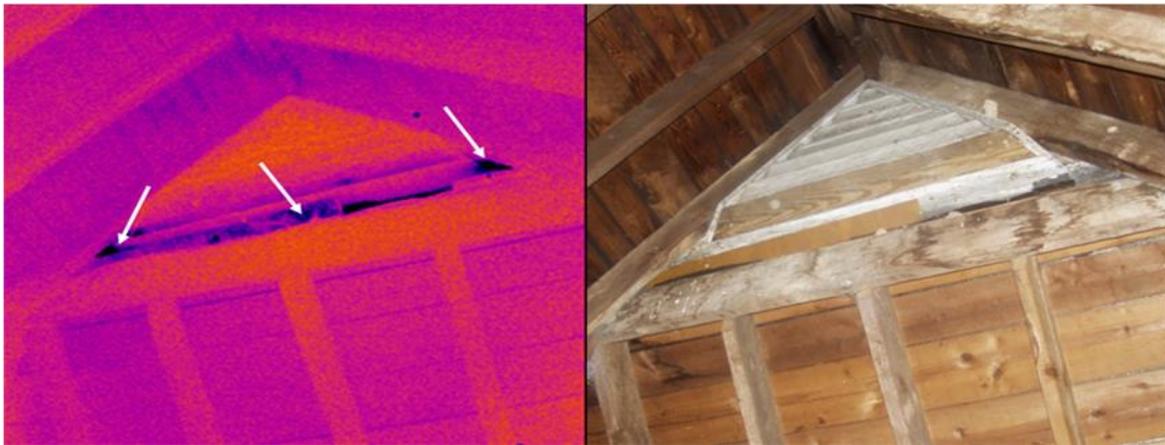
**Figure 1: Water entering the attic of a large church at the gable end vent**

Water can leak into a building from the roof or skylights in the roof. A roof leak over an accessible attic space makes for some very easy detective work during a regular rain event. A flashlight is normally all that one needs to ascertain where the leak started and where it's going. If the manufactured skylight component itself can be eliminated as a source of water intrusion, then the likely cause would be inadequate or improper flashing of the unit to the roof. Water leaking at the roof-to-chimney juncture or any other place such as venting, is usually easily found visually and even more easily found with an IR imager (see figure 1). A combination roof/ceiling assembly created using scissors trusses proves to be one of the most difficult investigations to accomplish due to lack of access.

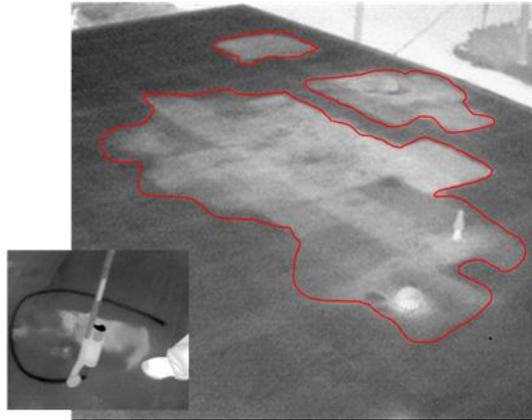
**Figure 2: On-roof moisture survey on an apartment building roof**

In buildings with flat or low-sloped roofs, water can enter the substrate through a breach in the waterproofing layer and be absorbed to the point where water enters the building from above. An infrared survey will often reveal the extent of the moisture contamination from above the roof so that surgical roof repairs can be made (see figure 2).

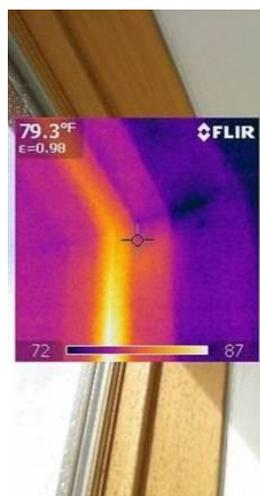
**Figure 3a: Water intrusion at a window**

The very best time to perform an infrared thermographic inspection is when the leak first presents. An infrared image documents the reality of the situation (see figures 3a/3b) and is the basis from where the investigation should go from there. With the proper information from the infrared inspection in hand, a builder may elect to remove interior finishes from around the window or door if a thermograph shows water not under a window - but off to the side of it. The same holds true for a door unit. An infrared thermograph offers a way to document water intrusion and may indicate that the leakage is under the doorsill for instance, which the builder must then correct himself.

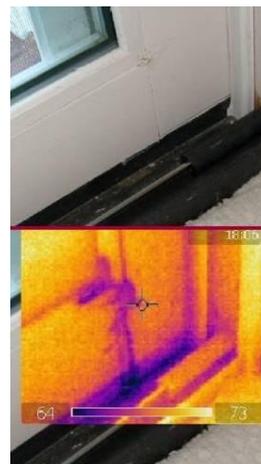
**Figure 3b: Water intrusion at a door**

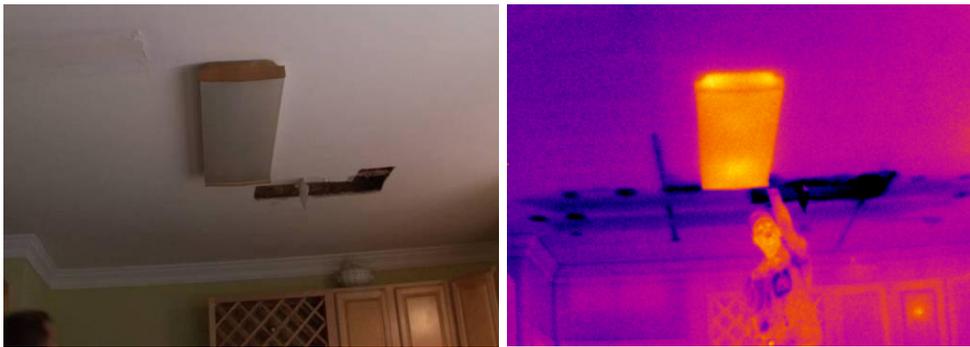
**Figure 4: Plumbing fixture leak in a house, found in seconds with an infrared imager.**

When plumbing pipes, (see figure 4), water lines, sprinkler lines, or mechanical lines within the structure leak, the damage can be devastating. Often, by the time the water leak is detected, much damage has already occurred. A broken plumbing pipe that goes unchecked for minutes, hours or in some cases, days, can cause horrific damage not only to the interior, but also to the structure of the building itself. Some problems caused by condensation on mechanical lines in an attic or within walls, such as low pressure return lines or a condensation evacuation line for an air conditioning unit can be quite insidious. These failures can contribute to a hidden growth of large colonies of mold. Infrared thermography is particularly good at tracking down active leaks of almost any kind.

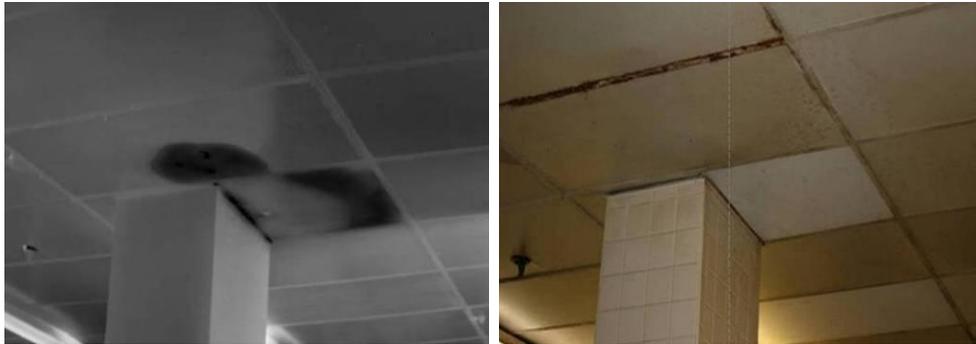
**Figure 5: Uninsulated column passing from cool area into the warm, moist interstitial space, causing condensation on the column, which then drips onto the ceiling tiles.**

Sometimes, moisture envelope problems are characterized by heat loss and by moisture that forms on the building surfaces where warm, moist air meets cool surfaces or vice-versa. This can happen on the surfaces of windows, doors, skylights, HVAC equipment, outside walls, interior walls, wall assembly interiors, and ceilings as a result of air leakage, thermal bridging, improper ventilation, design flaws and/or installation deficiencies. At the dew point, moisture forms and drips into the building (see figure 5).

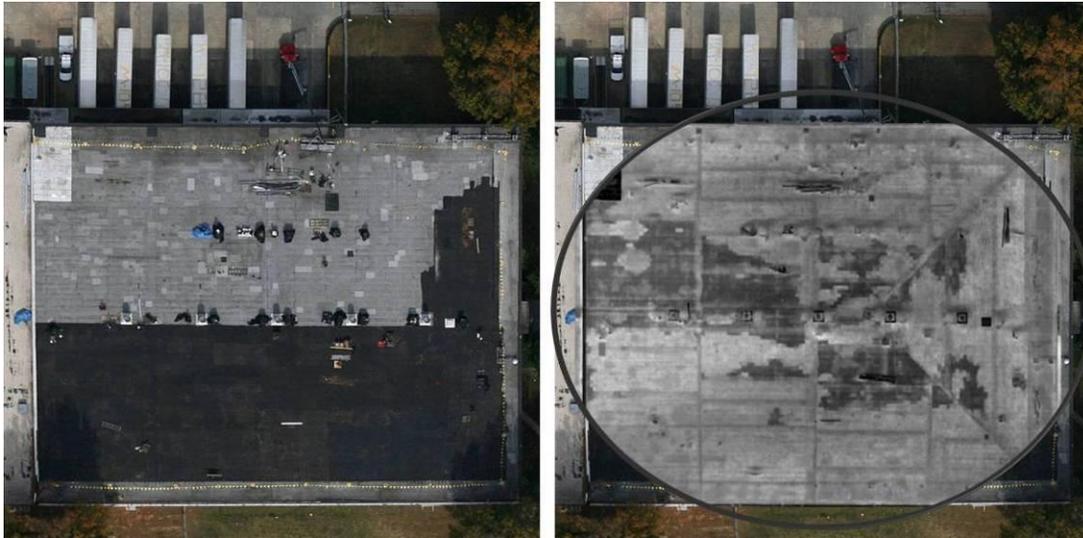
Figure 6: Flat roof with wet insulation (lighter gray) being covered with new coatings

If a new basement does not dry out completely or is flooded during construction, this can have an adverse effect on every building process that takes place above. The longer that a building component takes to dry, the more irreversible damage is done. Detection and mitigation of water intrusion throughout the entire building process is critical. There is no better or faster way to ensure that the building process remains true than by the active use of infrared thermography to detect and document the presence of moisture (see figure 6).

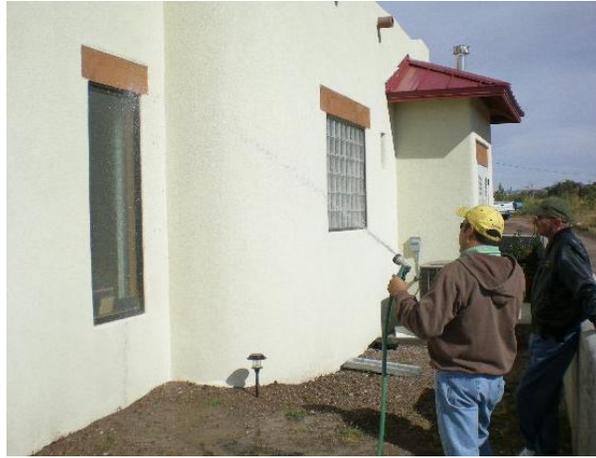
**Figure 7: Non-calibrated hose test being performed**

Even among experienced professionals, the type of testing most frequently used is a garden hose with an adjustable nozzle, operated in a manner dictated by the immediate objective of producing or replicating a leak (see figure 7). The water pressure, spray pattern, distance from target, angle of attack, and time of exposure are determined in the field to suit local conditions. While this may be effective as a diagnostic exercise, it has the disadvantage of potential criticism for a lack of objectivity. This type of testing produces results that do not replicate expected environmental conditions. An example would be the production of a test leak by pointing a nozzle up at a void under a soffit that would never be subjected to a wind-blown rain.

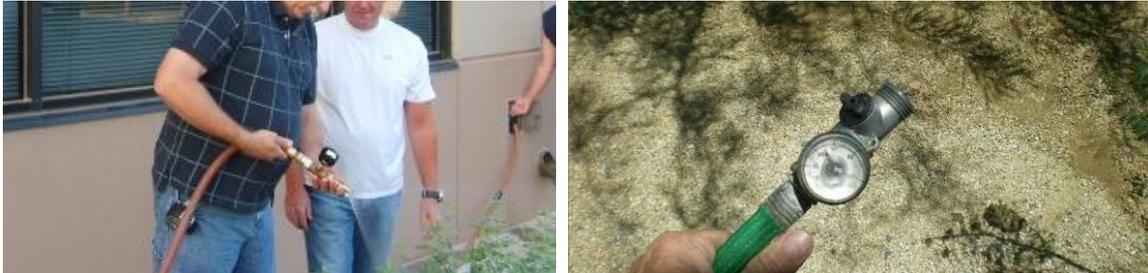
**Figure 8a/8b: Calibrated hose test in the simplest form**

To counter criticism involving objectivity as well as to provide reliable results, test procedures sanctioned by established industry associations and standards organizations are available and recommended. Relatively simple and inexpensive is the *American Architectural Manufacturers Association (AAMA) 501.2, Field Check of Metal Storefronts, Curtain Walls, and Sloped Glazing Systems for Water Leakage*. This test method is used for exterior windows, curtain walls, storefronts, sloped glazing systems, doors, and other wall components, and is similar in concept to the simple garden hose spray method. It is most effective for joints that are designed to be permanently closed or watertight. Often referred to or described as the Hose Test Method, it involves the use of a *calibrated* hose nozzle only (see figures 8a/8b) to

deliver water to the test specimen at prescribed pressures. The test procedure consists of systematically wetting the test specimen with water from a spray nozzle that is held at a distance of at least 12 inches from the joint. The nozzle is moved slowly back and forth along the non-operable joint, covering approximately 5 linear feet of joint during a 5-minute period. This test is not intended for residential use.

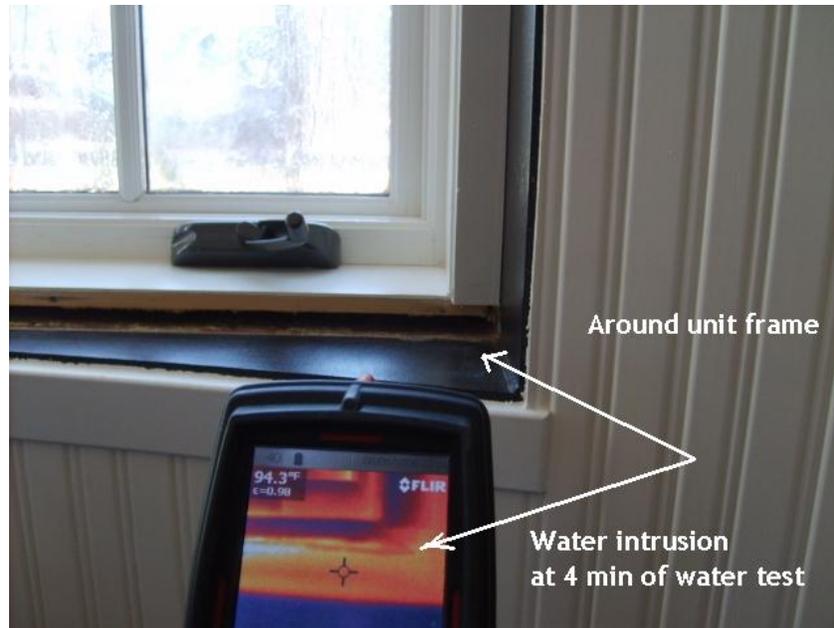
**Figure 9: Infrared imager documents water intrusion**

Infrared thermography, on the other hand, is not nearly as restricted to color, gloss or lighting conditions on an interior building finish. An infrared thermograph (see figure 9) is a digital record of the moisture as it intrudes and can often document the path and progress of water intrusion.

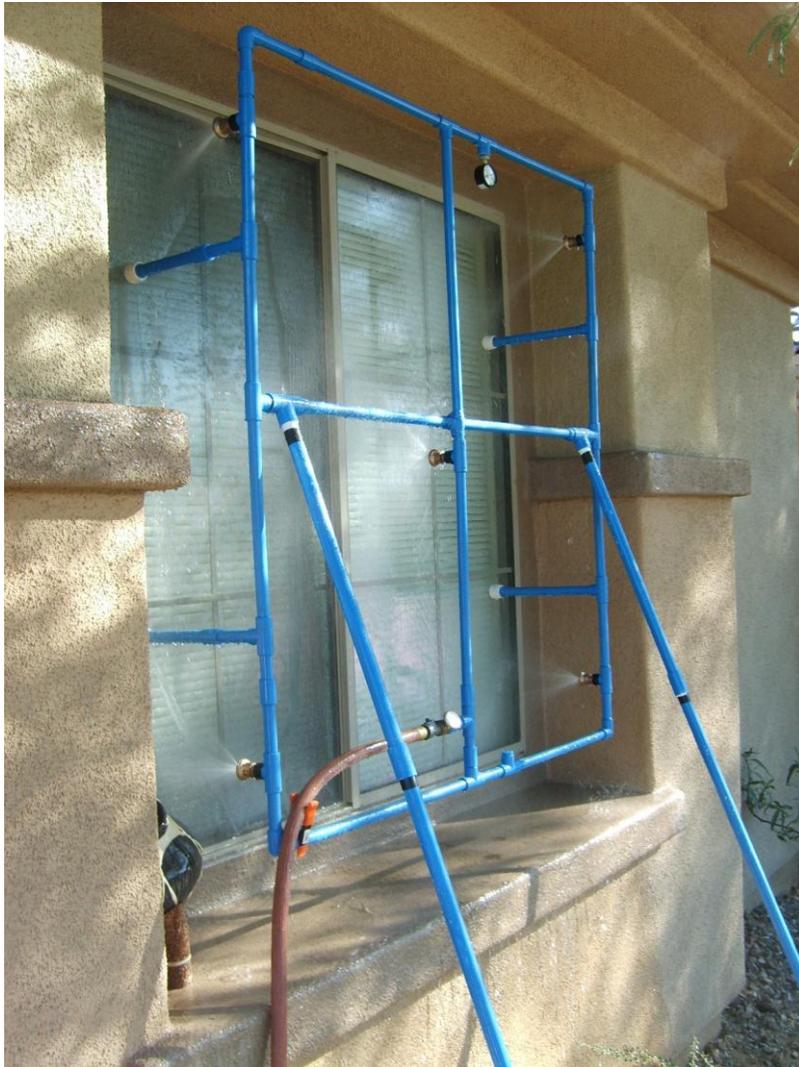
**Figure 10: Calibrated spray rack set-up**

This method is often referred to as the Chamber Test Method, or differential pressure method, because it specifies that a test chamber be installed either on the exterior or interior side of the test area (see figure 10). The test procedure consists of delivering water to the exterior from a calibrated spray rack at a minimum rate of 5gal/ft<sup>2</sup>/hr\*, while simultaneously applying a specified differential pressure across the specimen. The test can be performed for durations of 15 minutes of static pressure or in a cyclic procedure in which the differential pressure is applied for 5-minute durations, with 1-minute interruptions of no differential pressure and only water spray.
