Motor Efficiency and Fault Zone Analysis

Abstract

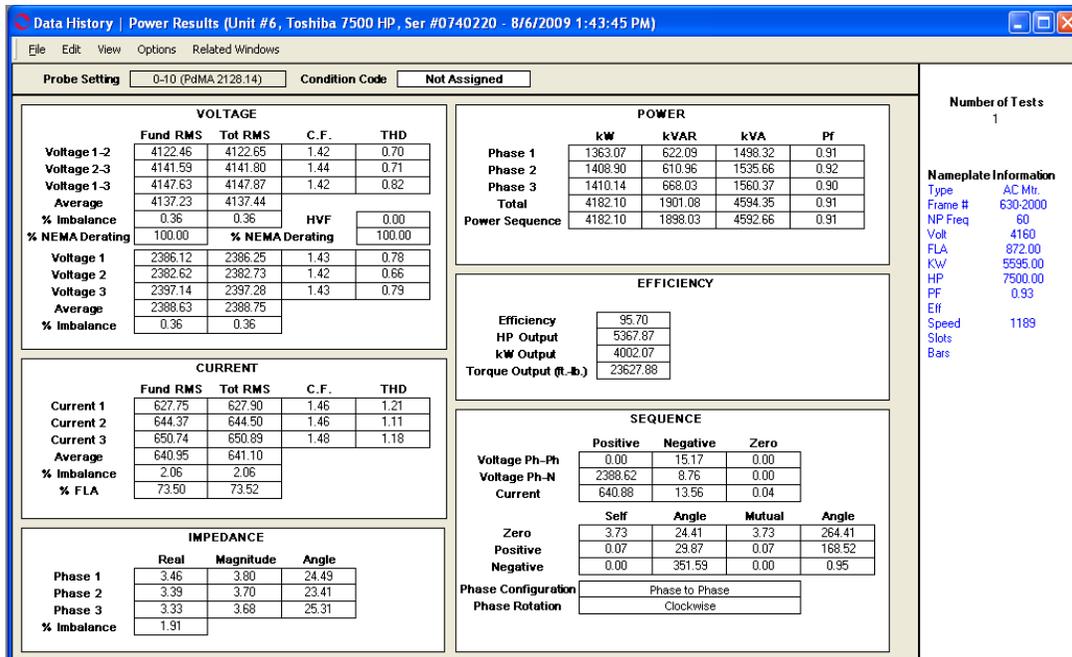
Figure 1

Data used to evaluate Power Quality is located in the phase-to-phase voltage section of the Results Page (Figure 1). Fundamental RMS, Total RMS, Crest Factor (CF), and Total Harmonic Distortion (THD) are listed for each of the phase-to-phase voltages. The average voltage and percent imbalance are also listed. Additionally, recommended NEMA derating factors are provided for both phase-to-phase voltage imbalance and Harmonic Voltage Factor (HVF).

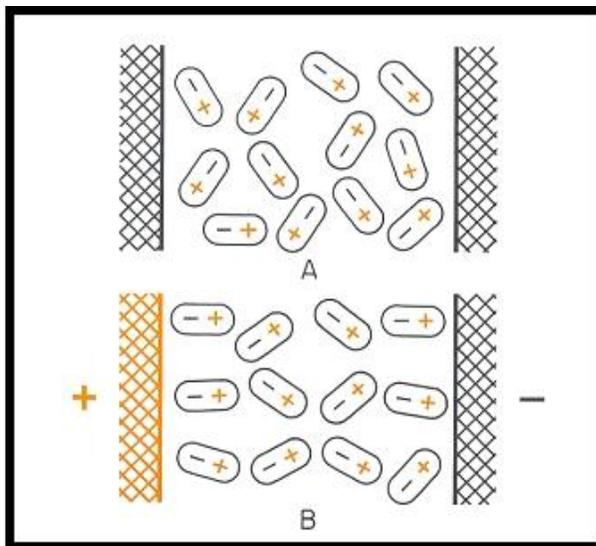
The **absorption current** is made of two components: the polarization of the insulation material and the second is due to the gradual drift of electrons and ions through the insulating material. The polarization current is caused by the reorientation of the insulating material. These materials, usually epoxy, polyester, or asphalt tend to change the orientation of their molecules when in the presence of a direct electric field. It normally takes a few minutes of applied voltage for the molecules to be reoriented, and thus for the current-supplied polarizing energy to be reduced to almost zero. The absorption current, which is the second component, is the gradual drift of electrons and ions through the insulating material. These electrons and ions drift until they become trapped at the mica surfaces usually found in rotating insulation systems. See Figure 2.

Section A of Figure 2 shows the random orientation of the insulation's molecules. As a direct voltage is applied via the MCE tester, the molecules start to polarize and align, (see Section B of Figure 2). The energy required to align the molecules, and subsequently reduce the amount of escaping molecules, is known as absorption current.

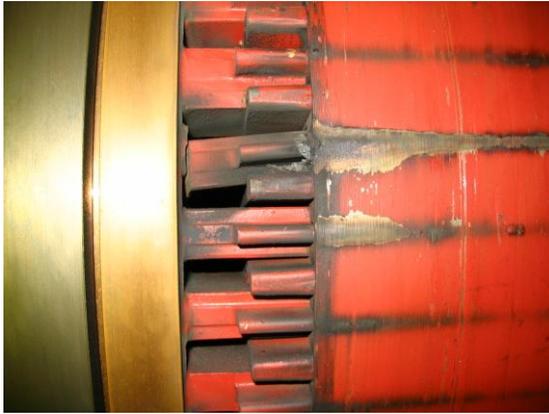
Figure 3

The design of the rotor plays a major role in the severity of an identified rotor anomaly. If the rotor is a closed bar design (Figure 3) the severity will be low due to the rotor iron acting to hold the broken rotor bar in place. However, if the rotor

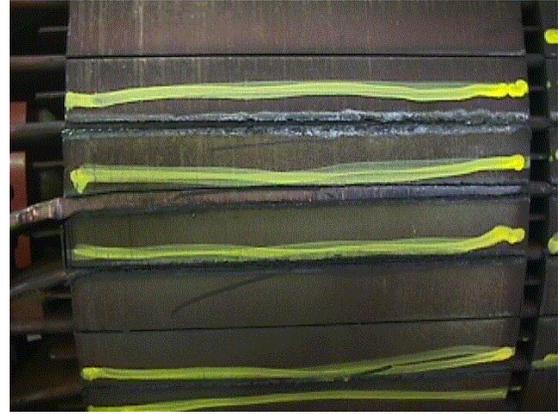
Figure 4

is an open bar design (Figure 4) then the severity increases significantly with the identification of a rotor defect. This elevated concern comes from the possibility of the rotor bar squeezing out of the rotor slot and contacting the stator.
