IR Thermography as a Tool for the Pest Management Professional

Jon L. Grossman
Hi-Tech Inspection Services, Inc.
7520 NW 54th Street
Miami, FL 33166
Phone: 305-639-1820
Fax: 305-639-1928

Abstract

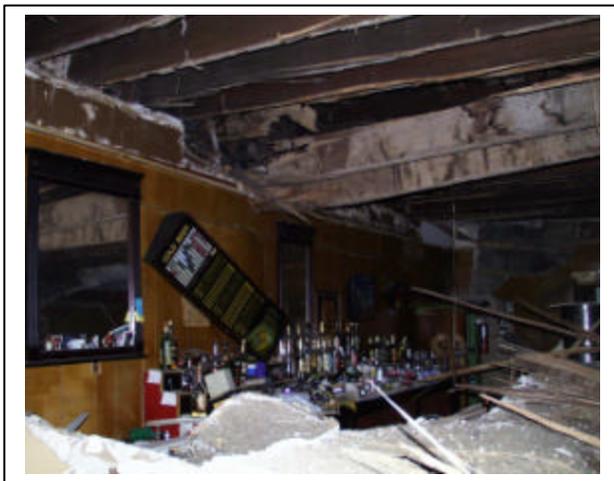
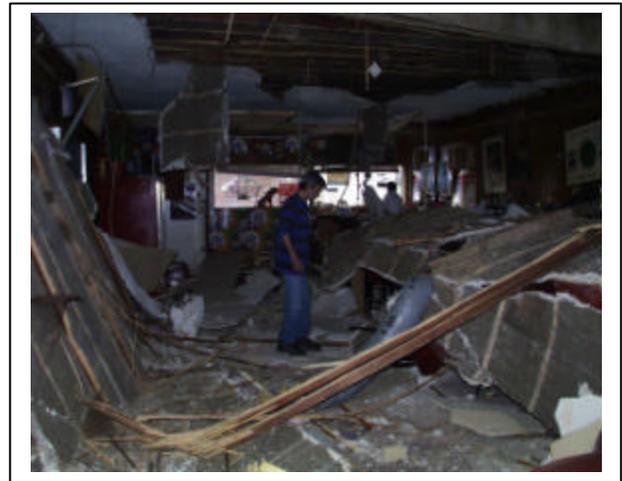
Above are two views of the Le Dale Hotel and Bar ceiling that collapsed from Formosan termite damage. Courtesy Jack Leonard – New Orleans.

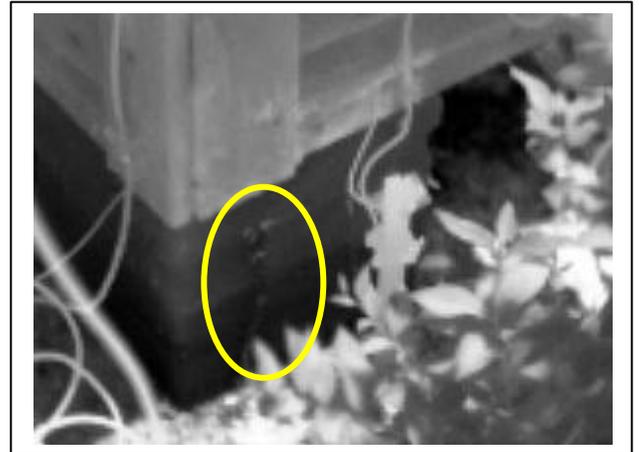
Termite mud tube on pier blocks – Orlando, FL

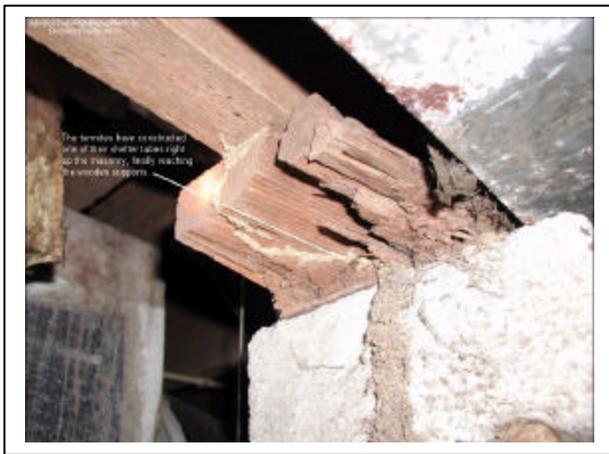
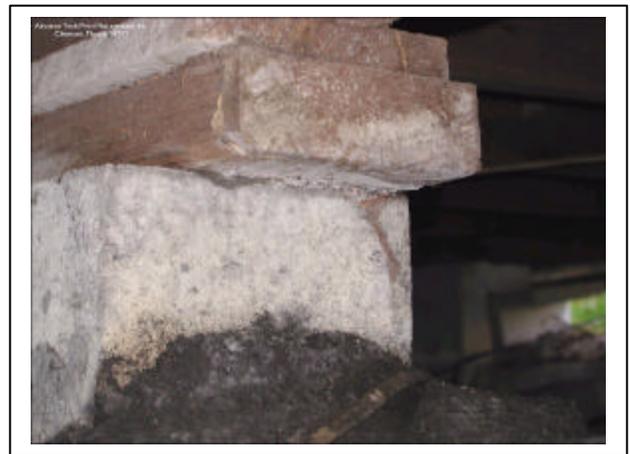
Crawl space area visually showing presence of termite mud tubes both of active and inactive nature.
Courtesy – Advance Tech Pest Management, Clermont, FL.

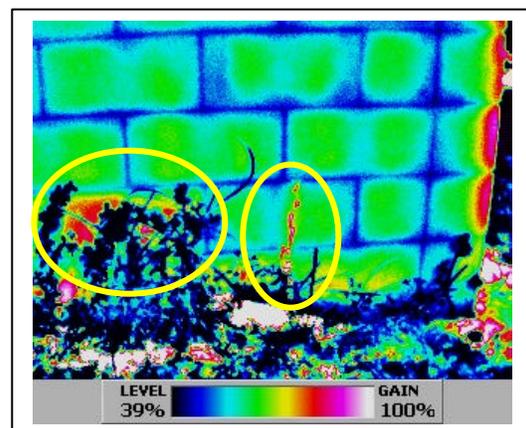
Active termite tubes on cement blocks. Courtesy Jack Leonard- New Orleans.

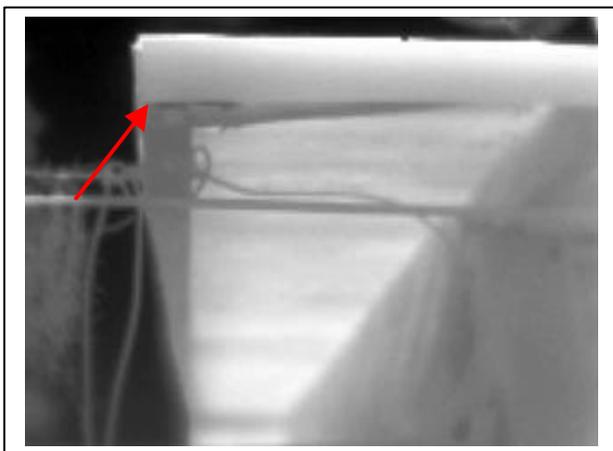
Damage in eaves area – Orlando FL.

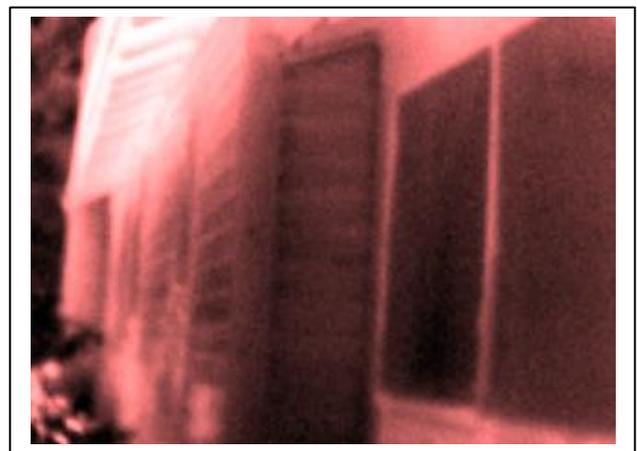
Anomalous cooling in exterior wall area, no gutters to permit runoff - Orlando, FL.

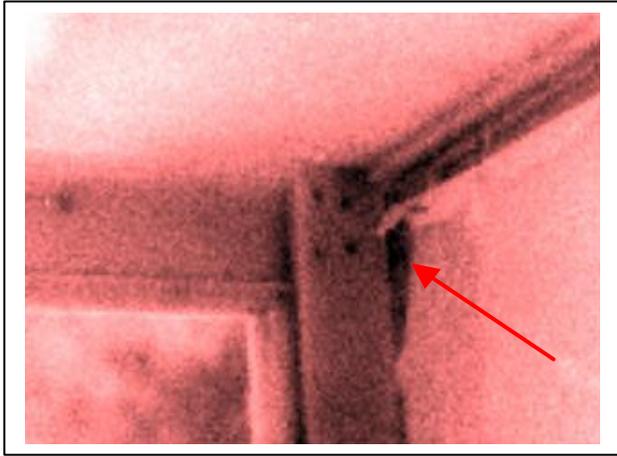
Anomalous cooling in wall area. Orlando, FL

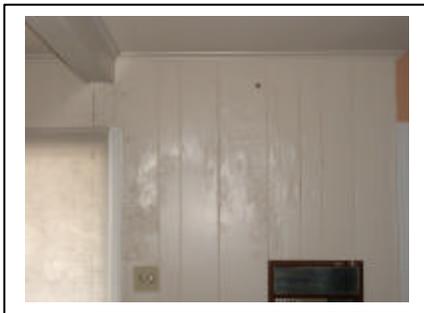
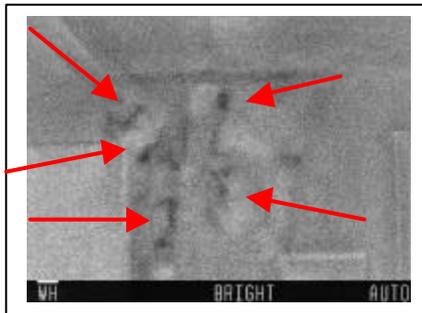
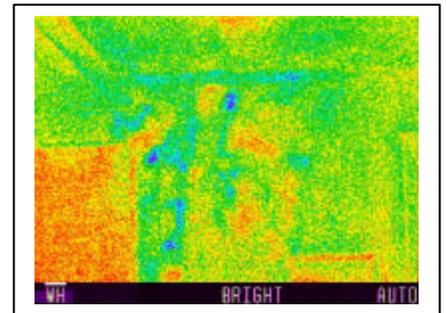
Digital, grayscale and colorized images of wall area in house with termite activity behind wall. – Jack Leonard New Orleans

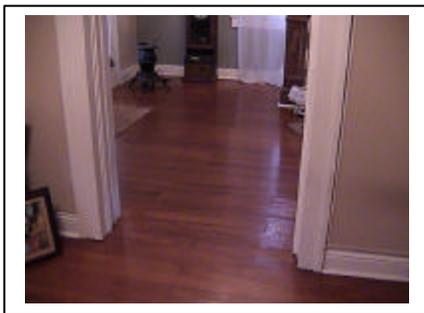
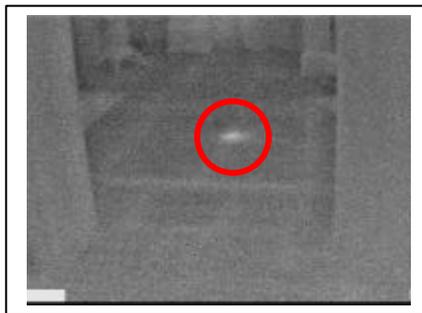
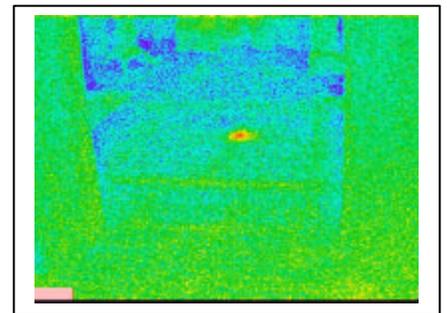
Digital, grayscale and colorized images of floor area in house with termite activity. – Jack Leonard New Orleans.

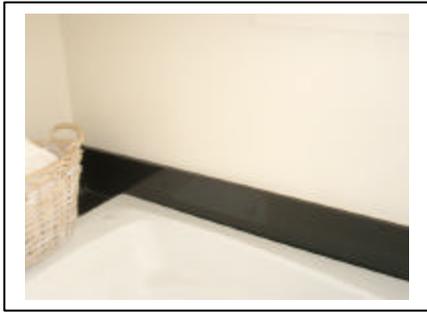
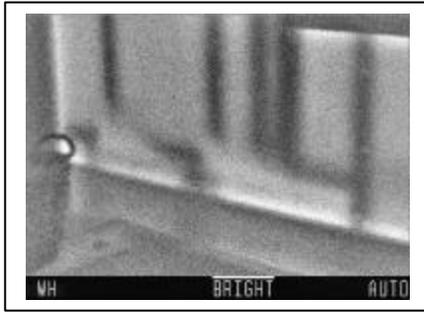
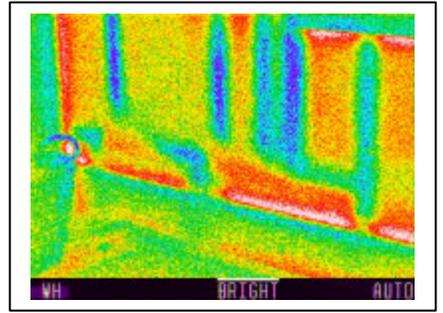
Digital, grayscale and colorized image of wall area with active termite activity.
Jack Leonard New Orleans.

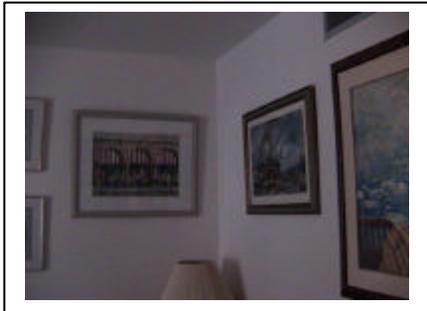
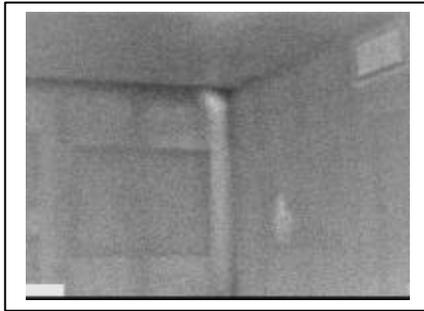
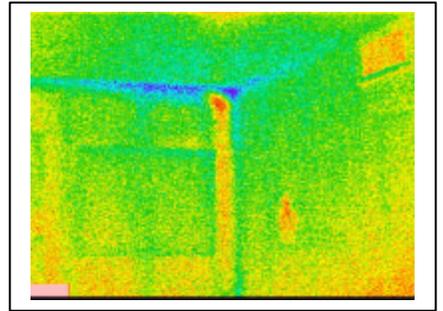
Digital, grayscale and colorized image of wall area with active termite activity.
Michael Potter, PhD. Lex., KY.

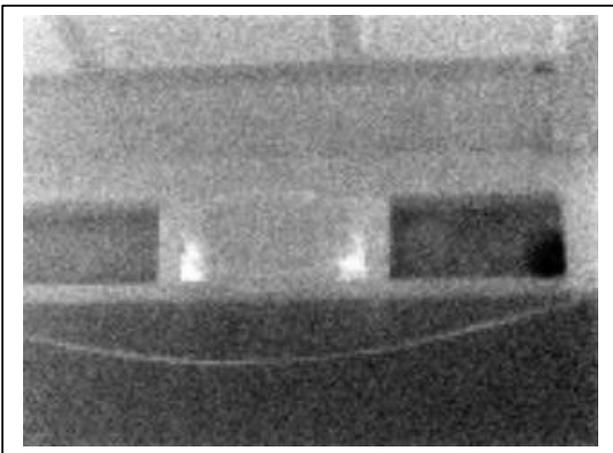
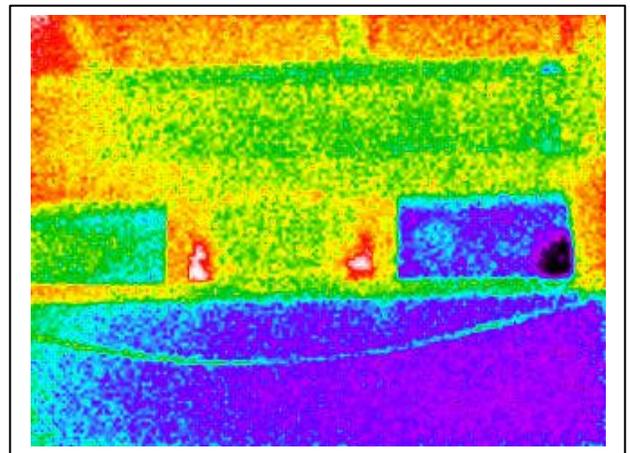
Grayscale and colorized images of basement box header with termite activity.
Michael Potter, PhD. Lex., KY.

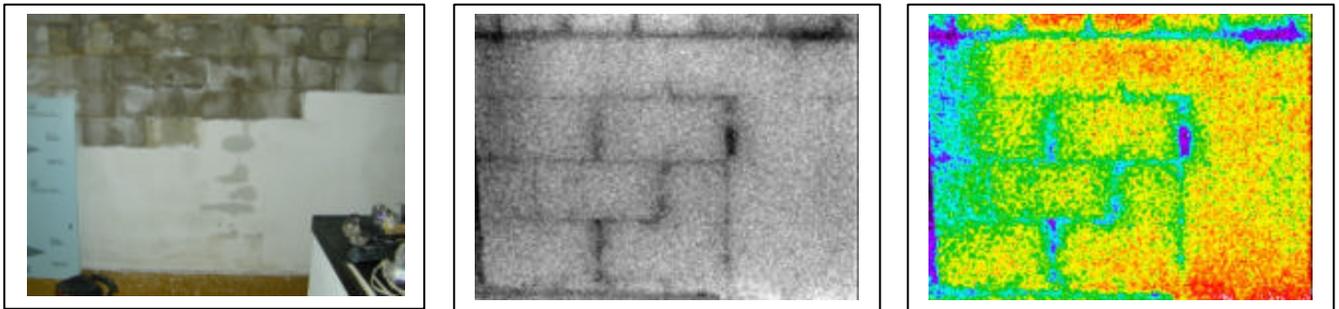
Digital, grayscale and colorized images of inside basement wall area with termite activity.
Michael Potter PhD. Lex., KY.

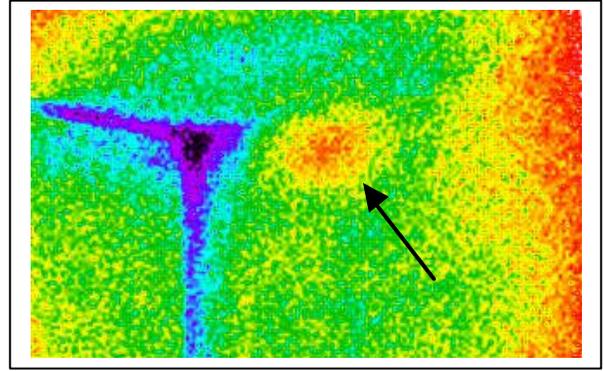
Grayscale and colorized images of 2 separate wall areas in house with unknown anomaly at left and hidden termite carton nest at right. – Michael Potter PhD – Lex., KY

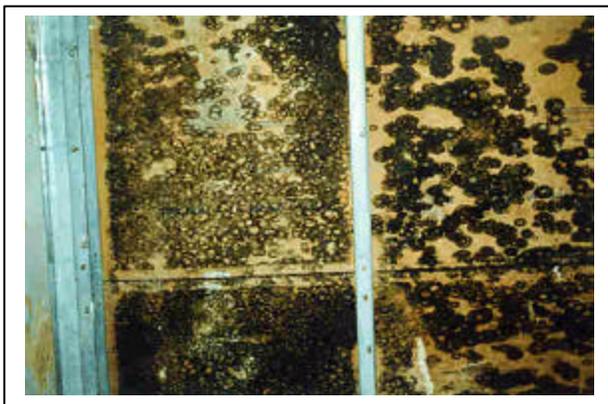
Stachybotrys chartarum mold in bathroom wall.

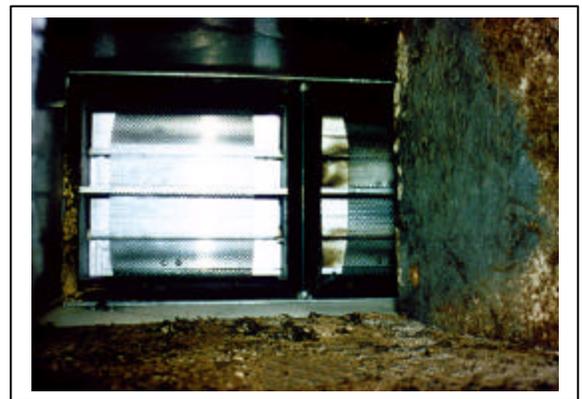
Mold in HVAC ductwork.

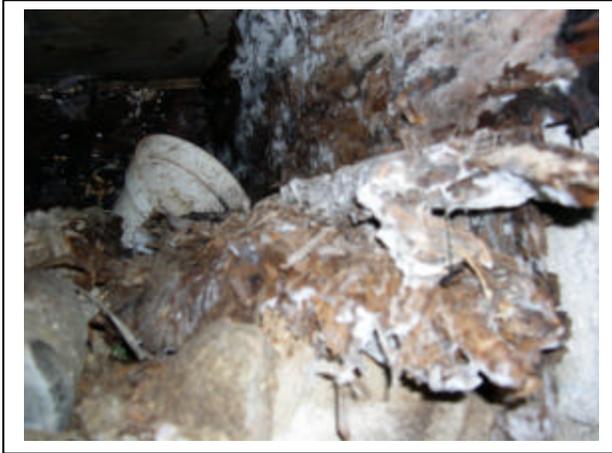
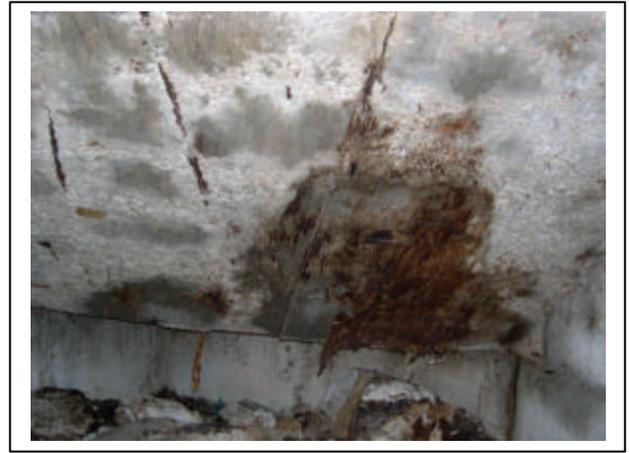
Active mold in crawl space located in Miami, FL.

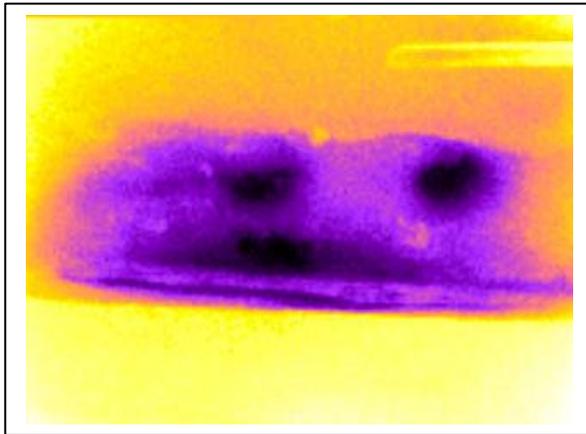
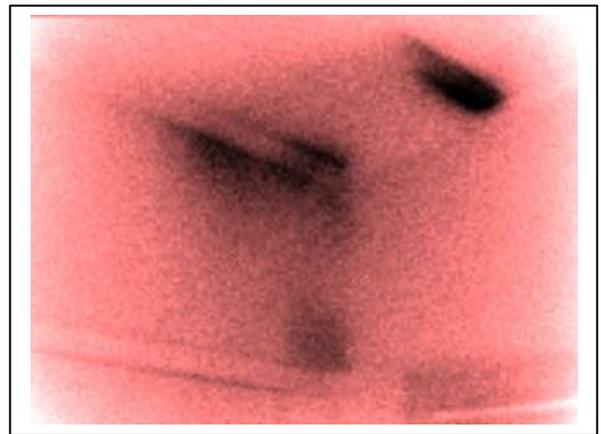
Active moisture area in beam and ceiling where active mold growth was revealed – Miami, FL

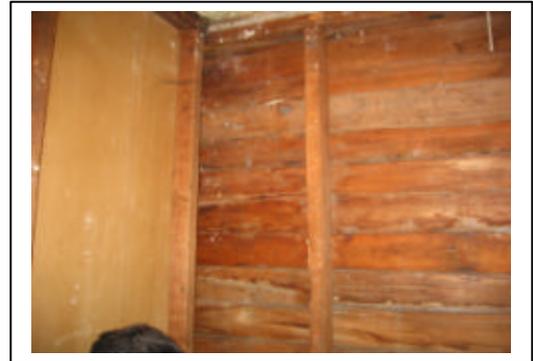
Digital image of exposed interior stud

Subsurface defects shown in both images using active thermography – Orlando, FL.

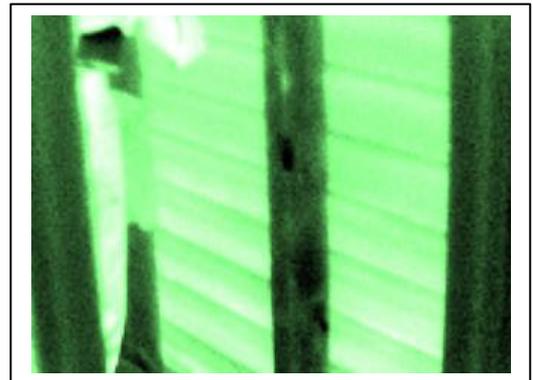
Colorized image of subsurface defect in interior stud

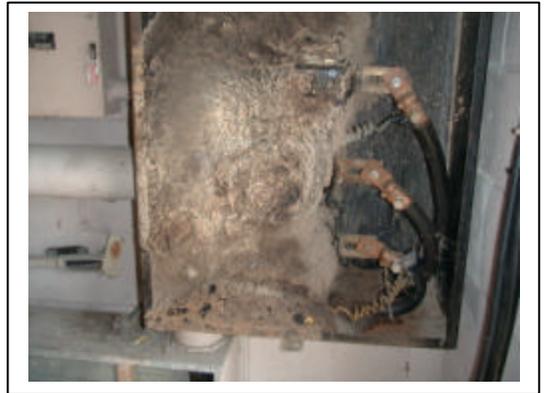
Insect pests have been known to infiltrate electrical panels. The termite carton nests above can pose serious problems. Jack Leonard – New Orleans.

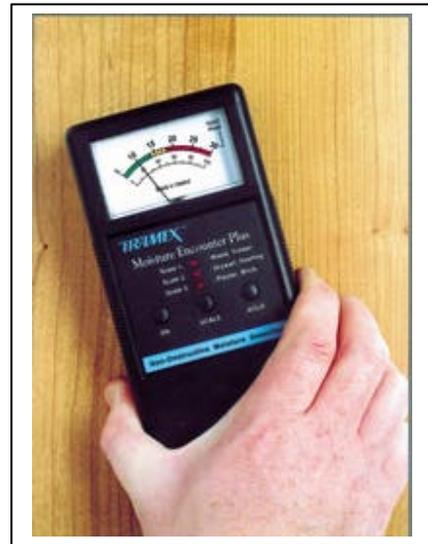
Locating the presence of latent moisture is not enough. A pest thermographer must then confirm the presence and level of moisture. Usually, a moisture meter will be employed.

Tramex Moisture Meter

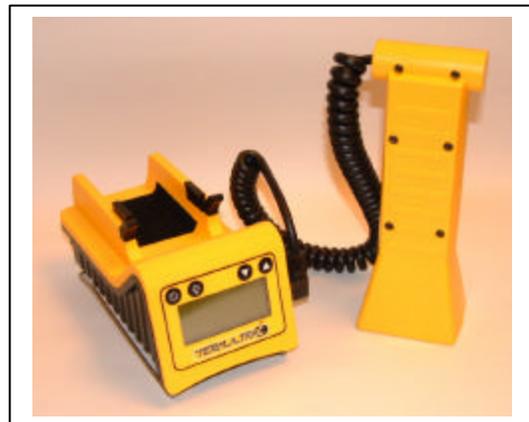
Termatrac[®] is a hand-held portable detection device using patented microwave technology. Termatrac[®] can detect insects and other pests in unseen areas such as wall voids, cracks, crevices, air pockets, construction flaws, beneath floors, and in ceilings, etc. Termatrac[®] will detect activity through a variety of materials such as brick, wood, stucco, concrete block, ceramic tile, marble, terracotta tile, mica, plastic veneers, vinyl and many other materials. Termatrac[®] is non-invasive and non-destructive, thereby avoiding damage to a client's property.

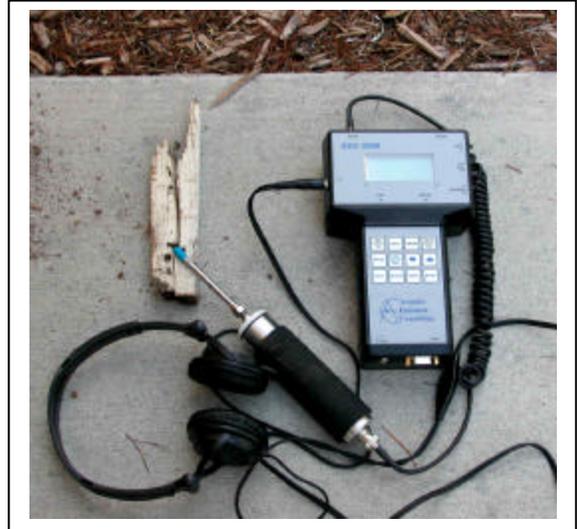
AED 2000L is a portable hand-held instrument that is the most advanced and sensitive acoustic detection system for locating termites and hidden insect pest infestations in wooden structures, trees, plants and soil. The AED, a product of several years collaboration with the USDA Agricultural Research Service literally permits the user to listen to the insect pests eating their way through wood or even in some cases walking.

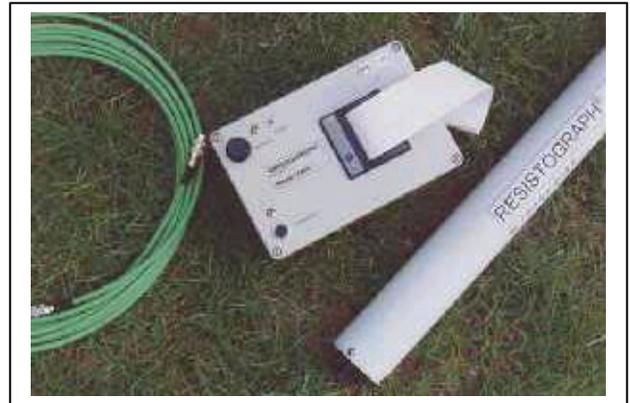
The Resistograph is an instrument that is utilized to measure the structural integrity of wood structures. Utilizing a very fine drill, the Resistograph, as the drill penetrates the wood structure at a predetermined rate and torque, measures the resistance and changes in torque to provide a printable data record of the probing actions. If there is an insect pest gallery present or if there is wood decay, the Resistograph will provide the data necessary to make a structural analysis of the situation.

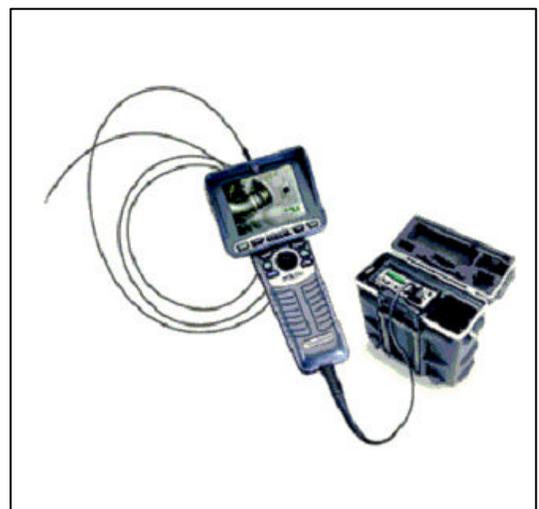
Boroscopes, both manual and video imaging, can provide crucial confirmation of the presence of insect pest infestations. Inserted through a tiny hole, the boroscope probe can be manipulated to the suspected area of infestation where visual confirmation can be obtained. Either video or digital imaging cameras can be utilized to record the findings.

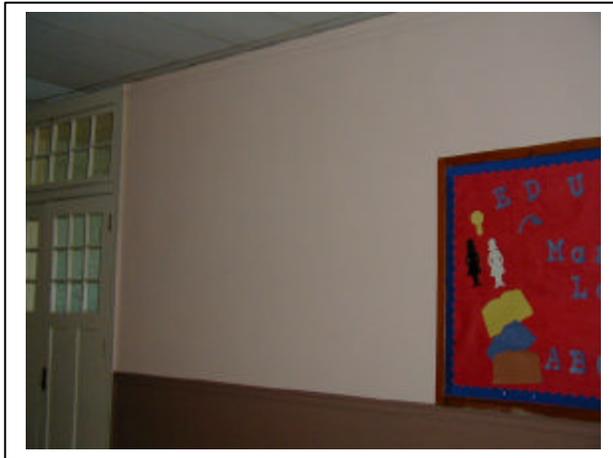
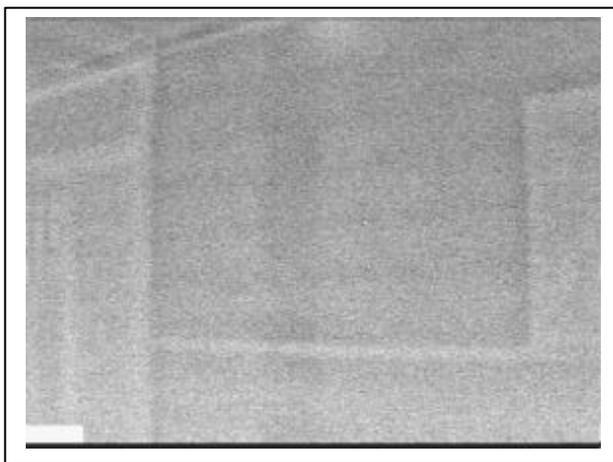
- A final caution. It is additionally important to know your equipment and its capabilities. Sometimes one must realize that you may not have the right imager for the job. Also, you may have the right type of imager but perhaps the sensitivity of your imager itself makes it the wrong imager for the job. Additionally, it is the author's opinion that color viewfinder images have a tendency to wash out the tonal contrasts needed to detect many of the anomalies associated with pest problems. Look at the following:

A field study was performed by Jack Leonard in New Orleans utilizing 2 comparable uncooled IR cameras – one being the Palm IR250 with various lenses and the other being the IR-100/ISI Insight. The results are shown here. The digital picture at top left shows the subject area. The image at the upper right was taken with the Palm IR250 with a 50mm lens. The image at the lower left was also taken with the Palm IR250 with a 25mm lens. The image at the lower right was taken with the Protec IR-100/ISI Insight with a 20mm lens. Though similar in nature, the image at the lower right revealed more detail and showed an anomaly more clearly than the other, more costly camera.
