Paper Mill Saves Budget Dollars with IR Window Program ROI Case Study 1

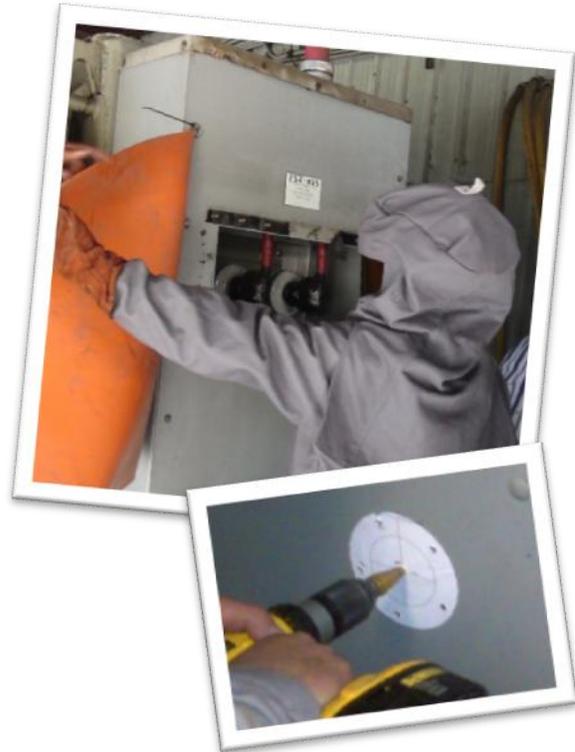
Installation of the infrared inspection panes was conducted during three nights and three days during the ten-day shutdown. Some installations were completed on live gear using additional safety measures; however, the vast majority were conducted on deenergized equipment in what NFPA terms an “electrically safe work condition”.

Although our plan allowed for twelve-hour shifts, installers were quickly and safely moving at a rate of approximately six window installations per hour, and were finishing the plant on the night shifts within six hours. Installations during normal business hours allowed much more flexibility; therefore, all “live works” were completed during these periods. When the clients’ electricians assisted with the installations, the installation rates were also faster than originally planned (7 to 8 windows per hour). All window installations were completed well within the allotted timelines.
